SAFETY INVESTIGATION REPORT

REPORT NO.: 10/2019

MY LA POLONIA **Fatal fall in the cabin,** **in the port of Imperia, Italy** **04 July 2018**

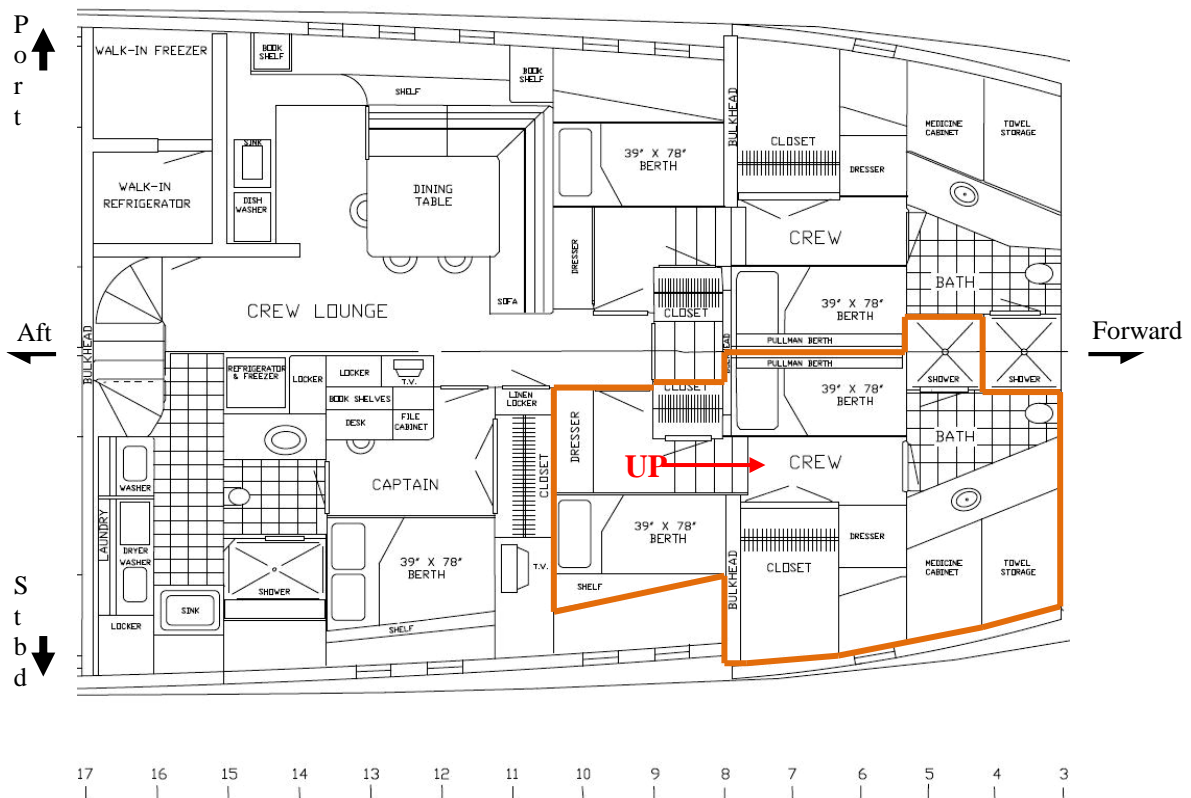
Figure 1: Extract of General Arrangement Plan (Scale 1:48)

The chief stewardess' cabin was located on the Lower Deck, as highlighted in Figure 1.

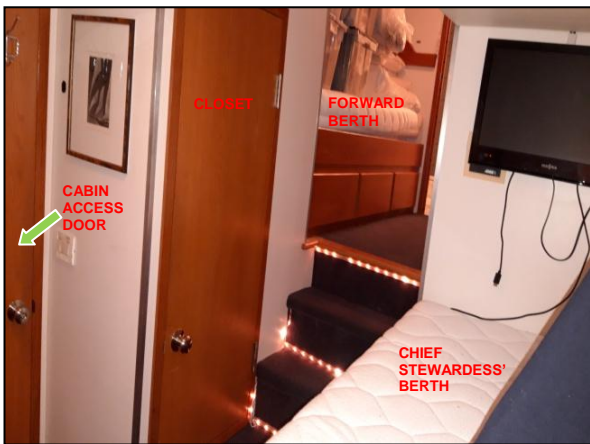
Figure 2: Layout of the cabin occupied by the chief stewardess

The cabin consisted of three berths – two forward (upper), which included a Pullman Berth¹, one aft (lower), and a shared bath. The chief stewardess was occupying the first berth (the aft berth) of the cabin, and was the sole occupant of the cabin. The other three crew members were occupying the berths on the port side of the vessel. In order to access the bathroom of this cabin, one would have to pass the chief stewardess’ berth, and walk up five steps, thereafter passing by the forward berth (Figure 2).

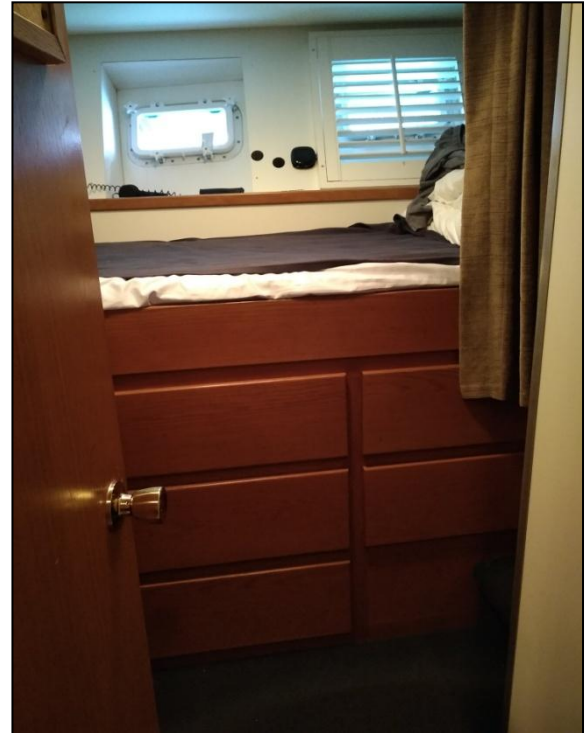
Figure 4: Height of the bed – aft (lower) berth (Similar to the one occupied by the chief stewardess)

The bed which was occupied by the chief stewardess was high above the floor of the cabin, and could be estimated to be approximately one metre above the cabin floor (Figure 4).

There were neither permanent nor temporary steps available, which could have facilitated climbing in or out of the bed; and the bed was not fitted with any guard rails.

The last two hypotheses led the safety investigation to understand that a fall from the height of the bed could have contributed to the fatal injuries sustained by the chief stewardess.

10/2019_R4 assess the risks associated with the heights of the bunks in the cabins, and take measures to mitigate the same, if so identified;
