Maritec Tanker Management Pvt Ltd

NAVIGATIONAL CAMPAIGN (MTMPL/QHSE/NAVIGATIONAL/01 of 2023)

SUBJECT: CONTACT INCIDENT WITH BERTHED VESSEL AND JETTY DURING RIVER TRANSIT

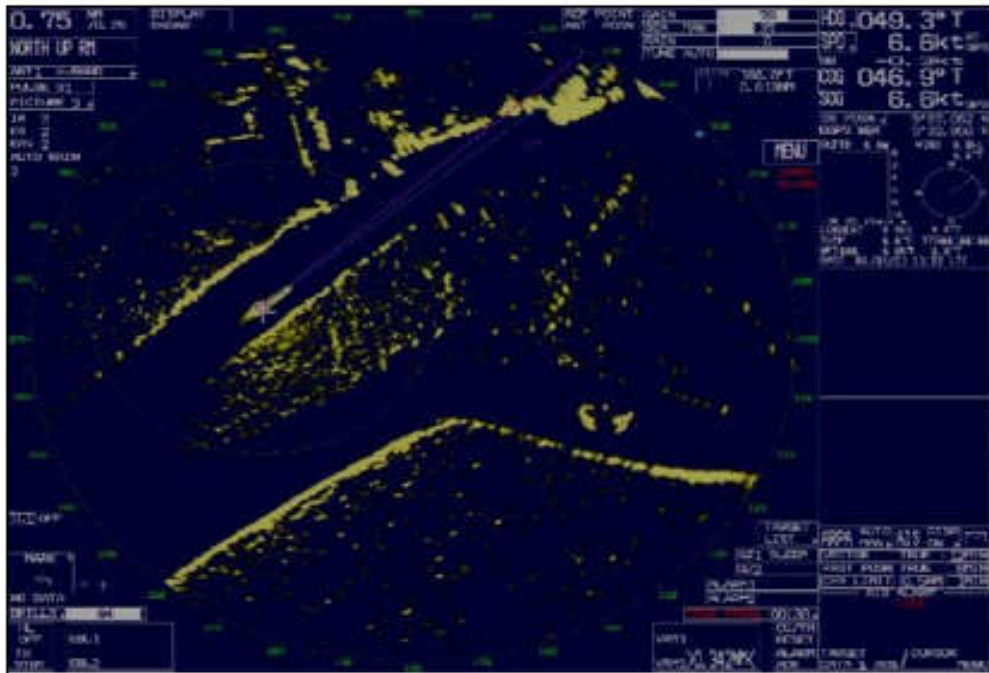
TIME	1355 UTC
HEADING	049.3°
COG	046.9°
SOG	6.6 Knots
OTHER VESSEL	Acquired Vessel Alpha berthed at port side.
AUDIO	Pilot – Stbd. 5 / H/M – Stbd. 5

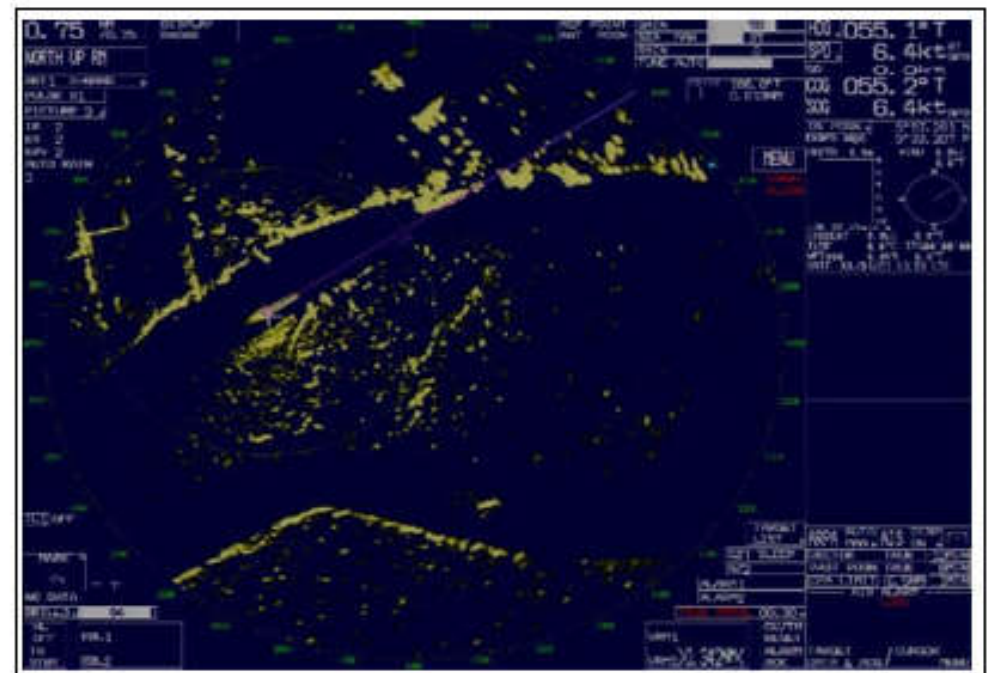
TIME	1358 UTC
HEADING	055.1°
COG	055.2°
SOG	6.4 Knots
AUDIO	Pilot – Hard to stbd. / H/M – Hard to stbd. Sir Pilot – Thruster to stbd. / OOW – Thruster to stbd. sir Pilot – Full ahead / OOW – Full ahead

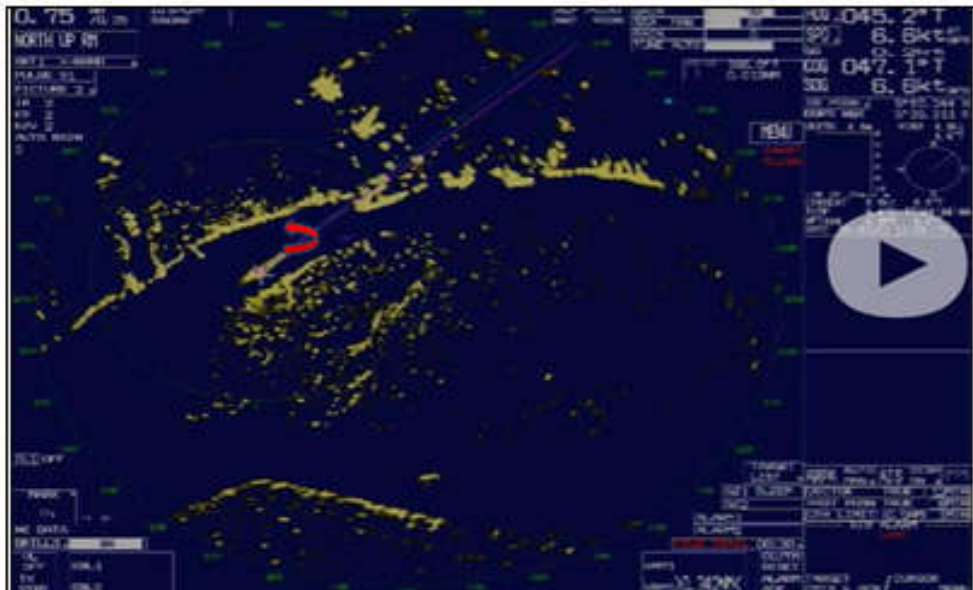
TIME	1359 UTC
HEADING	045.2°
COG	047.1°
SOG	6.6 Knots
OTHER VESSEL	Approaching Vessel Alpha
AUDIO	Pilot – Full ahead / OOW – Full ahead Pilot – Hard to stbd. / H/M – Wheel on full to stbd. Sir Pilot – Increase the pitch, Hard to stbd. Please quickly

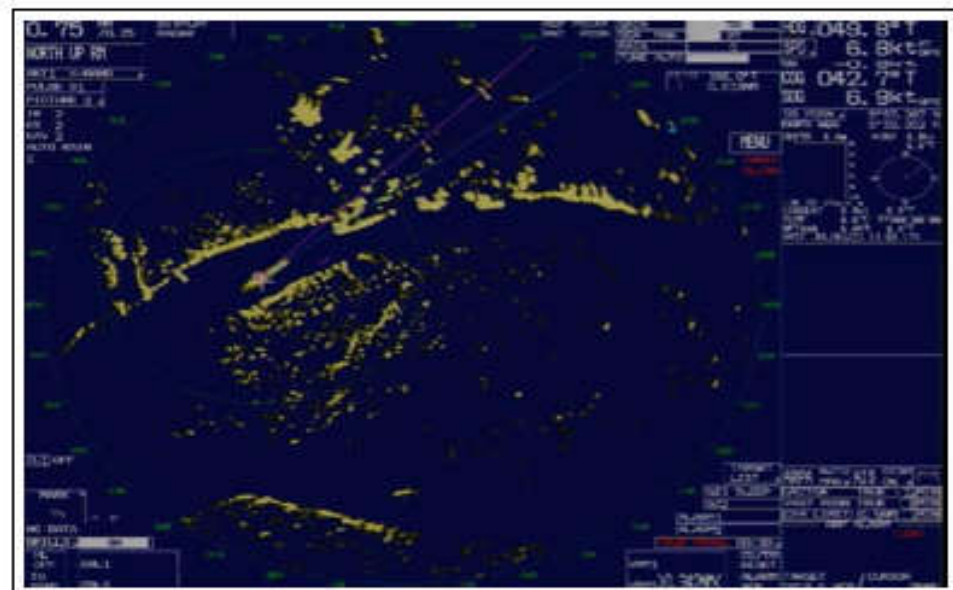
TIME	1400 UTC
HEADING	049.8°
COG	042.7°
SOG	6.9 Knots
OTHER VESSEL	Approaching Alpha
AUDIO	Pilot – Hard to stbd. / H/M – Wheel on hard to stbd. Sir Pilot – Midship / H/M – Midship Pilot – Hard to stbd. / H/M – Hard to stbd.

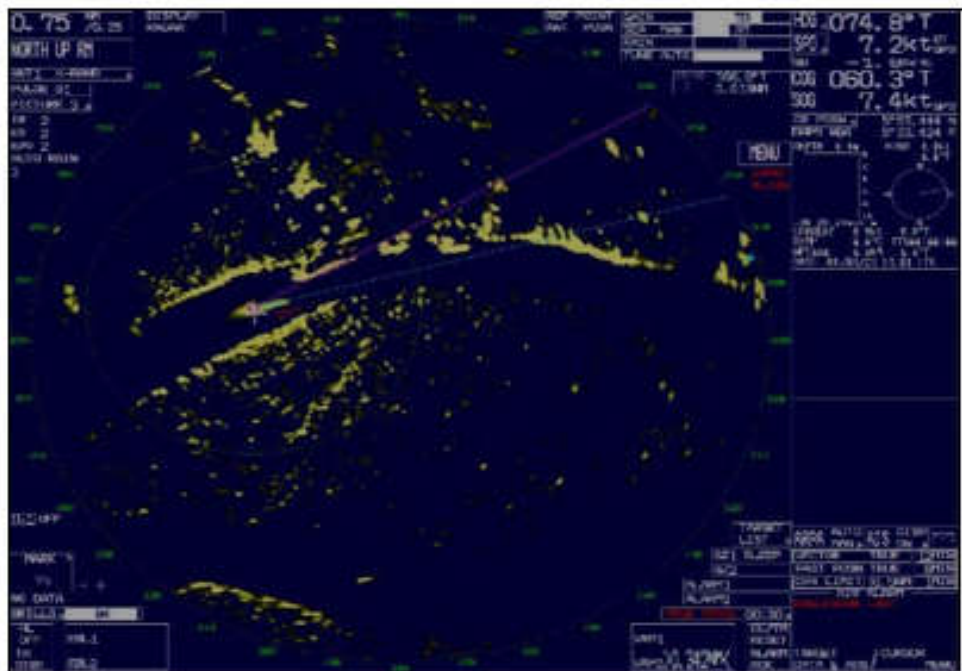
TIME	1401 UTC
HEADING	074.8°
COG	060.3°
SOG	7.4 Knots
OTHER VESSEL	Zulu passing Alpha very close.
AUDIO	Pilot – Keep clear, Full ahead / OOW – Full ahead sir Pilot – bow thruster full stbd.

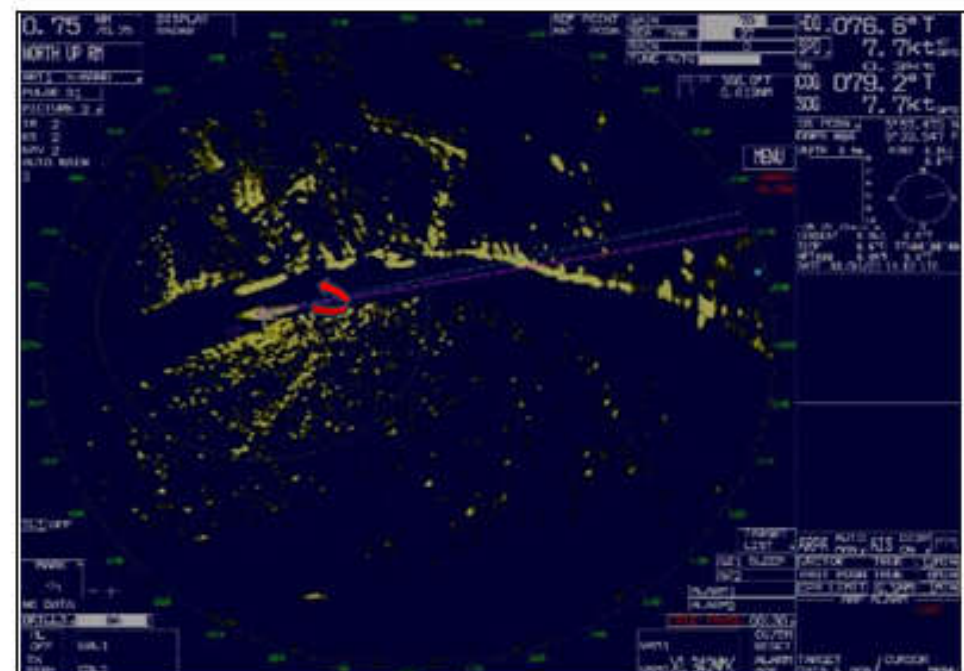
TIME	1402 UTC
HEADING	076.6°
COG	079.2°
SOG	7.7 Knots
OTHER VESSEL	<u>Vessel passing</u> Alpha from port side, closed onto starboard bank
AUDIO	Pilot – Hard to stbd. / <u>H/M</u> – Hard to stbd. Pilot – Stop thruster / OOW – Stop thruster sir

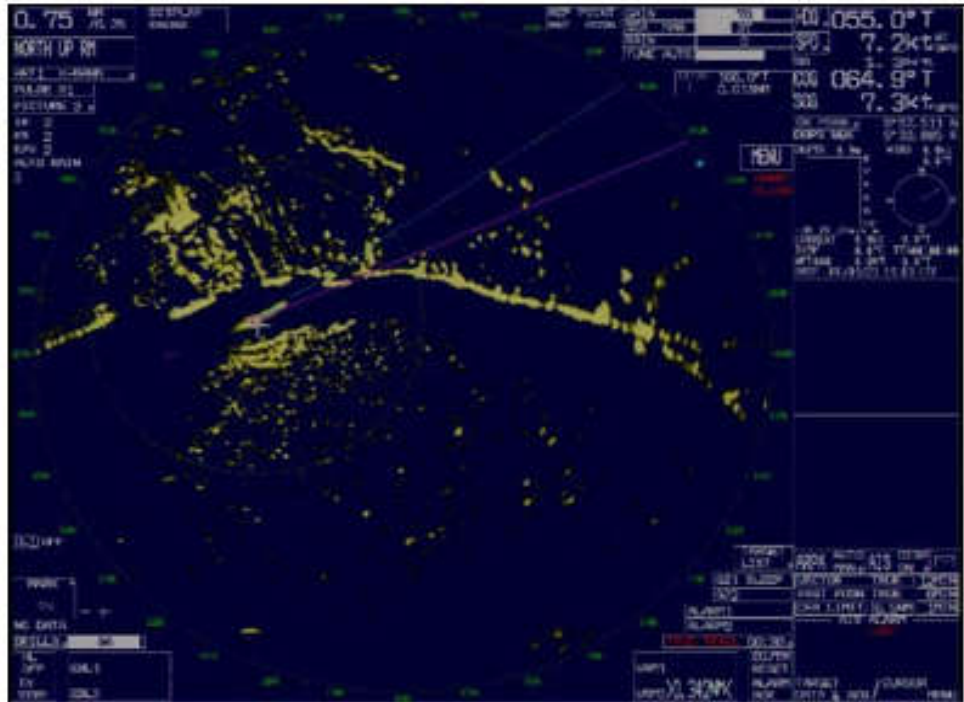
TIME	1403 UTC
HEADING	055.5°
COG	064.9°
SOG	7.3 Knots
VESSEL BETA	Right Ahead
AUDIO	Pilot – Hard to stbd. / H/M – Hard to stbd.

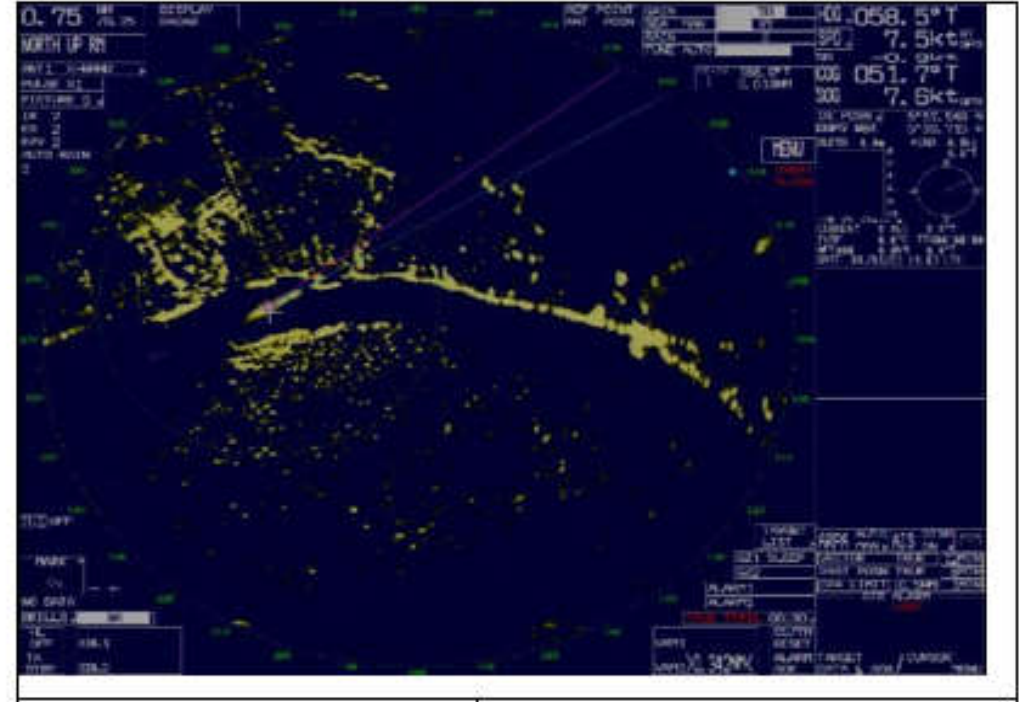
TIME	1403:30 UTC
HEADING	058.5°
COG	051.7°
SOG	7.6 Knots
VESSEL BETA	Very close to the bow
AUDIO	Master – Engine stop / Pilot – Don't <u>stop</u>

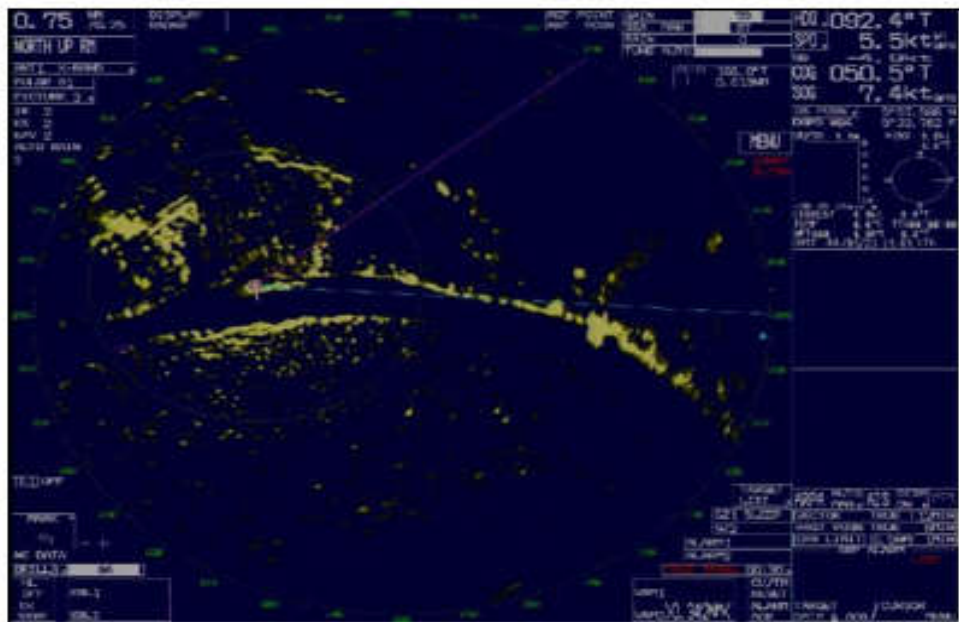
TIME	1404 UTC
HEADING	092.4°
COG	050.5°
SOG	7.4 Knots
OTHER VESSEL	Vessel Zulu Contact with port quarter of Vessel Beta
AUDIO	Master – Anchor / OOW – Anchor is <u>gone</u> Master – Anchor hang with this ship; we <u>have to</u> stop engine. / Pilot – Please don't stop. Pilot – Hard port / H/M – Hard port sir Pilot – Thruster Full to port / OOW – Full to port sir
MARK	Vessel Zulu <u>made contact with</u> Vessel Beta

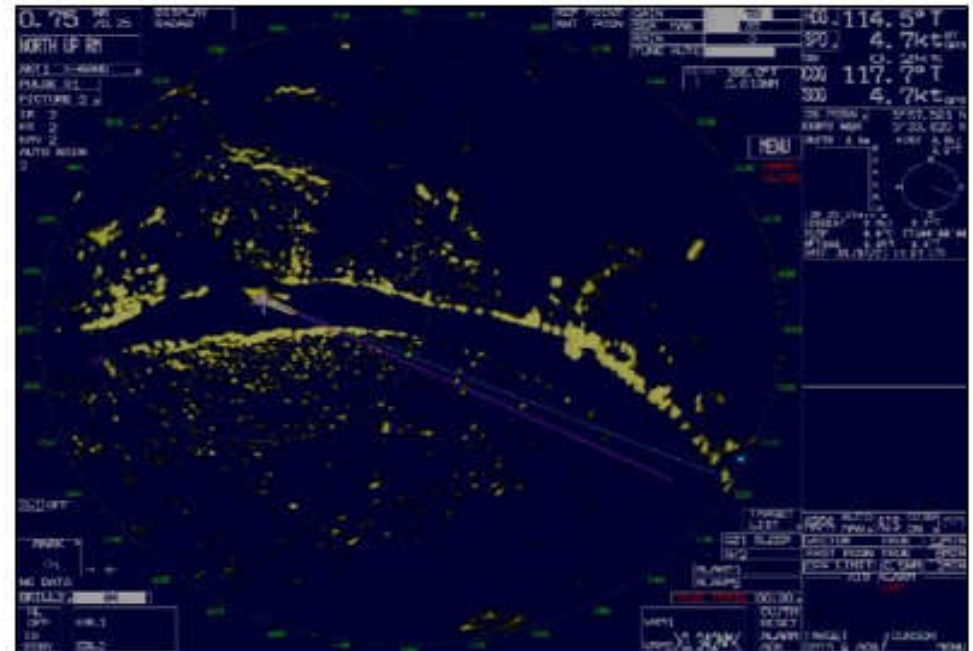
TIME	1405 UTC
HEADING	114.5°
COG	117.7°
SOG	4.7 Knots
OTHER VESSEL	Vessel Zulu port quarter contact with Jetty / Pier
AUDIO	Pilot – Stop Thruster / OOW – Stop thruster Pilot – Hard to port / H/M – Hard to port <u>Sir</u> Master – Anchor is stuck with another ship, Stop Engine, Let Go Stbd. Anchor / OOW – Let go stbd. anchor

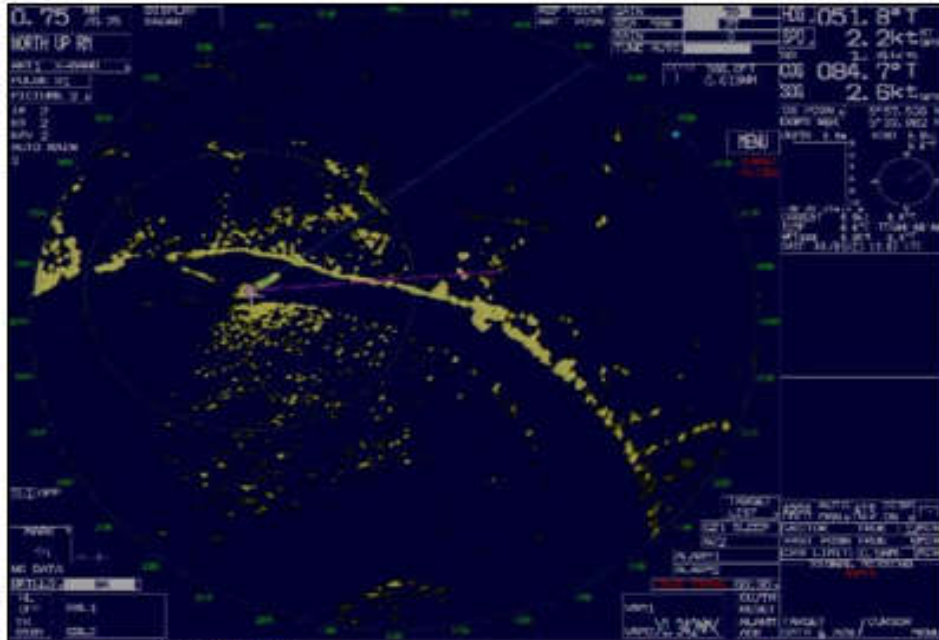
TIME	1407 UTC
HEADING	051.8°
COG	084.7°
SOG	2.2 Knots
OTHER VESSEL	Stuck Anchor in Vessel Beta accommodation
AUDIO	Alarm ringing no clear voice <u>heard</u> On PA System – Attention – 2 Muster station everybody come to bridge H/M – Midship OOW – Full to stbd. sir

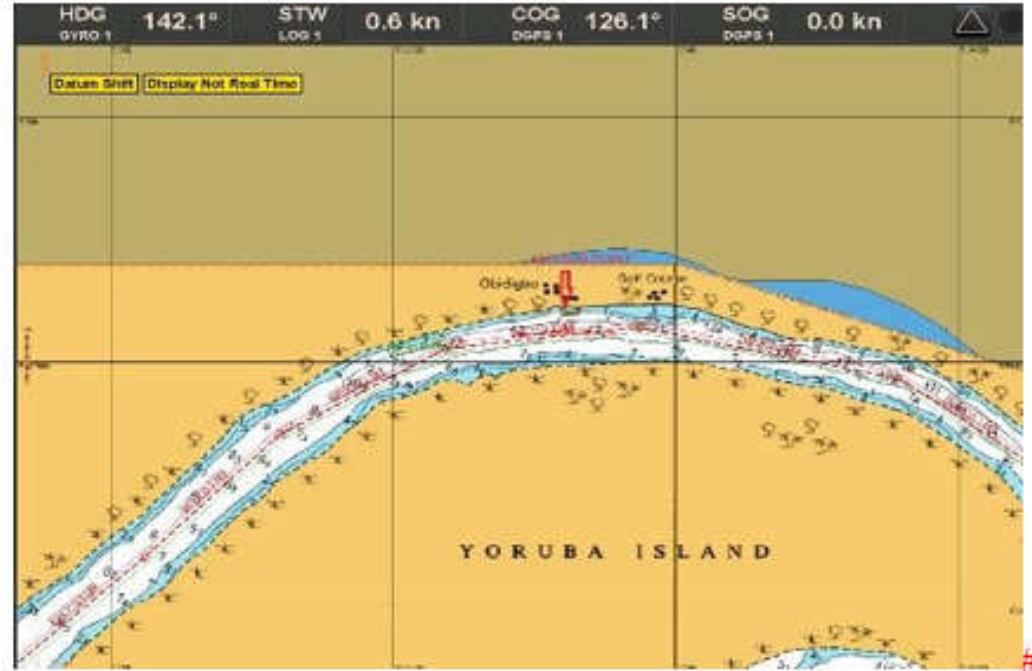
Location marked by Red Arrow location of Collision
