CCR. 7.2 (A) - TANK CONDITION REPORT – CARGO TANKS

Vessel: MT. Bahama Blue

Cargo Tank: 1P

Insp Date: 04.02.2021

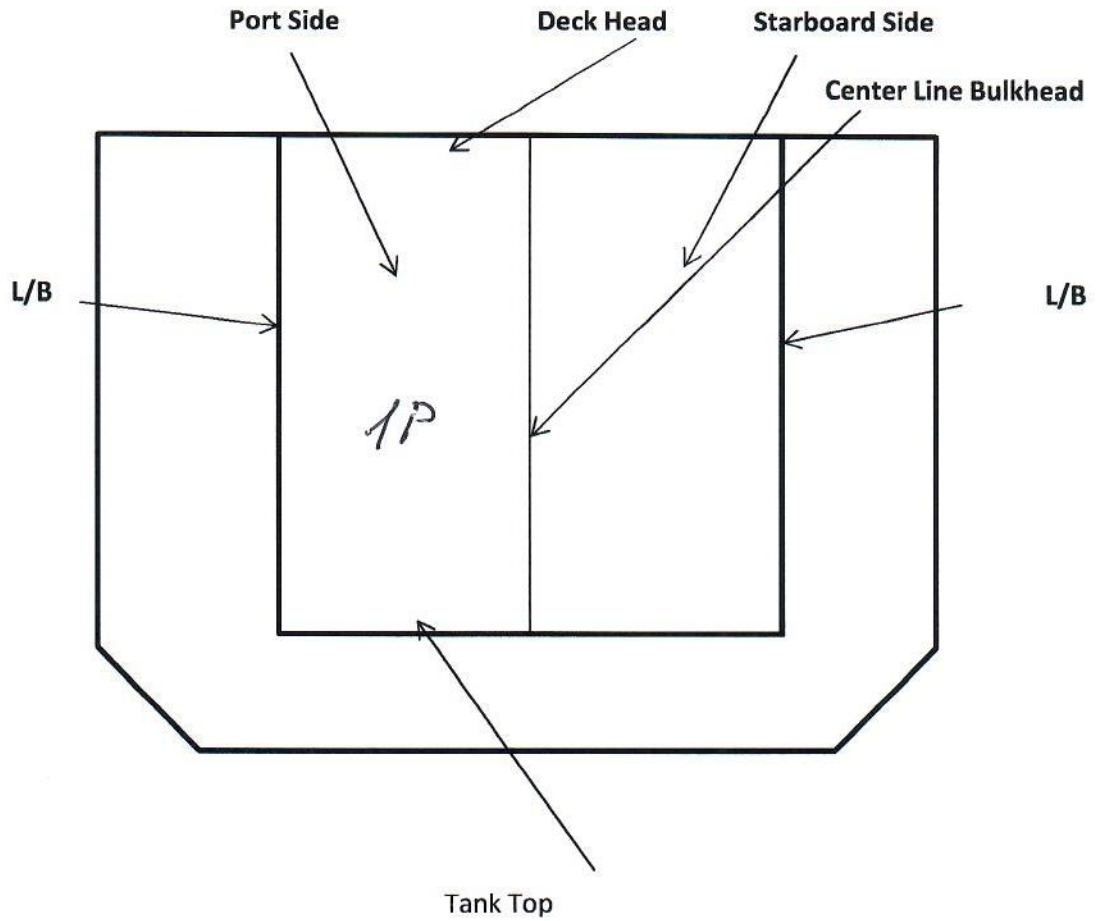
Tank Bottom Insulation COATING	<input type="checkbox"/>	<input type="checkbox"/>	<input checked="" type="checkbox"/>	<input type="checkbox"/>	Localised pitting.
Port Bulkhead Insulation COATING	<input type="checkbox"/>	<input type="checkbox"/>	<input checked="" type="checkbox"/>	<input type="checkbox"/>	
Starboard Bulkhead Insulation COATING	<input type="checkbox"/>	<input type="checkbox"/>	<input checked="" type="checkbox"/>	<input type="checkbox"/>	
Centre Line Bulkhead (Insulation / Coating)	<input type="checkbox"/>	<input type="checkbox"/>	<input checked="" type="checkbox"/>	<input type="checkbox"/>	
Forward Bulkhead (Insulation / Coating)	<input type="checkbox"/>	<input type="checkbox"/>	<input checked="" type="checkbox"/>	<input type="checkbox"/>	
AFT Bulkhead (Insulation / Coating)	<input type="checkbox"/>	<input type="checkbox"/>	<input checked="" type="checkbox"/>	<input type="checkbox"/>
