**CCR. 7.2 (A) - TANK CONDITION REPORT – CARGO TANKS**

Vessel: MT Bahama Blue

Cargo Tank: 15

Insp Date : 04.02.2021

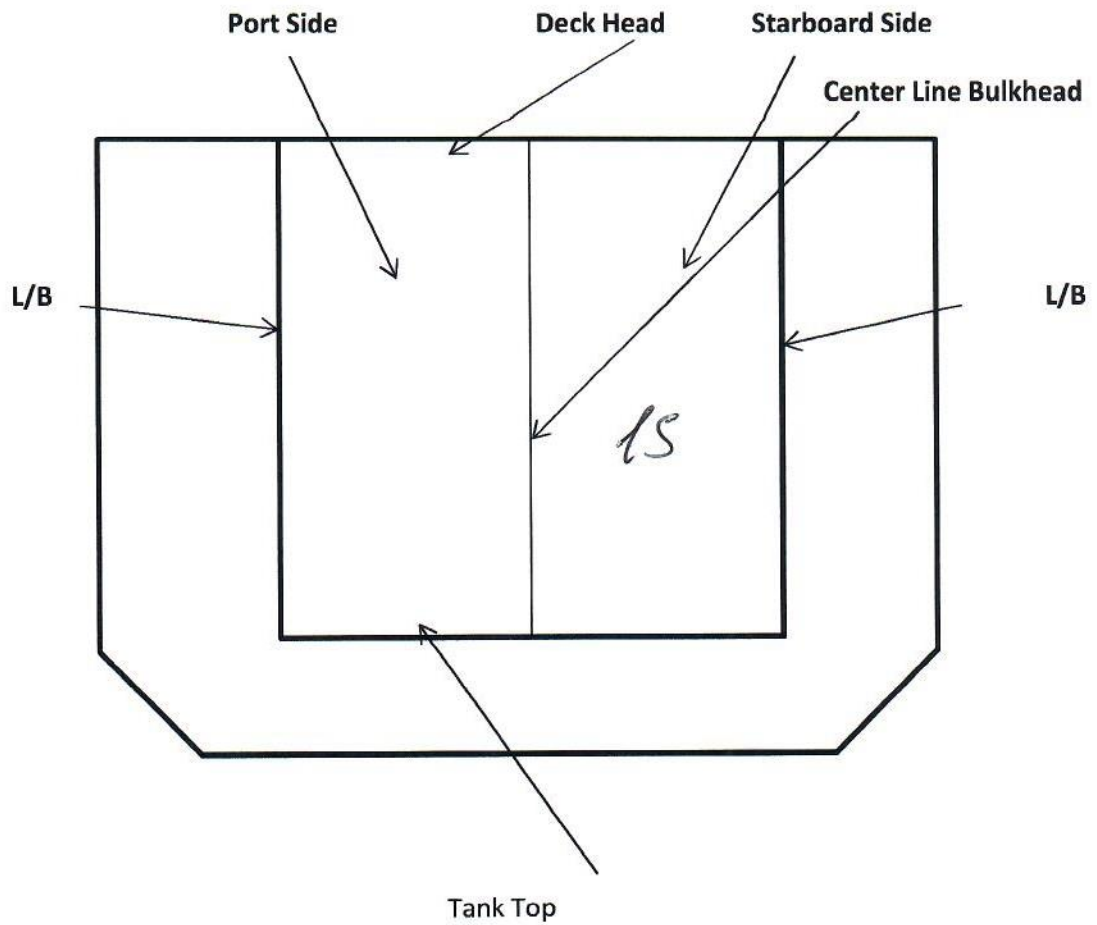
Tank Bottom Insulation COATING	<input type="checkbox"/>	<input type="checkbox"/>	<input checked="" type="checkbox"/>	<input type="checkbox"/>	LOCALISED PITTING
Port Bulkhead Insulation COATING	<input type="checkbox"/>	<input type="checkbox"/>	<input checked="" type="checkbox"/>	<input type="checkbox"/>	
Starboard Bulkhead Insulation COATING	<input type="checkbox"/>	<input type="checkbox"/>	<input checked="" type="checkbox"/>	<input type="checkbox"/>	
Centre Line Bulkhead (Insulation / Coating)	<input type="checkbox"/>	<input type="checkbox"/>	<input checked="" type="checkbox"/>	<input type="checkbox"/>	
Forward Bulkhead (Insulation / Coating)	<input type="checkbox"/>	<input type="checkbox"/>	<input checked="" type="checkbox"/>	<input type="checkbox"/>	
AFT Bulkhead (Insulation / Coating)	<input type="checkbox"/>	<input type="checkbox"/>	<input checked="" type="checkbox"/>	<input type="checkbox"/>
