BITU ATLANTIC

CCR. 7.2 (B) - TANK CONDITION REPORT - BALLAST / FRESH WATER TANKS

CCR. 7.2 (B) - TANK CONDITION REPORT - BALLAST /FRESH WATER TANKS

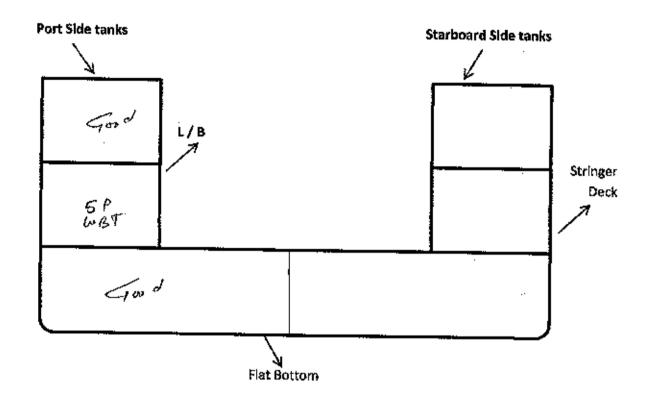
Condition Of Tank Structure Describe Details Of Any Fractures, Substantial Corrosion, Localised Pitting, Buckling, Condition Of Coating (Good, Fair, Poor), Hard Rust, Areas of Penetrations, Leakage from Adjacent Compartments Sood = Minor Spot Rust Only Seir = Local Breakdown Only								
Poor = General Br		Hard Rust						
General Remarks	/ Action Requ	uired:			-			
lv B T Present	wes	sport c	h. p. bud/ Jamb	Panited Very g	dung	4/4	peuson

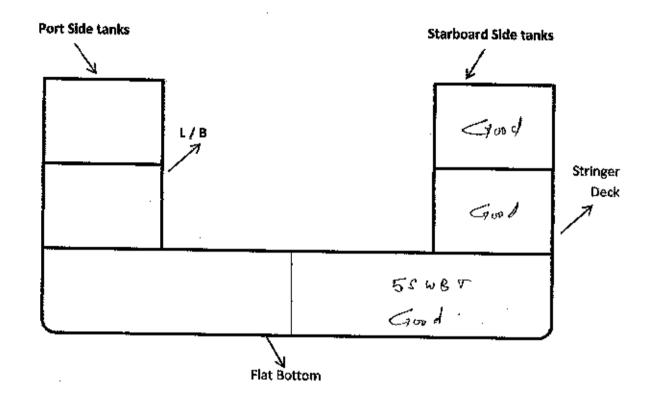
WBF was spot shipped / Pavided dwing obuydoch. Bresent condition of Lamb & very good.

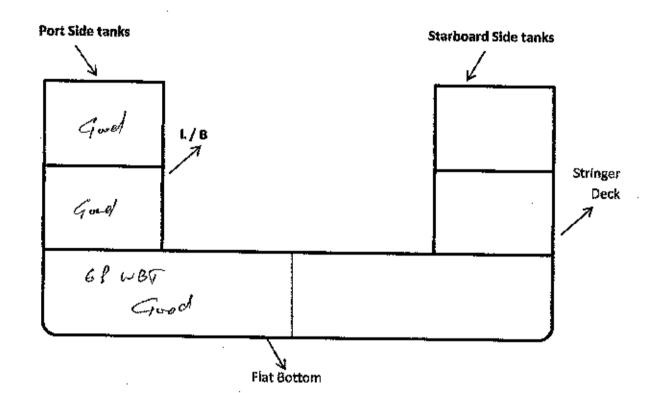
WET were spot shipped / Pander duny 5/4 person.
Present condition of Land very good

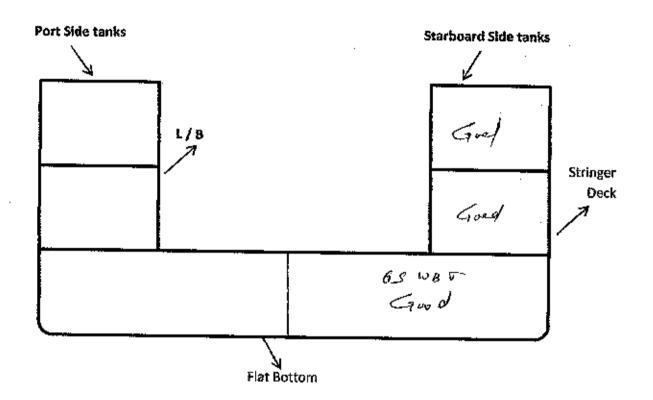
WET was spot chipber | Panted duny Shippard. Preser Could to of sands very good
