#### CCR. 7.2 (B) - TANK CONDITION REPORT - BALLAST FRESH WATER TANKS

Vessel: BITO ATLA	<u>N</u> TIC			L	ocation: FWTP) Cust s/y				
Cargo Tank: $\int \omega$	(1)	_			Insp Date: 20/10/108				
(Frequency : Ballast Tanks Bi-Annually, Fresh Water Tanks Annually)									
General Condition:	ahef	nely							
Coating: No Yes Type of Coating: 6 Pay Y									
Date Last Coating Maintenance: Full Re-coat Part Re-Coat Touch-up									
Tank Fitting & Equipment	Poor	Fair	Good	NA	Details Of Required / Attention				
Hatch Coamings / Man hole covers			Ø						
Ladders / Steps / Handraits			W.						
Level Gauge (Internal)				Š					
Sounding Pipes & Striking Plate			Ū∕						
Internal Frames									
Valve Reach Rod				D					
Eductor Lines & Valves									
Line Supports & Piping Dressers			K						
Suction Well			X						
Bellmouth			<u>"</u>						
Hydraulic Lines & Valves				u/	,				
Fixed Gas Detections Lines & Filters				U					
Ballast Line & Valves				W					
Anodes (If Fitted)					V. V				
Rust / Scale Formation			v		· · · · · · · · · · · · · · · · · · ·

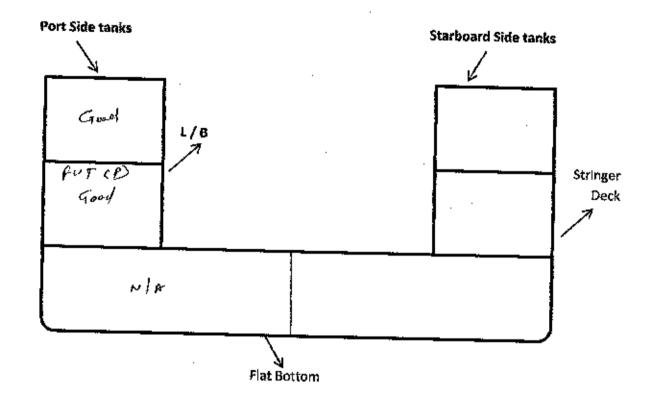
For tank was infected " Granual applition of tank found satisfeety.

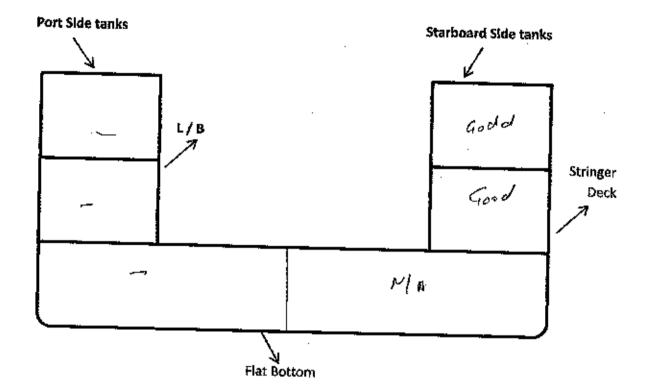
Inspection of DWT (3) careined out. Found cody be cleany in solistedy constituen
