CCR. 7.2 (A) - TANK CONDITION REPORT – CARGO TANKS

Vessel: BIRU ATLANTIC

Cargo Tank: 3P LOT

Cargo Tank: 3S LOT

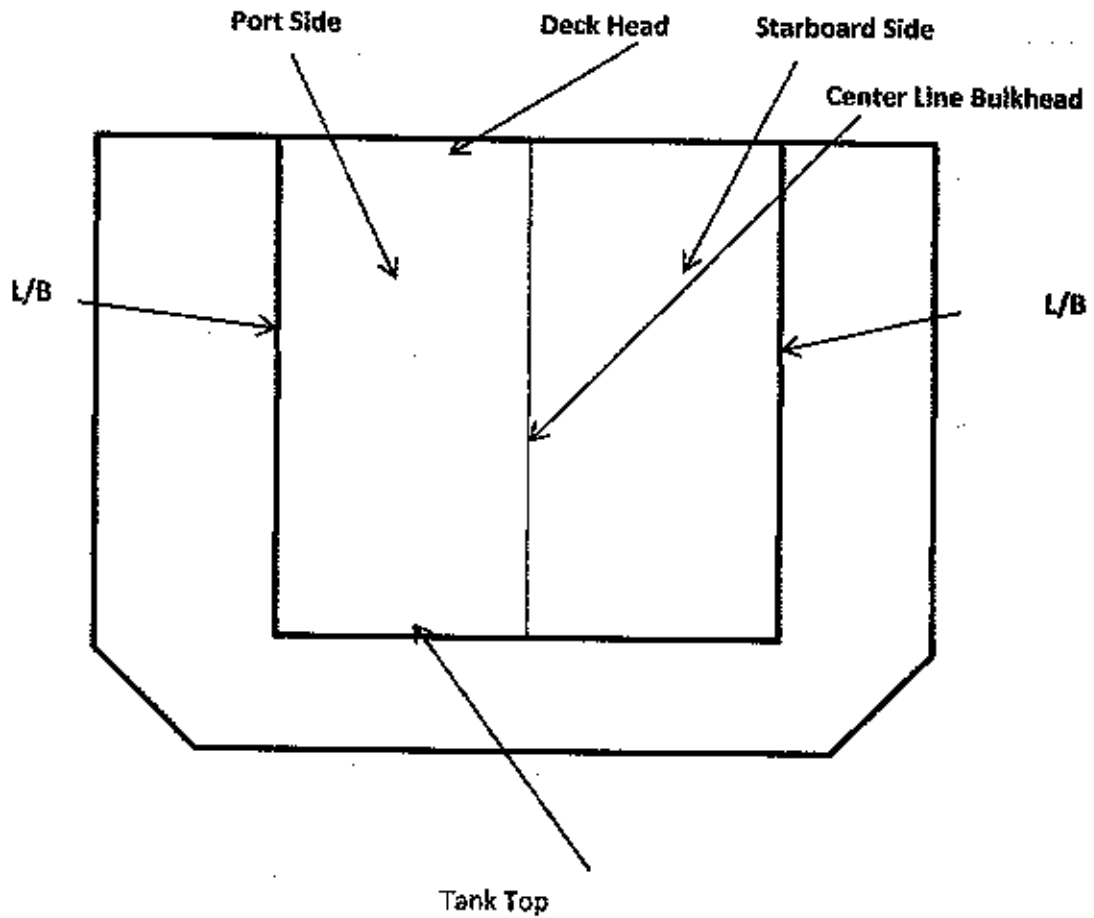
General condition of COT found satisfactory.
