Vessel: _ BITUAILANTIC

CCR. 7.2 (B) - TANK CONDITION REPORT - BALLAST / FRESH WATER TANKS

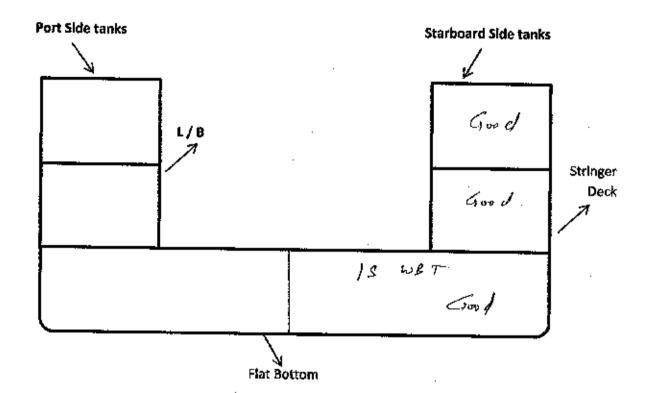
WBT was spot chipped / Parited duny 5/4. Present tanh condition very Goods

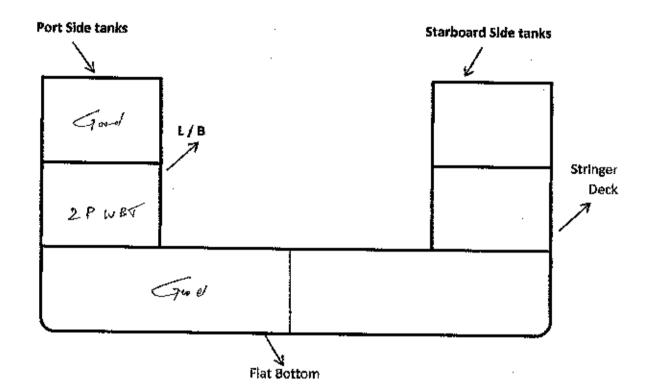
Condition Of Tank Structure Describe Details Of Any Fractures, Substantial Corrosion, Localised Pitting, Buckling, Condition Of Coating (Good, Fair, Poor), Hard Rust, Areas of Penetrations, Leakage from Adjacent Compartments						
Good = Minor S Fair = Local Brea Poor = General I	kdown Only			•		
General Remark	s / Action Re	quired:				
WRT Buses	were -	spot chiff	ed I lamited dung	S/y person

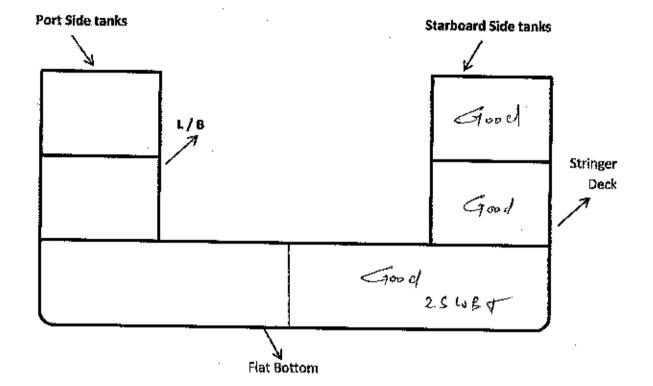
Condition Of Tank Structure Describe Details Of Any Fractures, Substantial Corrosion, Localised Pitting, Buckling, Condition Of Coating (Good, Fair, Poor), Hard Rust, Areas of Penetrations, Leakage from Adjacent Compartments	
Good = Minor Spot Rust Only Fair = Local Breakdown Only Poor = General Breakdown or Hard Rust	
General Remarks / Action Required:	
WBT was spot dipped I aimed dung dry doch Peresert Condition of Janh. very good
