CCR. 7.2 (A) - TANK CONDITION REPORT – CARGO TANKS

Vessel: BITO ATLANTIC

Cargo Tank: 6P COT

Insp Date: 10/10/2018

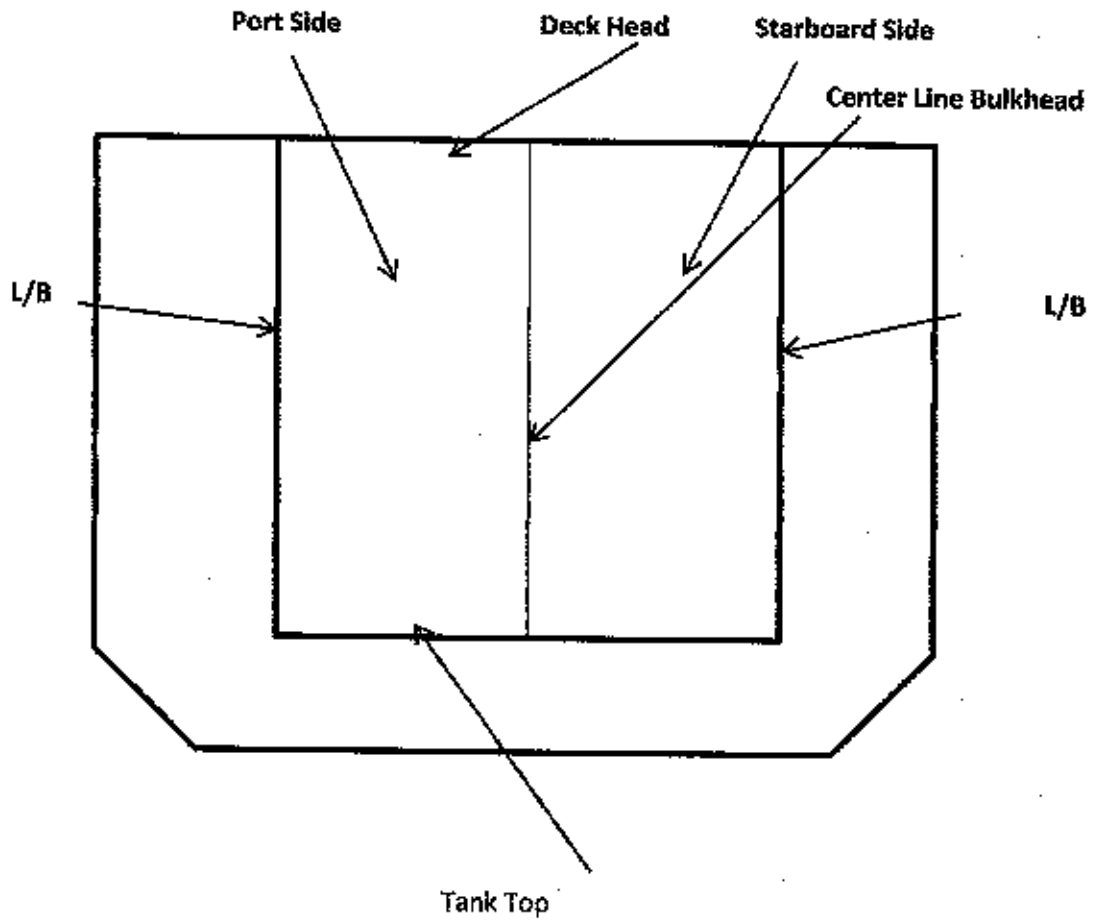
General condition of CoT found satisfactory

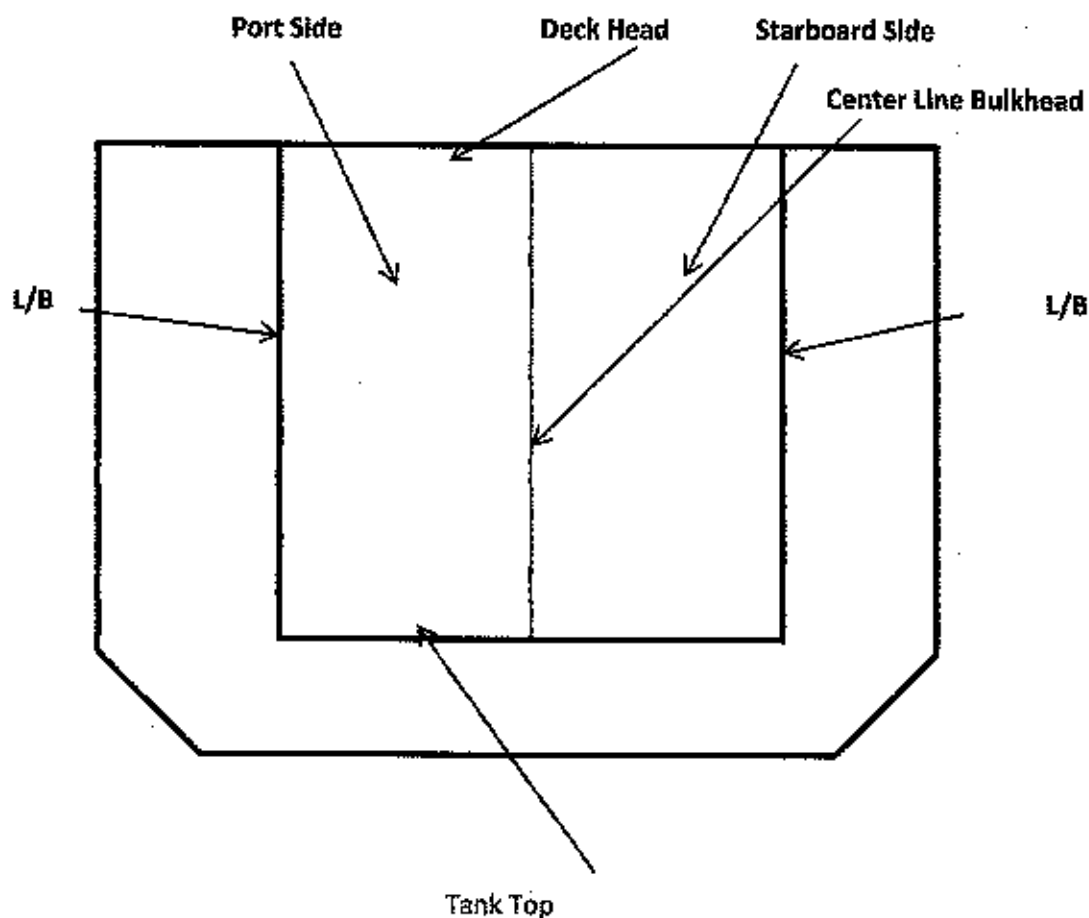
General condition of COT found satisfactory
