CCR. 7.2 (A) - TANK CONDITION REPORT – CARGO TANKS

Vessel: BIRD ATLANTIC

Cargo Tank: 7P COT

Cargo Tank: HS COT

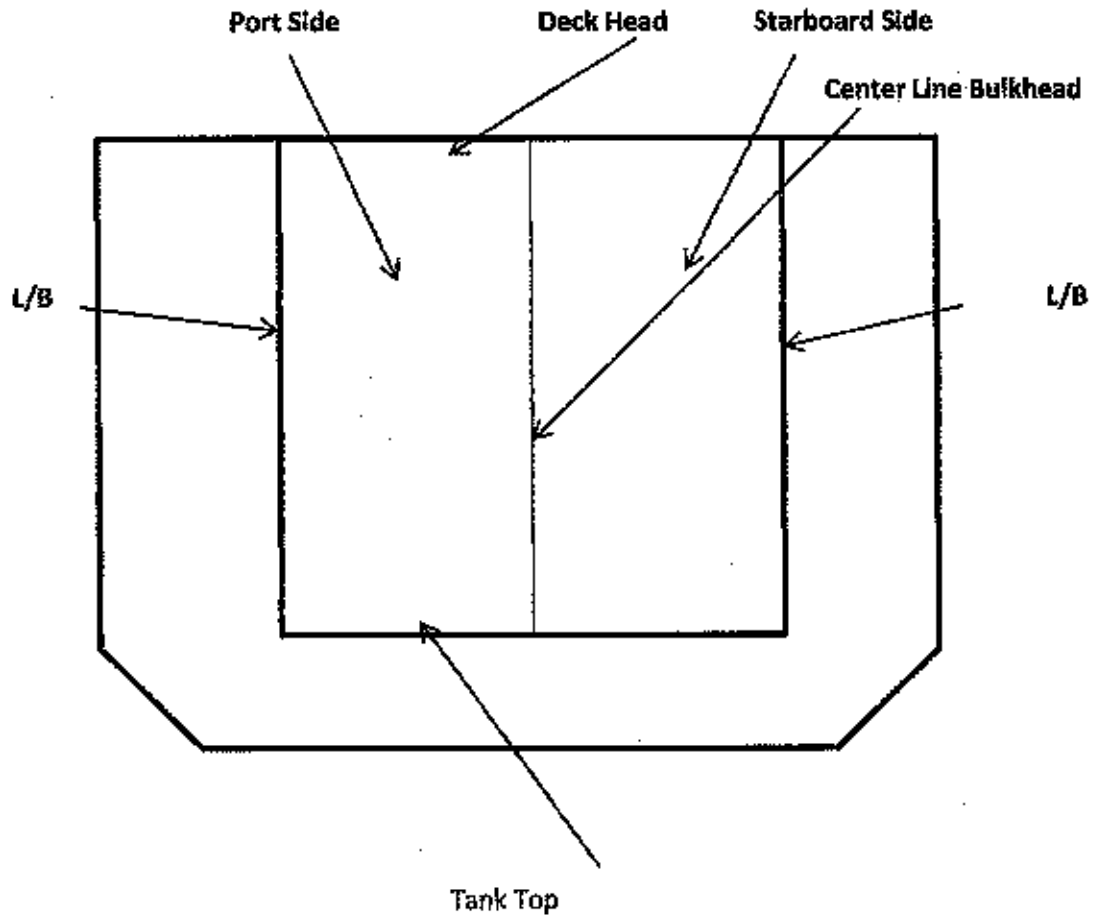
General condition of CoT found satisfactory

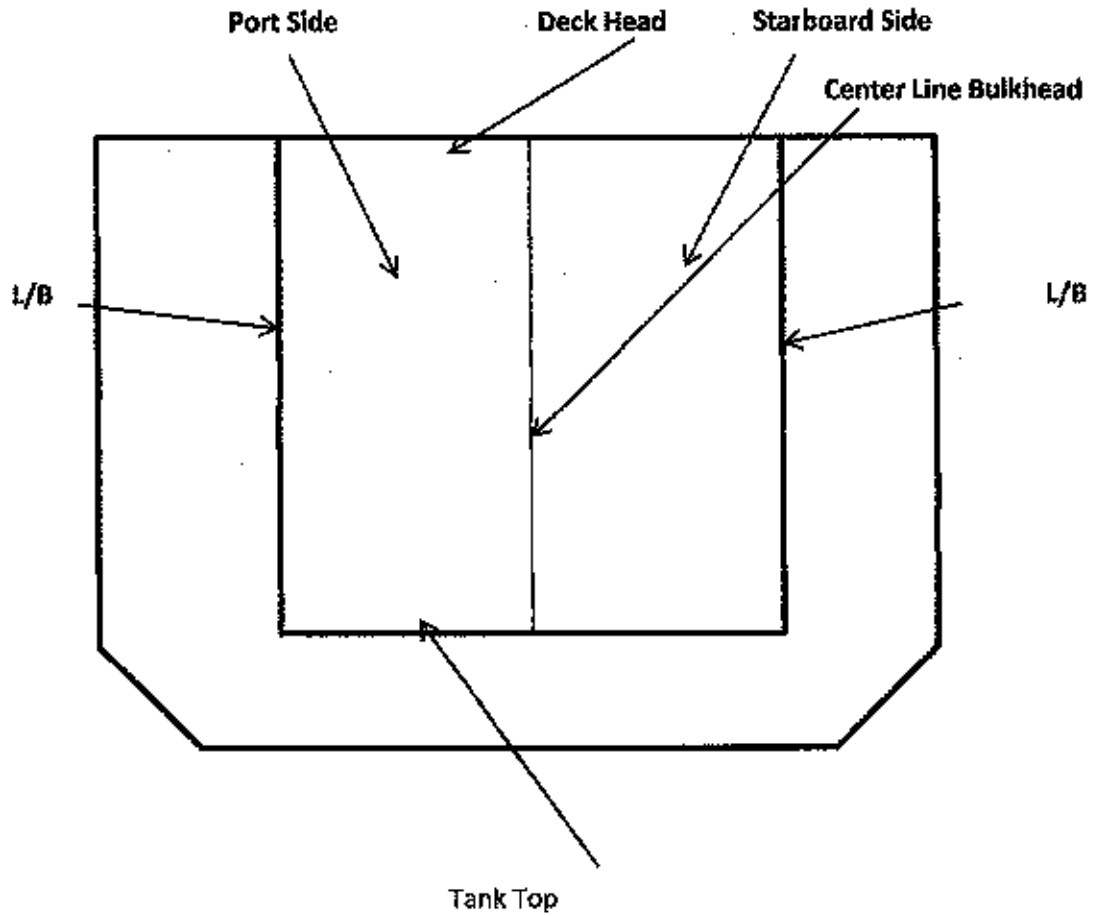
General condition of CoT found satisfactory.
