CCR. 7.2 (A) - TANK CONDITION REPORT – CARGO TANKS

Vessel: BTU ATLANTIC

Cargo Tank: 2P LOF

Insp Date: 11/10/2018

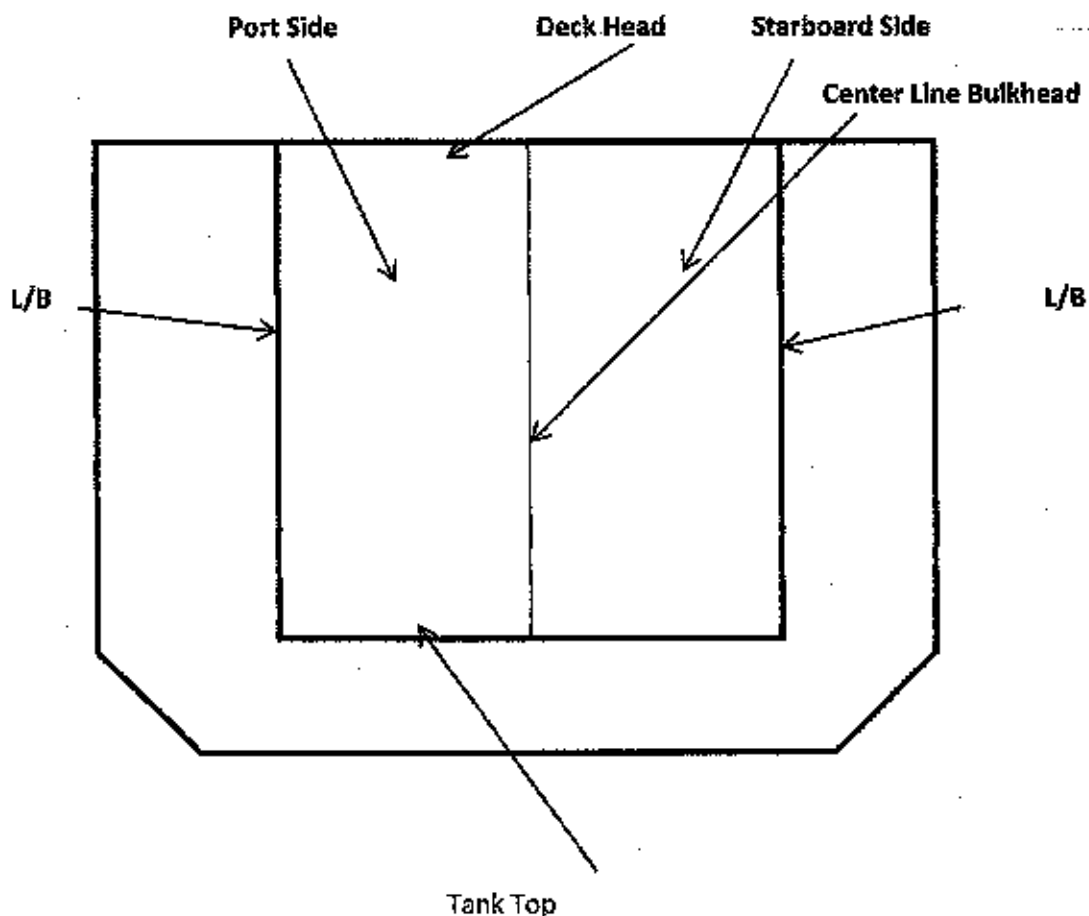
Condition of tank found satisfactory

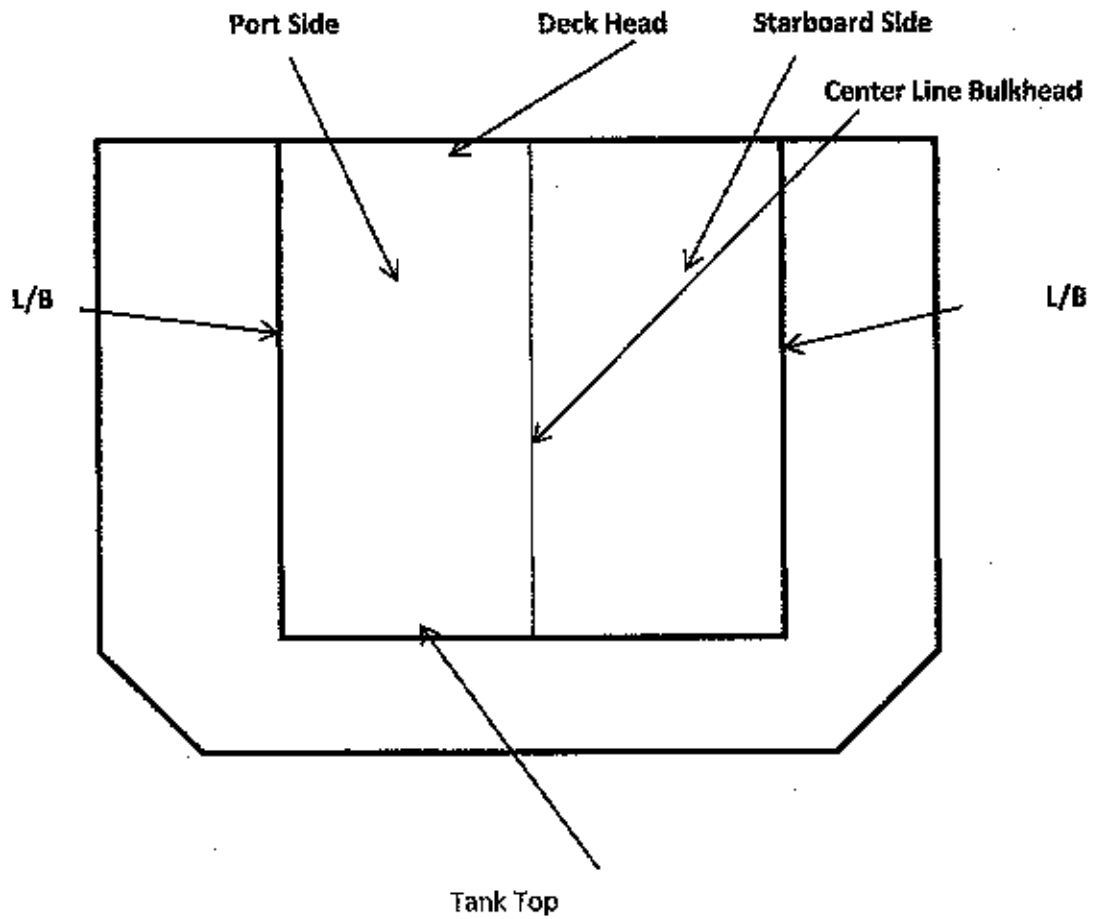
General condition of cot found satisfactory
