Vessel: \_ BITU ATLANTIC

### CCR. 7.2 (B) - TANK CONDITION REPORT - BALLAST / FRESH WATER TANKS

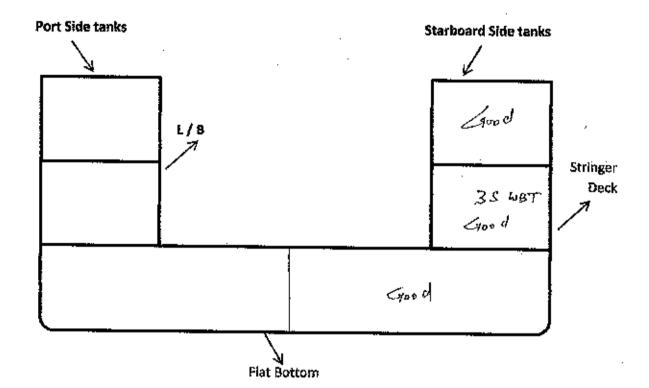
WBT was spot chapped / Painter during daydocks. Peresent tank condition very good,

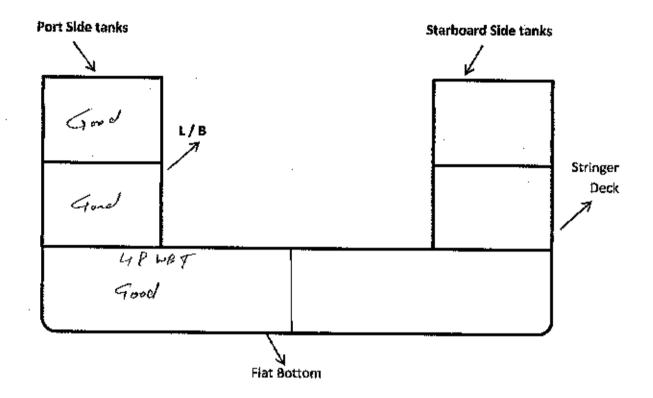
Conditio	Condition Of Tank Structure  Describe Details Of Any Fractures, Substantial Corrosion, Localised Pitting, Buckling,  Condition Of Coating (Good, Fair, Poor), Hard Rust, Areas of Penetrations, Leakage from Adjacent Compartments							
Fair ≈ Loca	inor Spot Rust Only al Breakdown Only peral Breakdown or Hard Rust							
General R	emarks / Action Required:							
WB Por	esent condition of conting very good
