CCR. 7.2 (A) - TANK CONDITION REPORT – CARGO TANKS

Vessel: BITU ATLANTIC

Cargo Tank: 4P COT

Insp Date: 10/10/2018

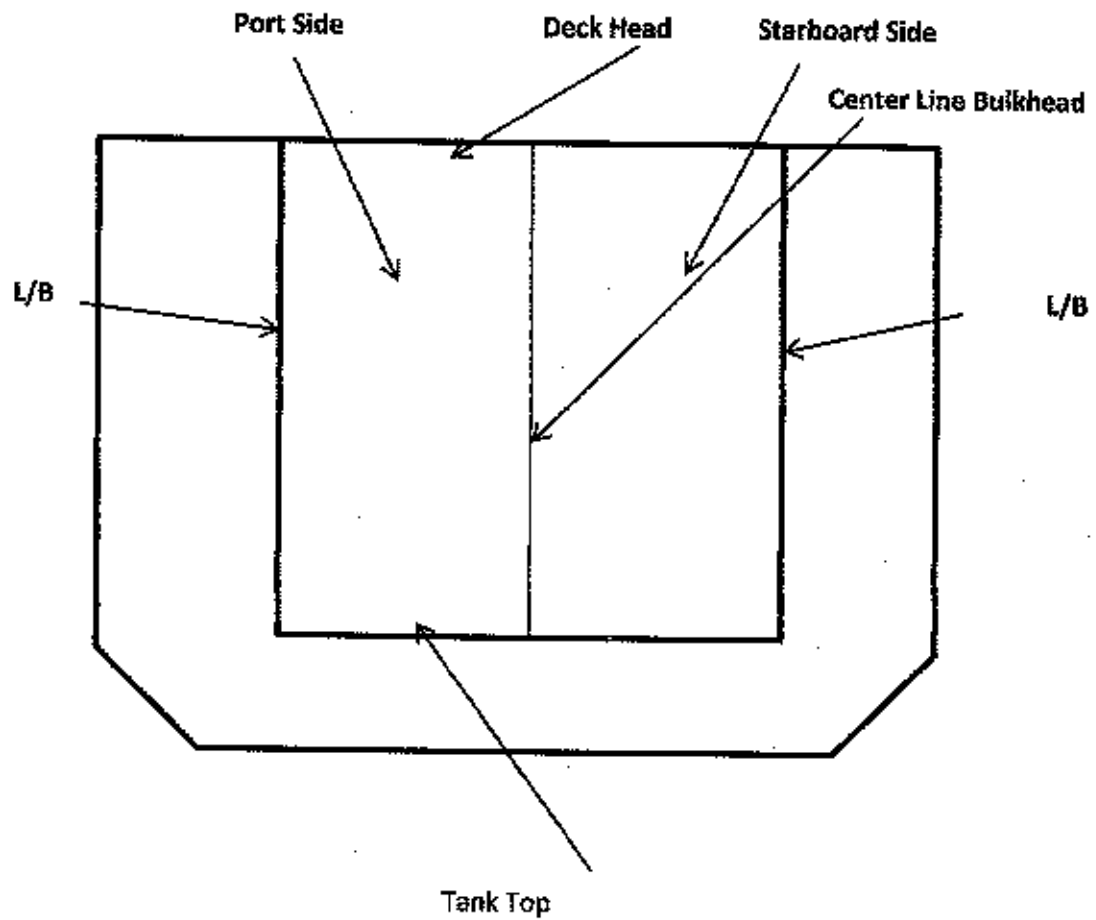
Good condition of COT found satisfactory

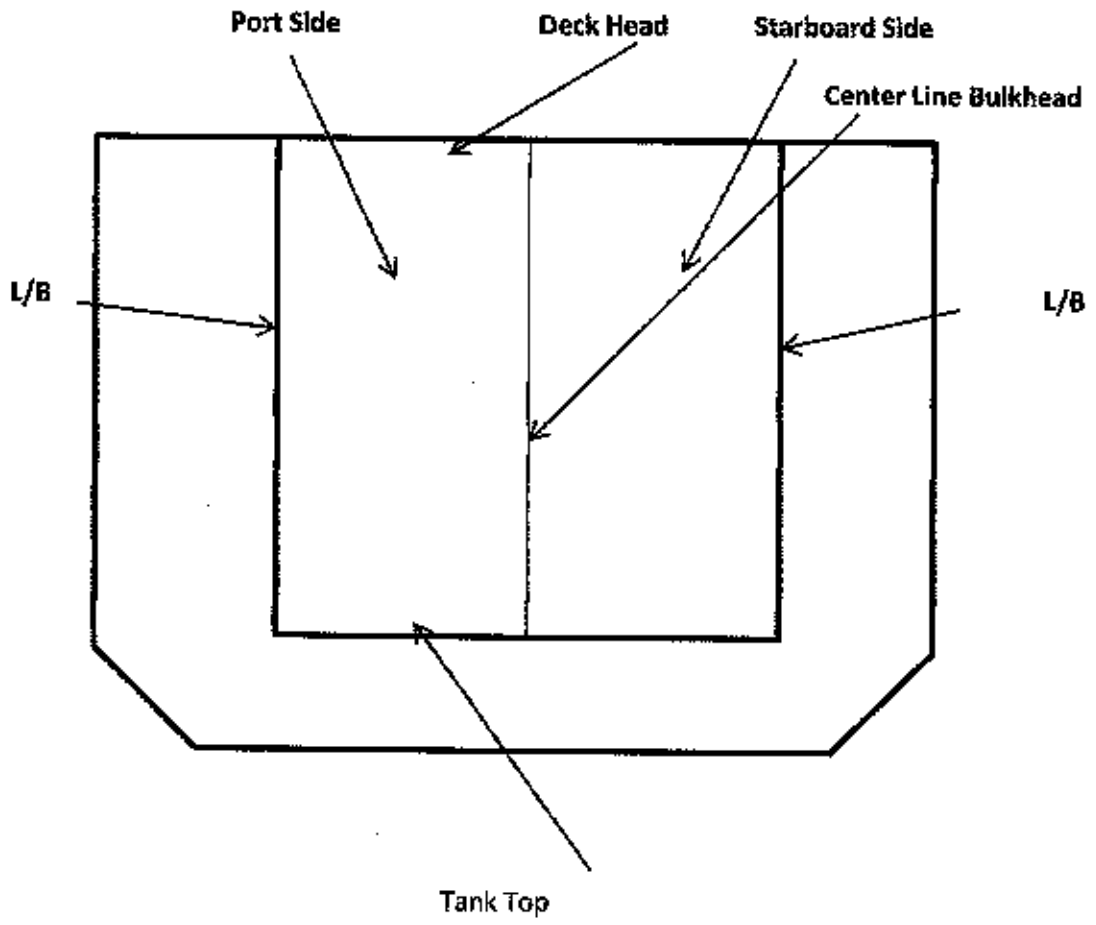
General condition of CoT found satisfactory.
