**CCR. 7.2 (A) - TANK CONDITION REPORT – CARGO TANKS**

Vessel: BITO ATLANTIC

Cargo Tank: SP LOT

Cargo Tank: 5S CDT

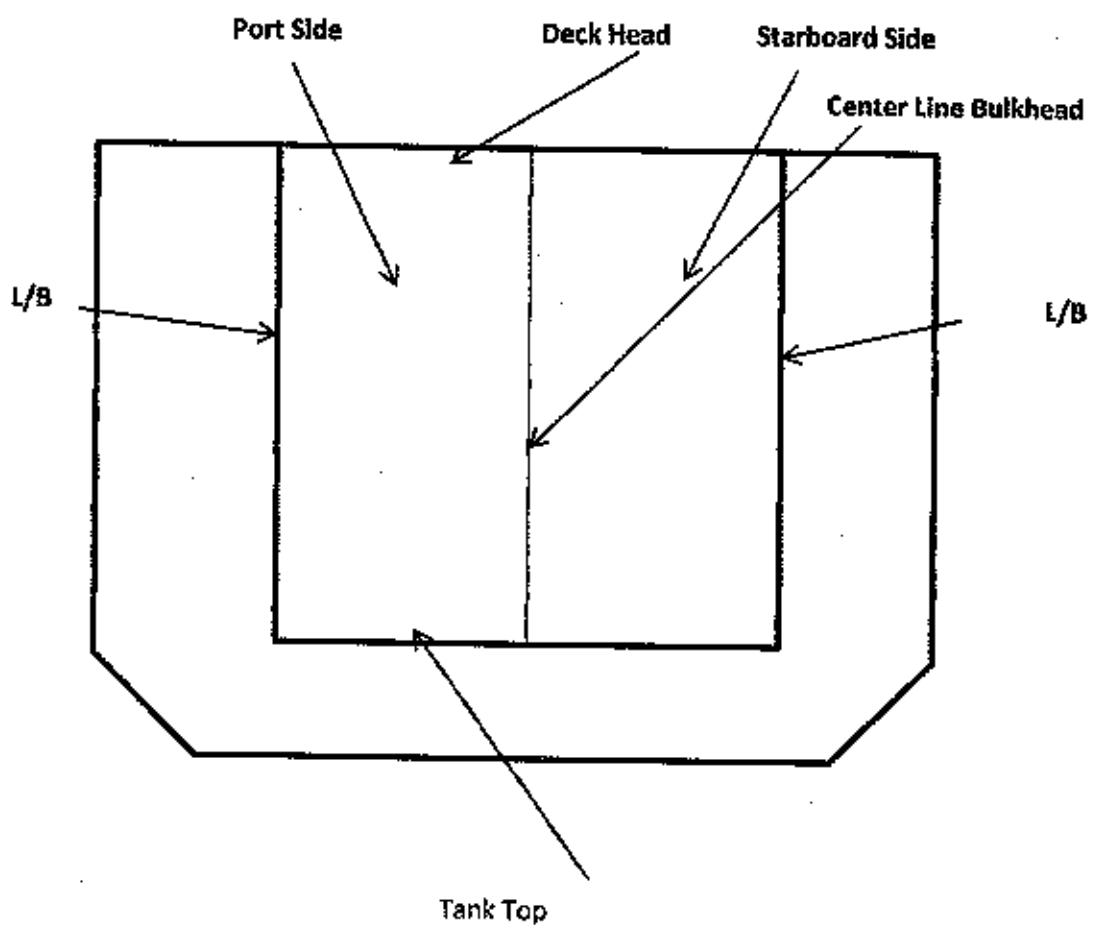
General condition of cargo tank satisfactory

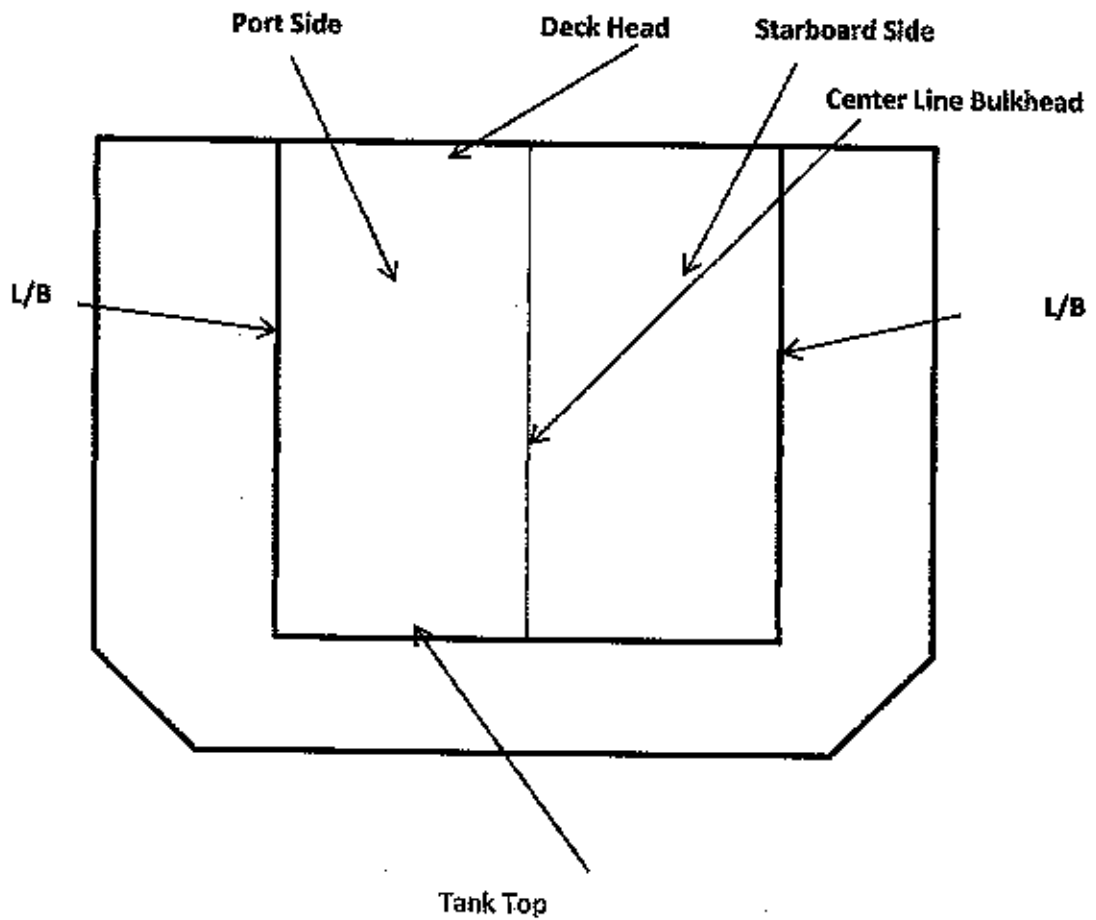
General condition of GT found satisfactory
