# Maritec Tanker Management

## Before & After pics

Vessel : Biskra

Defect ID : 150

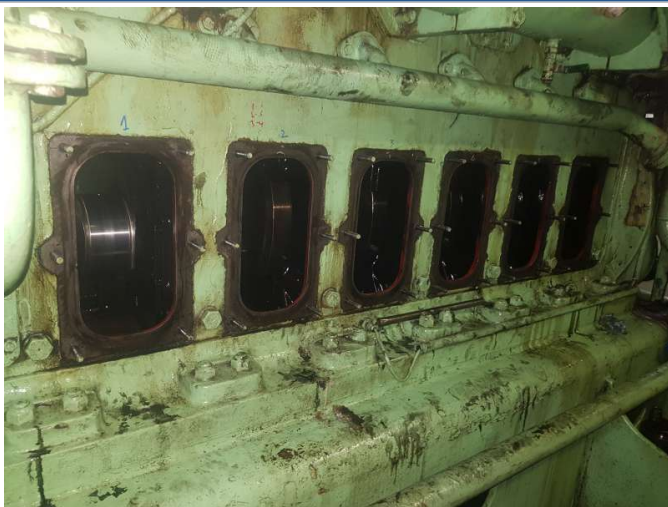
#### Before\_Picture

In data 23.08.2023 , in watch of 3rd engineer, the temperature of lub oil increased at 84 degree Celsius for Aux Eng no 1. An alarm was sounded and visible in Engine room .The temperature maximum admissible is 72 degree Celsius for Lub oil of Aux Eng no 1. Because of this situation we found small particle of metal from bearing shell of journal pin for each unit .We made inspection for all journal pin , dismantling all unit , We take out all piston for inspection .

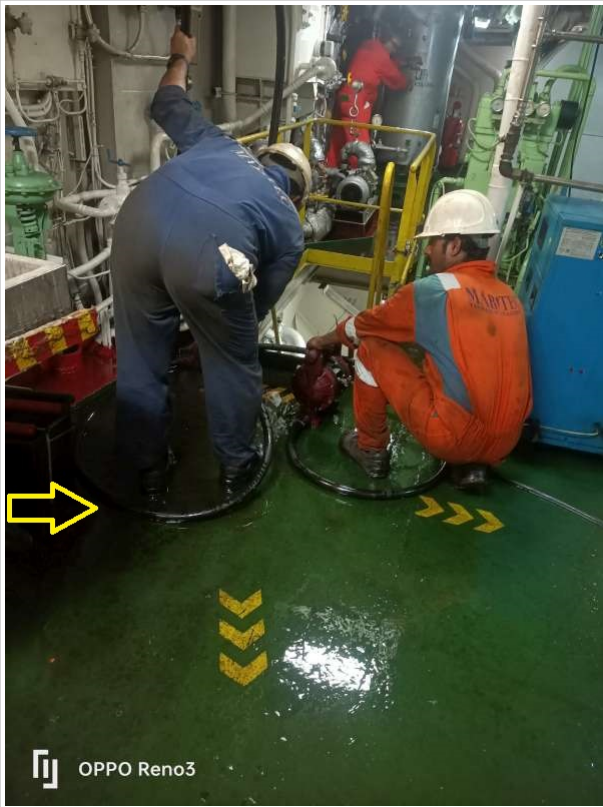
<b>Defect Details</b>
ON 18.08.2023 VESSEL TAKING BUNKER VLSFO AND MGO. DURING MGO BUNKER 7S TANK TOP MANHOLE WAS NOT TIGHTENED PROPERLY. AFTER COMPLETION OF BUNKER AIR BLOW GIVEN BY BUNKER VESSEL, DUE TO THIS MGO SPILLED ECR PLATFORM. IMMEDIATELY REQUESTED BUNKER VESSEL TO STOP AIR BLOW AND THE UPPER MANHOLE COVERED PROPERLY. THEN REQUESTED BUNKER VESSEL TO CONTINUE THE AIR BLOW AND FINISHED THE OPERATION. COLLECTED AROUND 3 DRUMS OF OIL AND NO WASTAGE.
