# Maritec Tanker Management

## Before & After pics

Vessel : Bitu Atlantic
Defect ID : 305

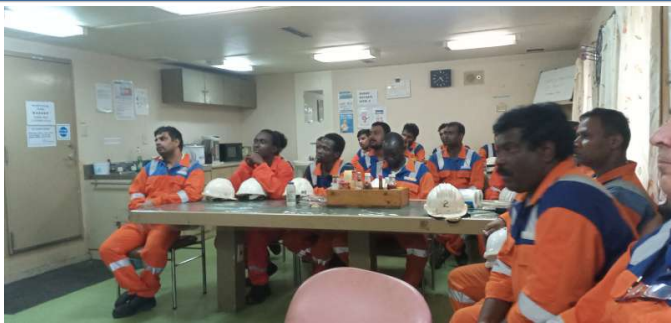
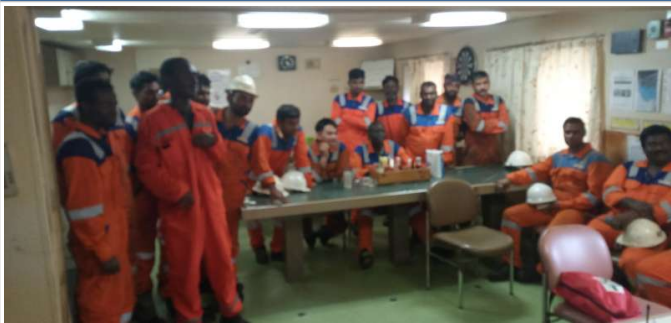
<b>Defect Details</b>
Communication between ship personnel during operations not in Common language 'English'

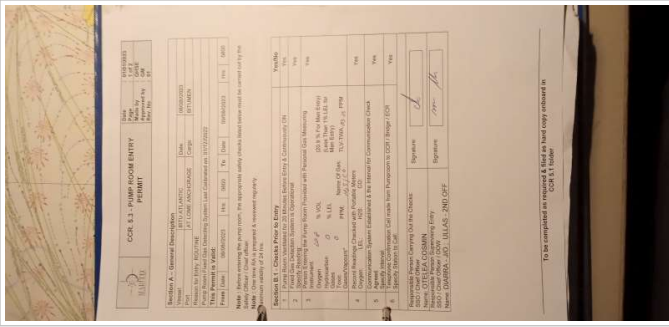
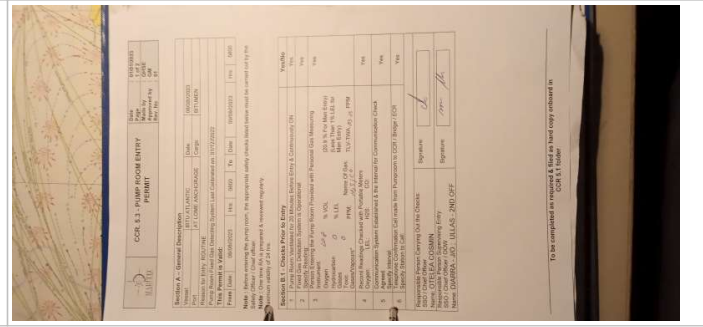
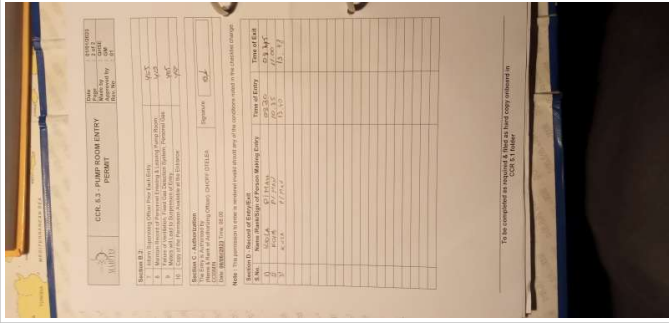
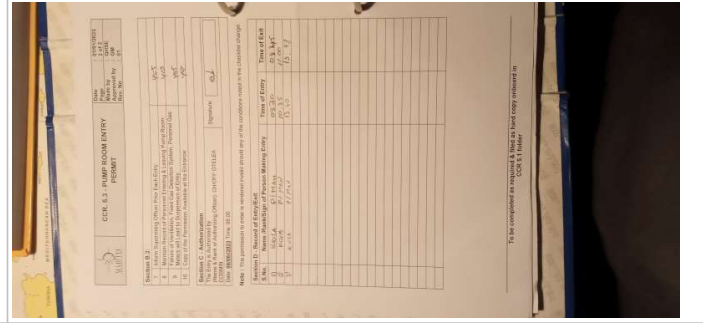
Vessel : Bitu Atlantic
Defect ID : 299

<b>Defect Details</b>
Pumproom permit was not available at time of entry. Pumproom permit was made without checking gases, meter at top of pumproom inoperational

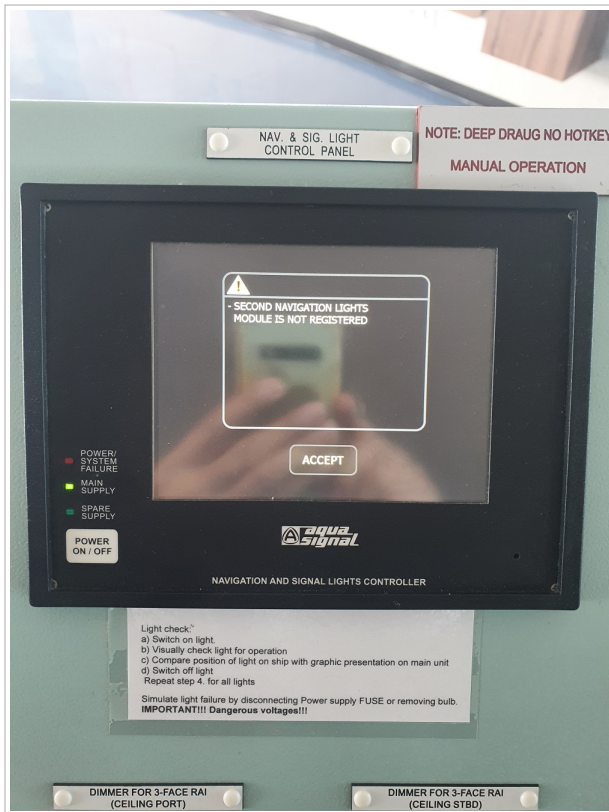
Vessel : Bitu River
Defect ID : 34
NCR # : 6/2023

Manual for Navigation and signaling light panel equipment is not matching with onboard existing equipment. Already equipment is defective and GC 079 raised. However, it is quite difficult to operate navigation light, in case light is busted or not working then no any alarm or indication to notify the watch keeper. OOW always check visually by themselves during change of watch and frequently during watch to confirm that navigational light is working.

On the navigational light controller when selecting RAM and NUC light controller is working. Only when selecting navigation and anchor lights this alarm is showing in the light controller/panel ( 2nd navigational module is not registered.)

At port, the navigational light continue on and need to switch off the main power to keep it off.

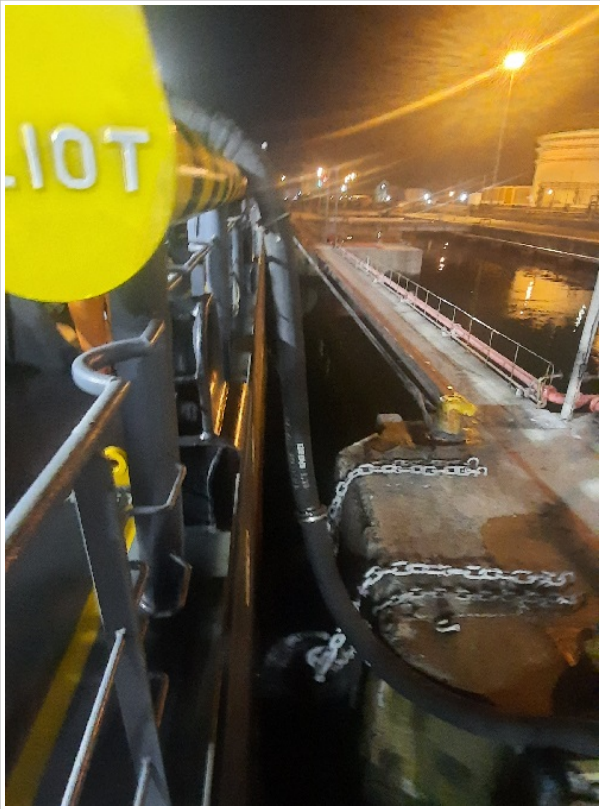
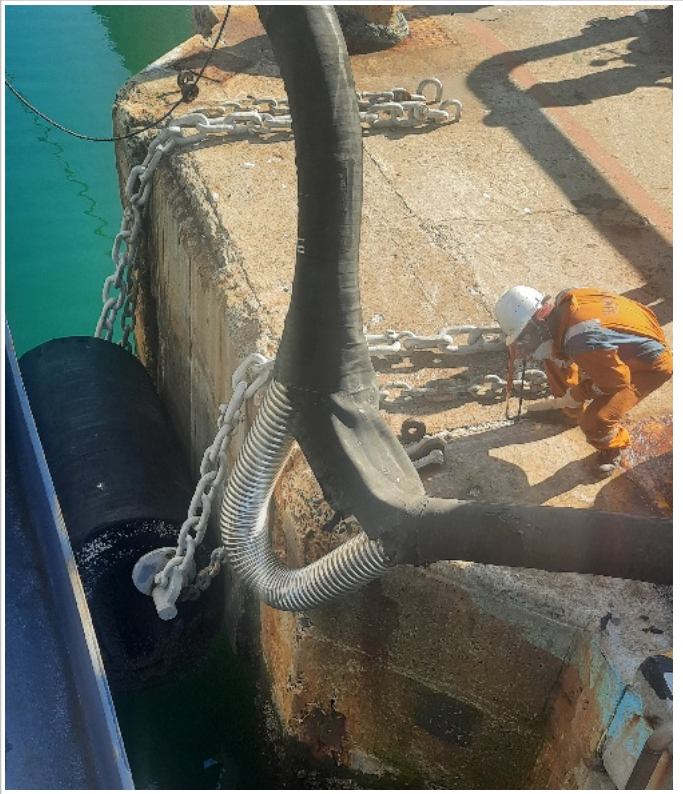
Vessel : Bitu River
Defect ID : 33
NCR # : 5/2023

While carrying out cargo hose air blow during cargo operations at Cape Town the cargo hose outer rubber layer got ruptured. The inner steel cargo hose was intact. Had the steel hose been of relatively poor quality like the outer rubber layer the steel hose could have also ruptured resulting in oil spill.
