Before & After pics

Vessel : Bitu Express
Defect ID : 125
NCR # : 11/2021

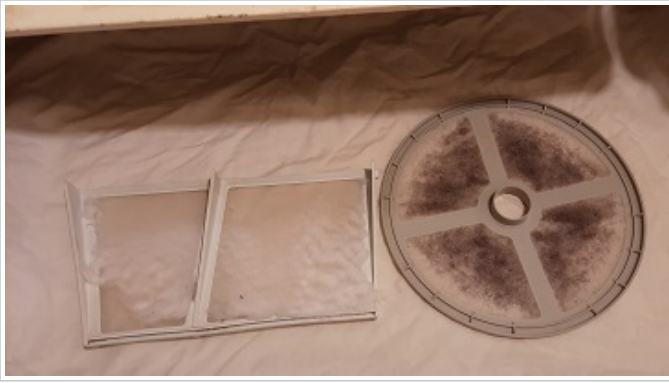
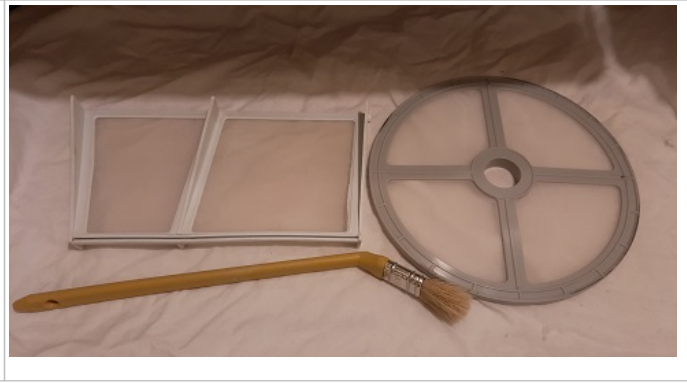
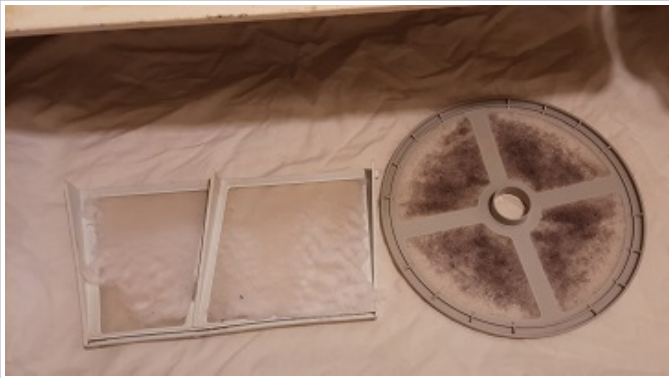
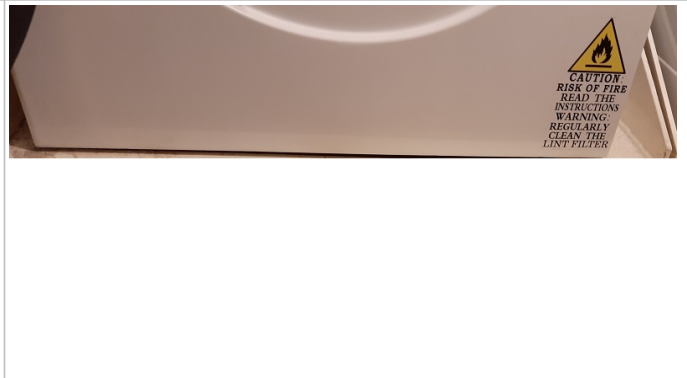
Defect ID : 106

Lint not cleaned from dryer machines.

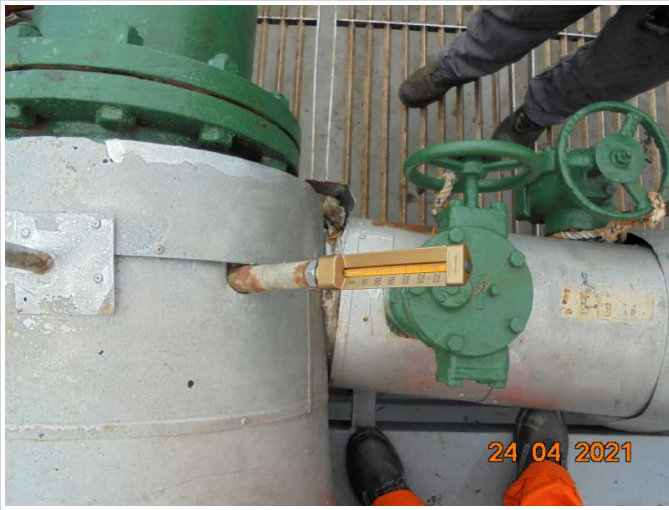
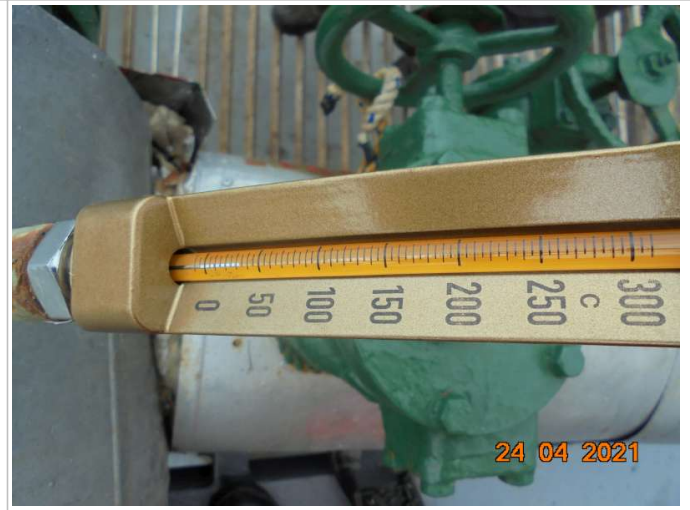
Vessel : Bitu Atlantic
 Defect ID : 127
 NCR # : 4/2021

Thermometer on loading manifold are not working

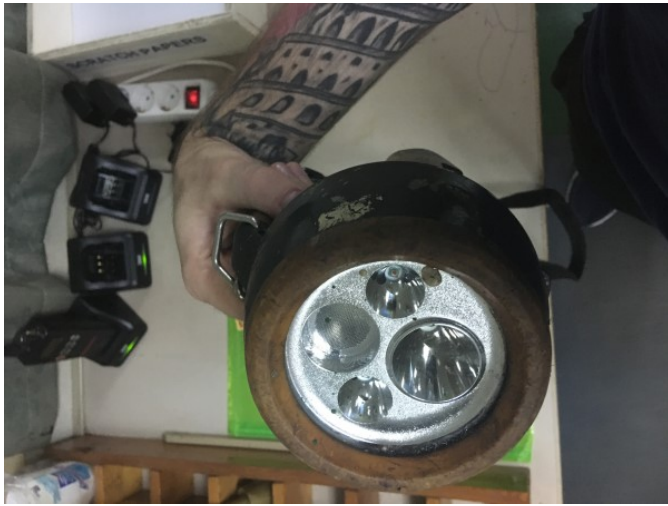
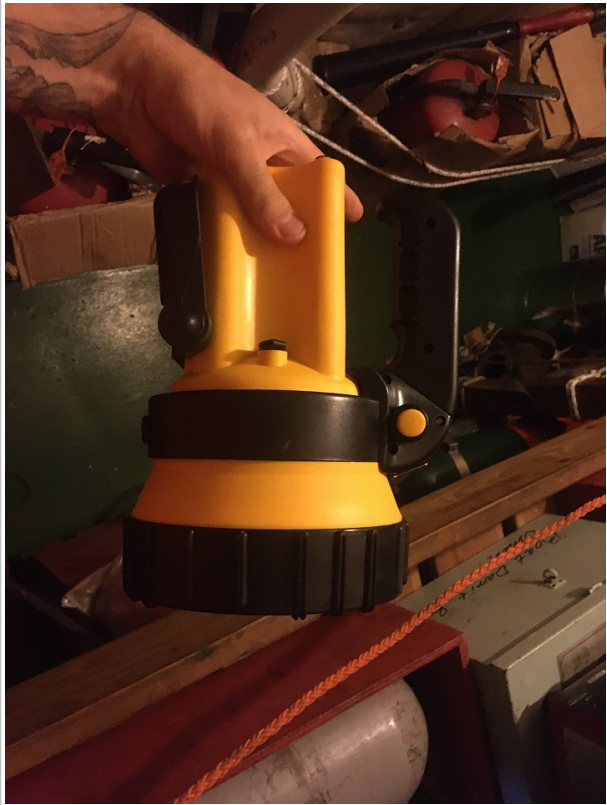
Vessel : Bitu Express
Defect ID : 79
NCR # : 3/2021

DURING FIRE DRILL ONE FLASHLIGHT FROM FIREMAN'S OUTFIT WAS NOT ILLUMINATING, AFTER CHECKING THIS IS FOUND THAT THE FLASHLIGHT IS NOT RECHARGEABLE. ALL FIREMAN OUTFITS ARE EQUIPED WITH SAME FLASHLIGHTS. AND THERE IS NO FLASHLIGHTS ON BOARD TO BE REPLACED.

Immediate Corrective Action(s) Taken	TEMPORARY USING DECK FLASH LIGHTS. REQUISITION ISSUED UNDER SAFETY/EMERGENCY PRIORITY.		
Root Cause	PERSONAL FACTORS NOT APPLICABLE		
	JOB FACTORS INADEQUATE / INCORRECT TOOLS AND EQUIPMENT		
Further Proposed Corrective Measures Required	REQUISITION RAISED FOR RECHARGEABLE FLASHLIGHTS. TEMPORARY USING DECK FLASH LIGHTS.

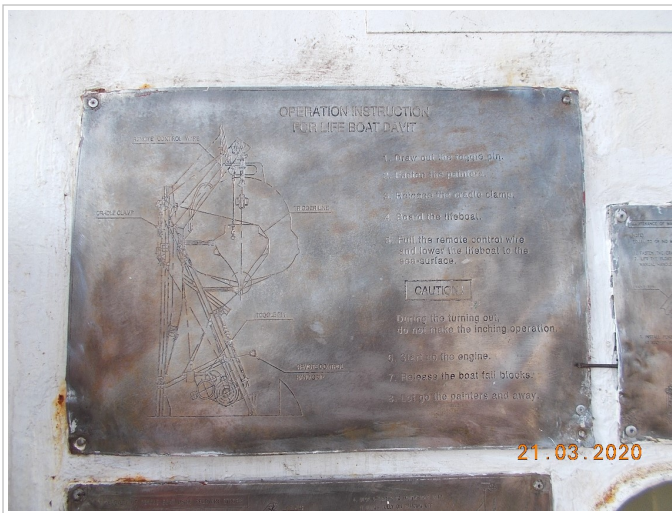
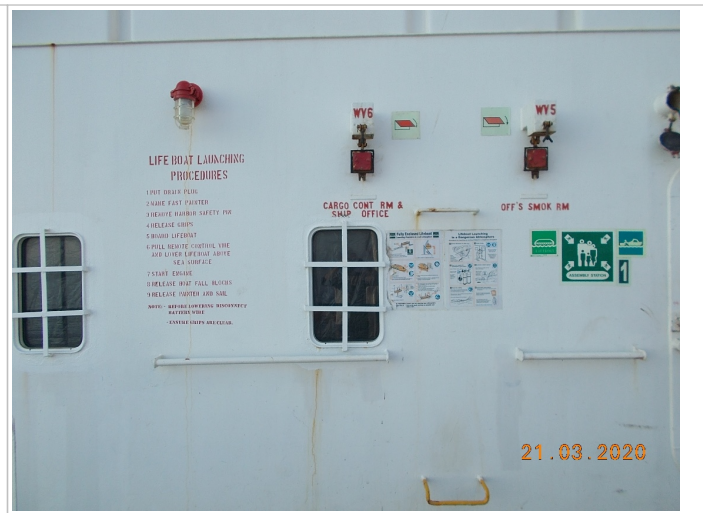
Defect ID : 73

11101 Operating instructions for Lifeboat STBD not readable

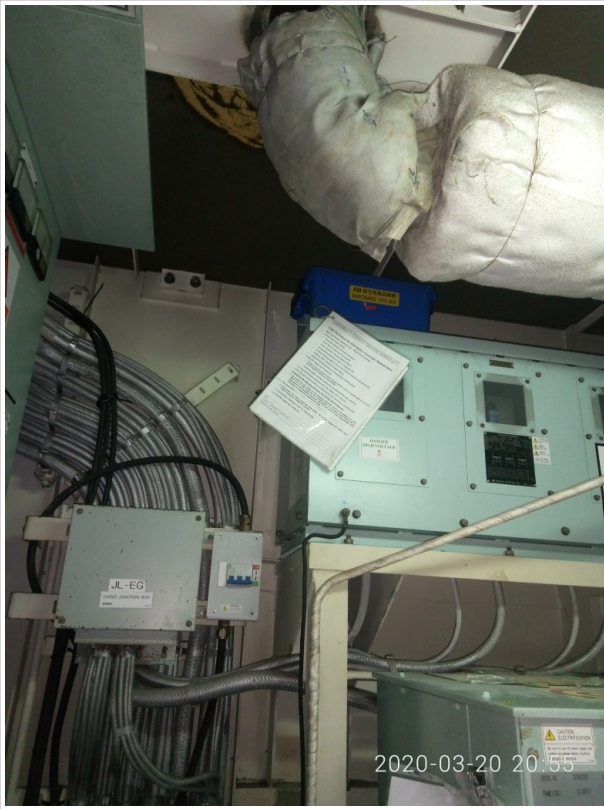
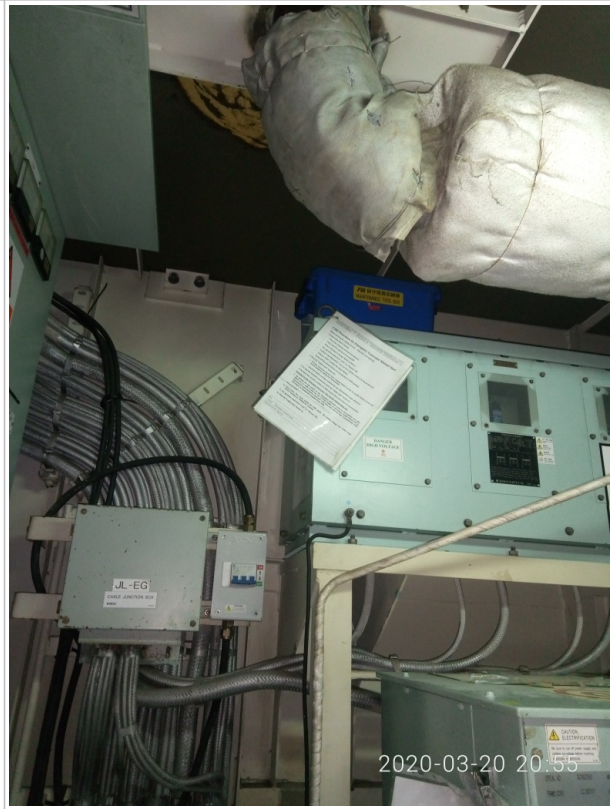
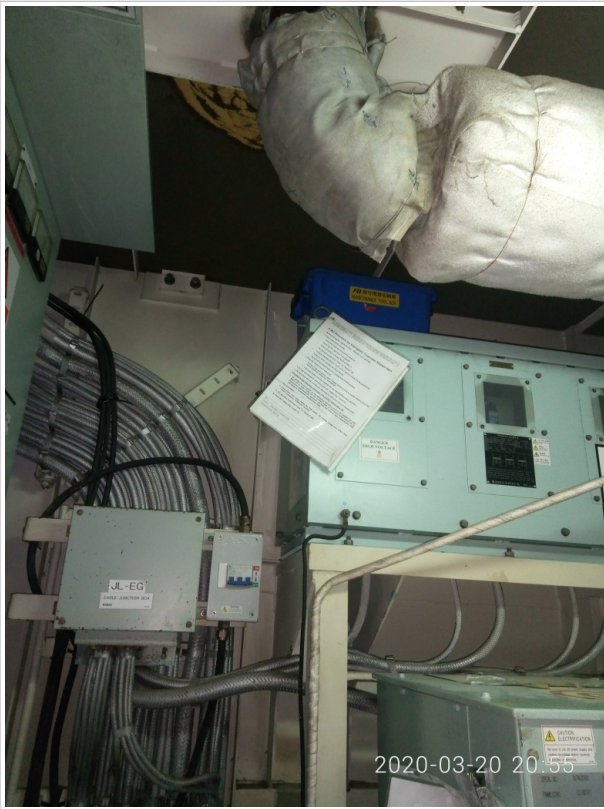
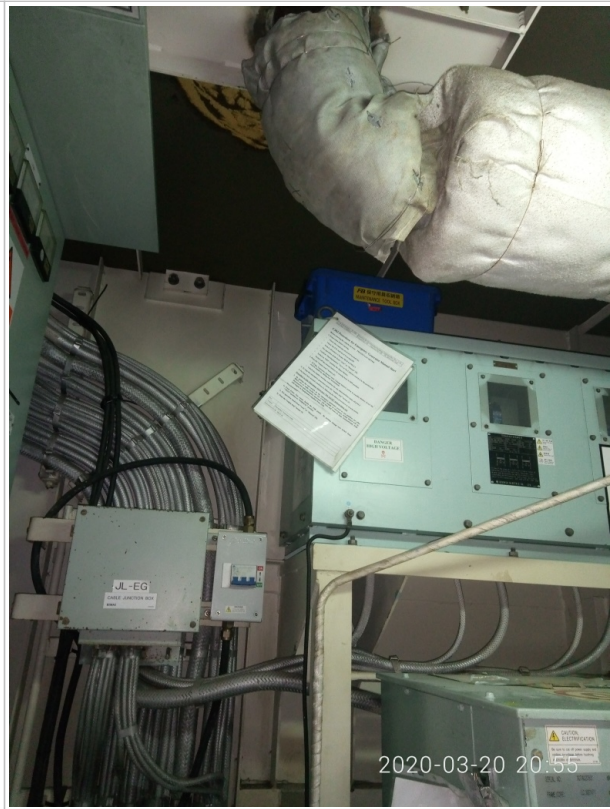
Vessel : Bitu Atlantic
Defect ID : 71
NCR # : 2/2020

Defect Details
07199 Pieces of insulation was missing to Emergency Diesel Generator exhaust gas elbow pipe (approx. 40 cm) and to Thermal Boiler Room Aft PS two pieces of insulation missing from steam pipes
