Maritec Tanker Management

Incident Report's Details

Vessel : Bahama Blue	Defect ID : 91	NCR # :	Is NCR ? : No
----------------------	----------------	---------	---------------

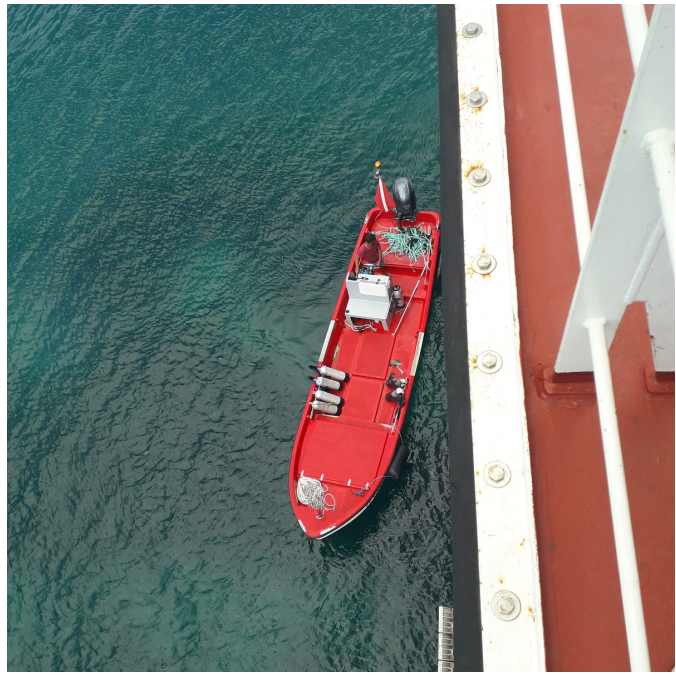
During vessel berthing at St. Barthelemy, while aft station crew will be sending their mooring lines to mooring boat they observed and reported to bridge that they sighted fishing line on the aft, expected entangled to the propeller. Since, vessel was already in position just to secure the stern mooring rope. Azimuth propellers put to stopped and send the stern mooring rope to mooring boat. At 1030 HLT all secured, pilot call for divers to check and remove the fishing lines entangled with the propellers.

Unsafe port/berth as Fishing net appears to be lying in the harbor area.

Pilot was alerted and Diver boat was arranged to remove the net from shipside.
