Maritec Tanker Management Incident Report's Details

Morbihan Defect ID: NCR #: 3/2023 Is NCR?: Yes Vessel:

Defect Details

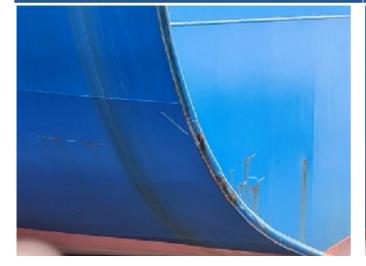
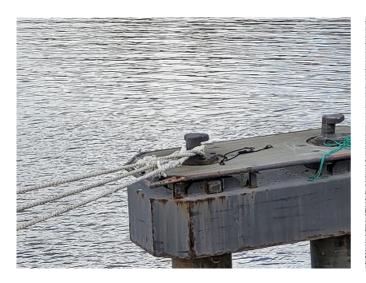
Before

On JANUARY 29, 2023, around 11:25 LT during the maneuver with the pilot on board at DDC, due to the very high tidal current, the ship scratched a mooring dolphin.

Due to the very high tidal current.

On	Ву	Follow Up	
02/Feb/2023	Nawin Khaware	Investigation is going on. P&I have been notified reg incident,	
01/Feb/2023	Giorgica Mardaru Staff Code - 10548 - MST	Just scratching the ship's hull and the mooring dolphin.

The lateral speed of the ship due to the strong tidal current was reduced by using the bowthruster and the Azimuth Thruster.

- The ship's speed control must be adjusted to the limit of the ship's manoeuvrability.
 If vessel berthing while strength of current is max then it's always advisable to use Tug during berthing/unberthing to control the lateral movement of the vessel.
