Maritec Tanker Management

Incident Reports Details

| Vessel : Morbihan | Defect ID : 80 | NCR # : 3/2023 | Is NCR ? : Yes |

On JANUARY 29, 2023, around 11:25 LT during the maneuver with the pilot on board at DDC, due to the very high tidal current, the ship scratched a mooring dolphin.

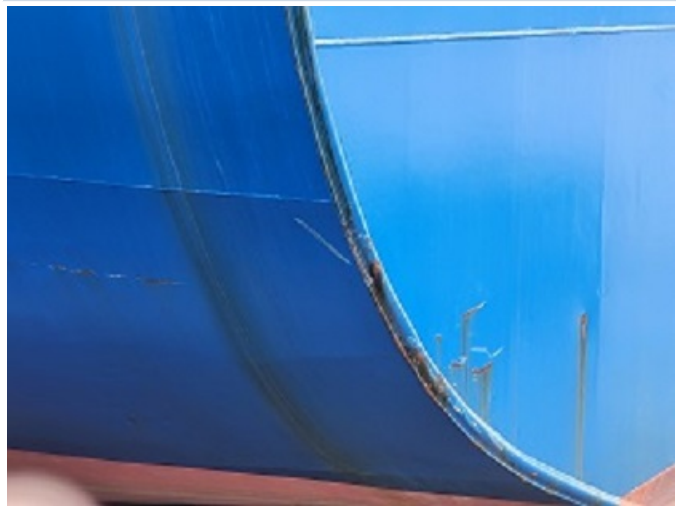
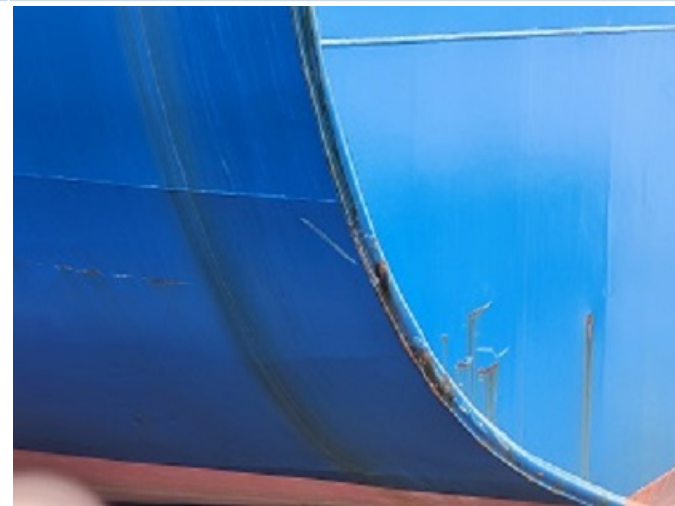
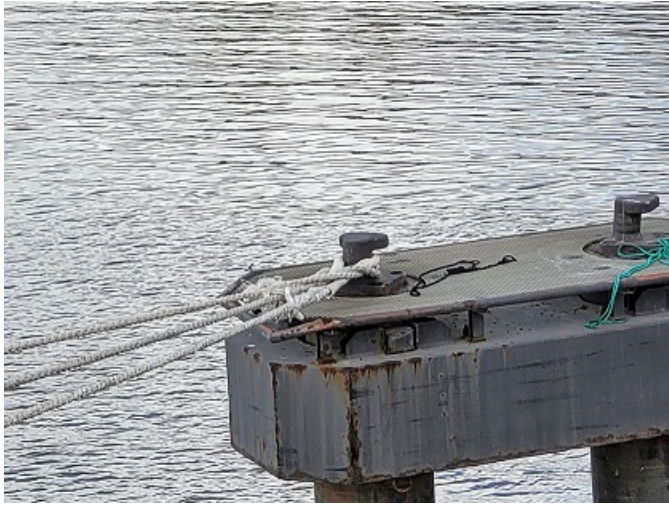
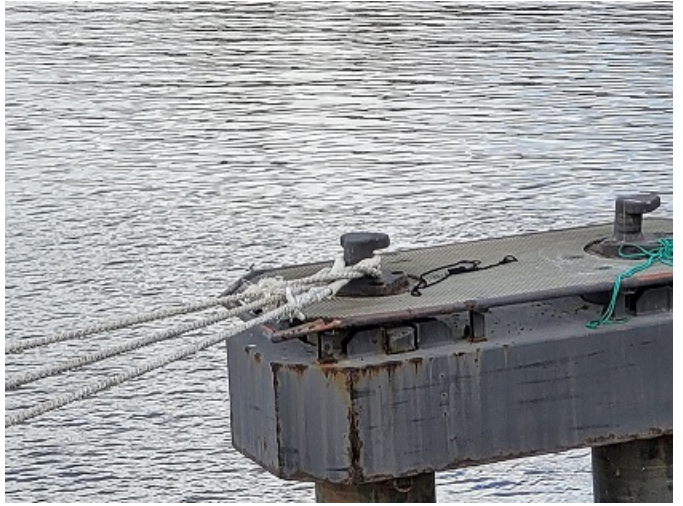
Before & After Pictures

Due to the very high tidal current.

| On | By | Follow Up | |
|---|--|--|--|
| 01/Feb/2023 | Giorgica Mardaru Staff Code - 10548 - MST | Just scratching the ship's hull and the mooring dolphin. | |

The lateral speed of the ship due to the strong tidal current was reduced by using the bowthruster and the Azimuth Thruster.

- The ship's speed control must be adjusted to the limit of the ship's manoeuvrability.
- If vessel berthing while strength of current is max then it's always advisable to use Tug during berthing/unberthing to control the lateral movement of the vessel.

| On | By | Follow Up | |
|---|--|--|--|
| 09/Feb/2023 | Nawin Khaware | P&I has kept some lump-sum amount in the kitty to deal with the claim in case if any arises in future. Scratched section of paint will be repainted during next DD as it doesn't affect safe running of the vessel. Basis above, we will consider this incident as closed now. | |
