## Maritec Tanker Management

### Incident Reports Details

Vessel : Bahama Blue	Defect ID : 182	NCR # : 4/2023	Is NCR ? : Yes
----------------------	-----------------	----------------	----------------

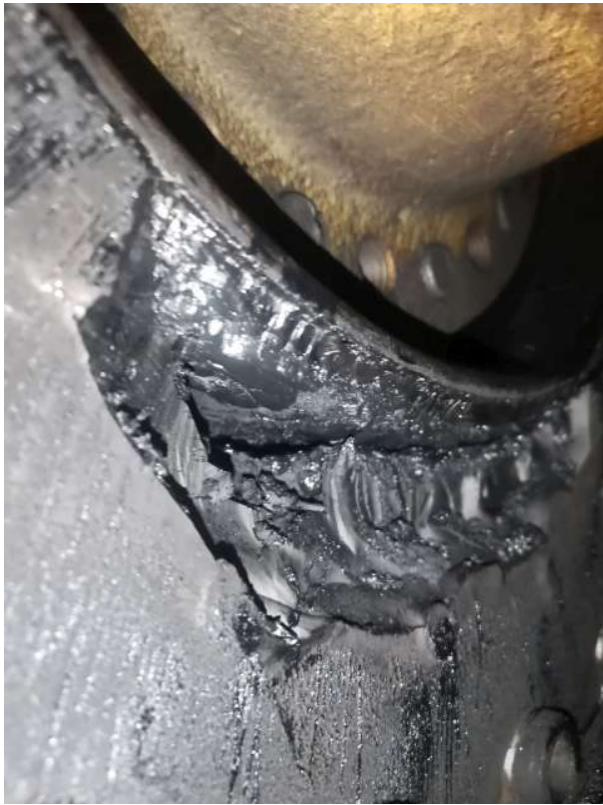
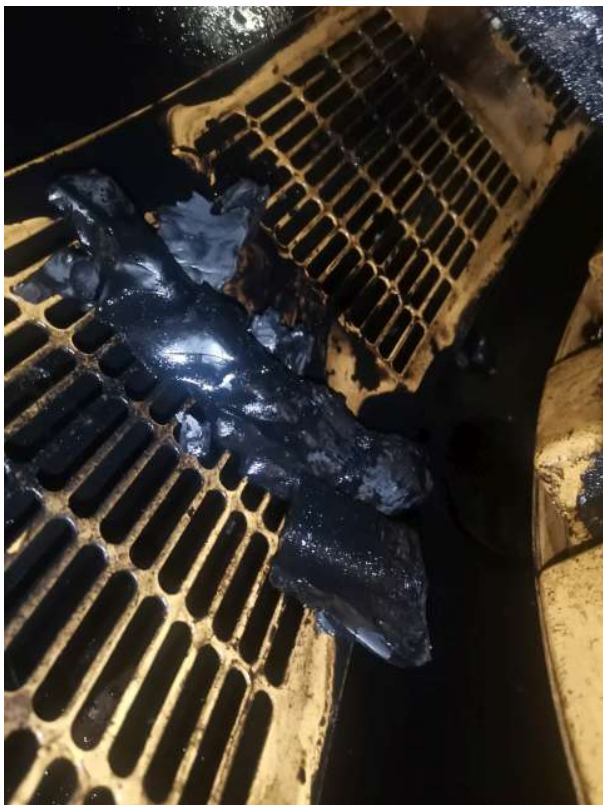
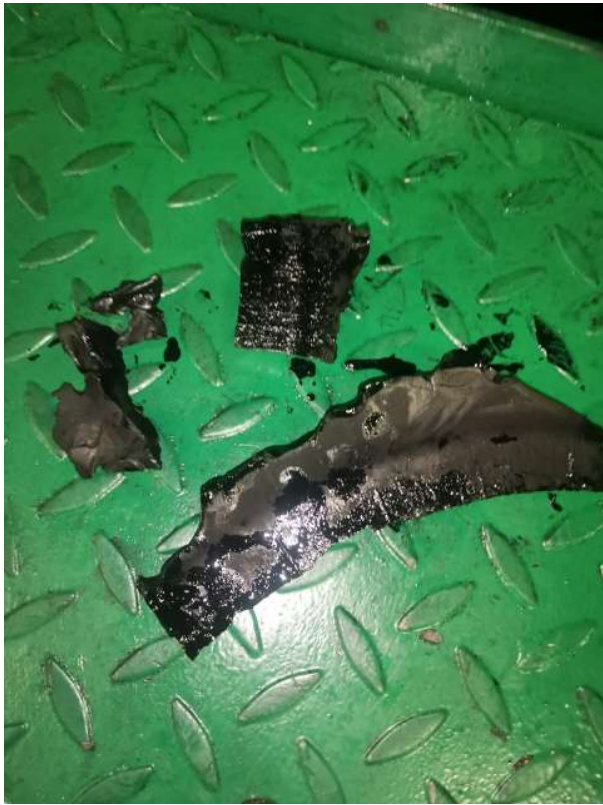
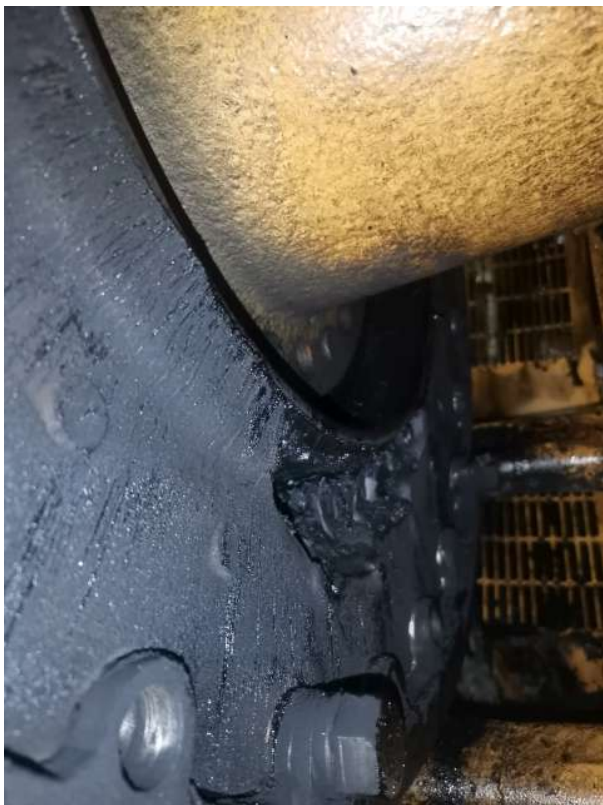
At 0400H 30 Apr. 2023 Vessel safely drift off coast of St. Croix waiting for berthing instruction from Limetree Bay Marine, Duty officer call Limetree Bay Marine for pilot schedule and port control reply that pilot boarding time is 5 hours from present time and they instructed that the vessel just maintain 6 NM away from channel entrance. Duty officer started STBD thruster and move away from the entrance channel. When the vessel is about 6 NM away from the channel duty officer reduce slowly the RPM of STBD thruster and suddenly blackout for all equipment on bridge and communication system is off and fire alarm sounded and it was located in the AC room and Engine room. All crew go to muster station and captain is on bridge and inform the crew the location of fire alarm and investigate according prescribed duties as per Muster list. Observed that smoke in engine room was by broken rubber coupling on shaft of generator no.3. Generator shut down by alarm. Smoke released by open doors.

No.3 Gen. flexible rubber coupling damage cause smoke and fire alarm activated.

On	By	Follow Up	
18/May/2023	Nawin Khaware	AE Shaft coupling has been sourced and equipment should be onboard by last week of May 23. Investigation reveals that coupling was damaged due to excessive wear and tier. Hence PMS routines will be reviewed and period will be reduced to 06-monthly intervals.	
05/May/2023	Nawin Khaware	Please submit the pictures of burnt items. Also advise how vessel will be able to prevent such incidents in future.	
05/May/2023	Valentin MITENKOV   Staff Code - 10552 - MST	Comments by Office :Kindly submit some pictures in incident report in JOT depicting broken rubber coupling on AE#03 shaft. Also submit the concrete preventive measures to avoid recurrence in future.

Checked generator to obtain damaged parts and reported to Technical department. Urgent requisition for spare parts raised.

- 1.Monthly inspection for Auxiliary Generators required to amend in PMS :  
Inspection for condition Flywheel couplings.
- 2.Spare parts availability for appropriate equipment.
