Maritec Tanker Management

Incident Reports Details

Vessel : Bahama Blue	Defect ID : 182	NCR # : 4/2023	Is NCR ? : Yes
----------------------	-----------------	----------------	----------------

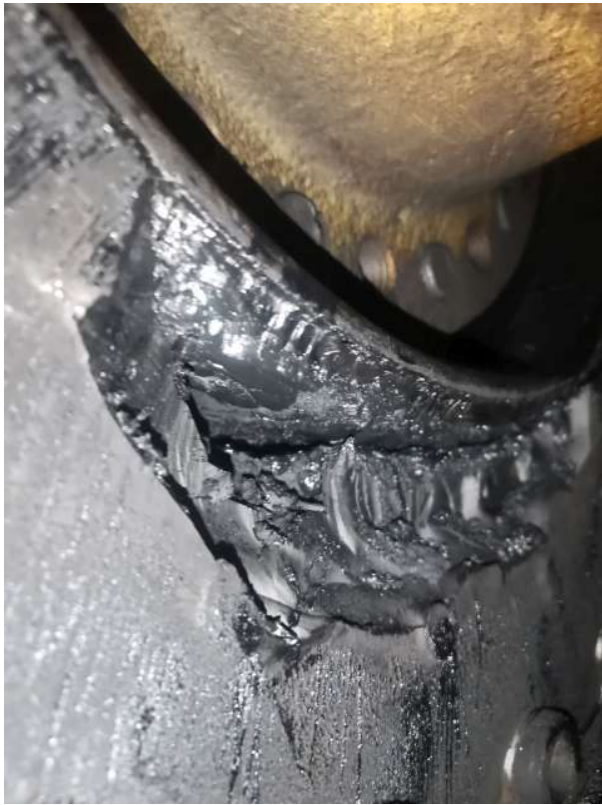
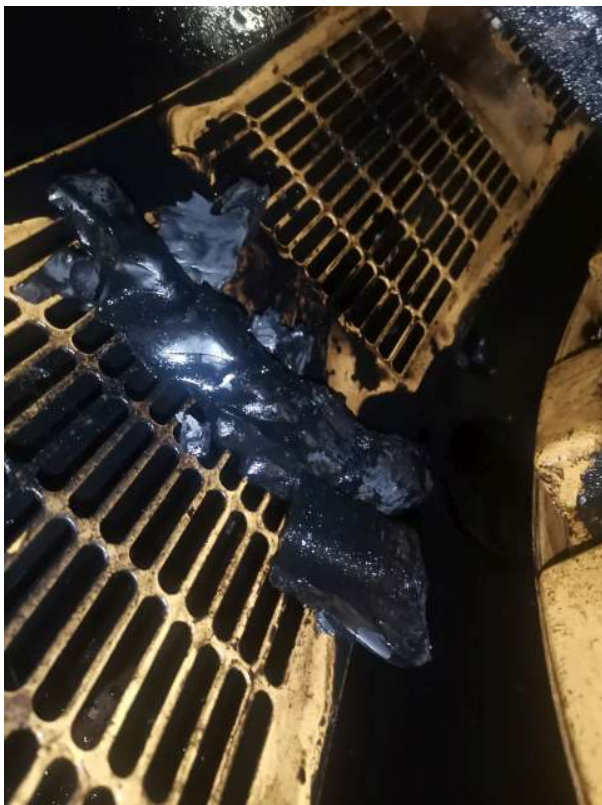
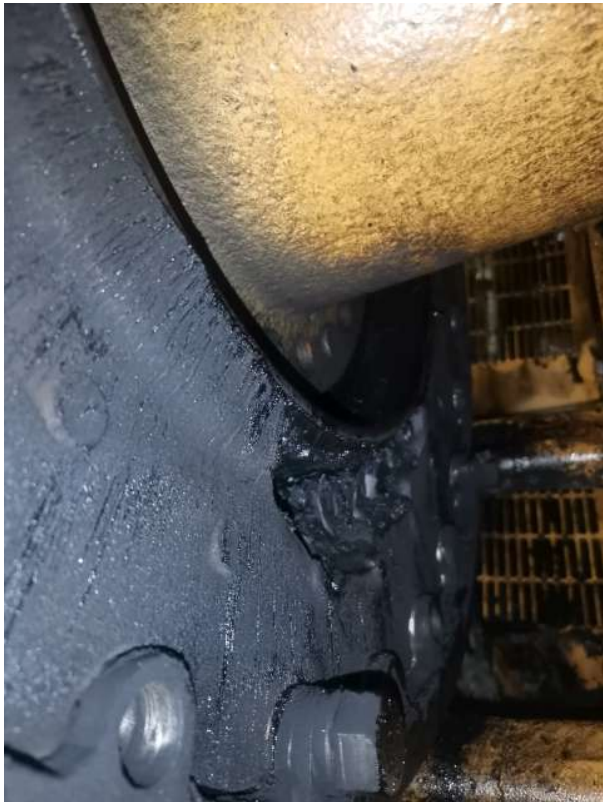
No.3 Gen. flexible rubber coupling damage cause smoke and fire alarm activated.

On	By	Follow Up	
18/May/2023	Nawin Khaware	AE Shaft coupling has been sourced and equipment should be onboard by last week of May 23. Investigation reveals that coupling was damaged due to excessive wear and tier. Hence PMS routines will be reviewed and period will be reduced to 06-monthly intervals.	
05/May/2023	Nawin Khaware	Please submit the pictures of burnt items. Also advise how vessel will be able to prevent such incidents in future.	
05/May/2023	Valentin MITENKOV Staff Code - 10552 - MST	Comments by Office :Kindly submit some pictures in incident report in JOT depicting broken rubber coupling on AE#03 shaft. Also submit the concrete preventive measures to avoid recurrence in future.

Checked generator to obtain damaged parts and reported to Technical department. Urgent requisition for spare parts raised.

- 1.Monthly inspection for Auxiliary Generators required to amend in PMS :
Inspection for condition Flywheel couplings.
- 2.Spare parts availability for appropriate equipment.
