Maritec Tanker Management

Incident Reports Details

Vessel : Bitu Atlantic	Defect ID : 270	NCR # : 5/2023	Is NCR ? : Yes
------------------------	-----------------	----------------	----------------

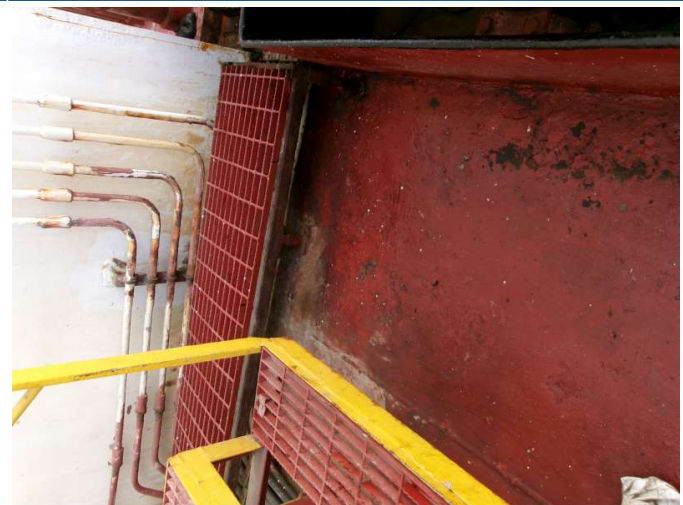
Date : 05-APR-23
Place : Lome
Berth : Mineral pier DB
V/I was DB with " SFL YUKON ". Truck is arranged at the jetty for discharging sludge. The discharge hoses (approx 10mtr x 5) were passing all the way from the ship via bulk carrier to the truck.
While discharging the sludge after approx 1.5hrs the hose started leaking on the bulk carrier, sludge spilled approx 25ltrs. Immediately stopped the sludge discharge. Sent the ship staff for the cleanup operation on the other vessel. SFL YUKON master was satisfied of the cleanup operation.
Sludge operator were not having any additional hose to replace so further operation cancelled.

Substandard Conditions Related to Carg
Direct Causes- Unsafe Acts
Other Substandard Act(s)
Job Factors
Wear and Tear (Not Related to Lack of Maintenance)
Personal Factors
Not Applicable
Substandard Conditions
Busting of Hose Pipes
Defective Materials

Follow Up			
On	By	Follow Up	
05/May/2023	Nawin Khaware	Basis submitted evidence, this incident could be considered as closed now.	
26/Apr/2023	Nawin Khaware	Incident took place due wear and tier of sludge discharge hose, spilled oil was cleaned and understand that no oil had gone overboard. Learning - All the discharge gear including hoses must be checked for it's proper integrity prior commencing the operation. All SOPEP gears must be deployed prior starting the operation.	
25/Apr/2023	Vivek Kashyap Staff Code - 10239 - MST	AWAITING OFFICE ACTION for this job has been changed to Yes

Immediately stopped the sludge discharge. Sent the ship staff for the cleanup operation on the other vessel.

Preventive action: Check the condition of hose before discharge.
Prefer discharge to the barge instead to the truck with so many hoses which operation cannot be monitored from ship.
