# Maritec Tanker Management

## Incident Reports Details

Vessel : Bitu Atlantic	Defect ID : 270	NCR # : 5/2023	Is NCR ? : Yes
------------------------	-----------------	----------------	----------------

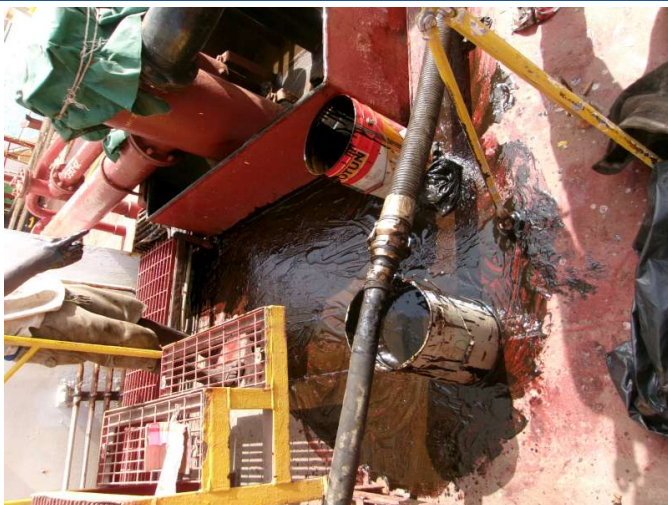
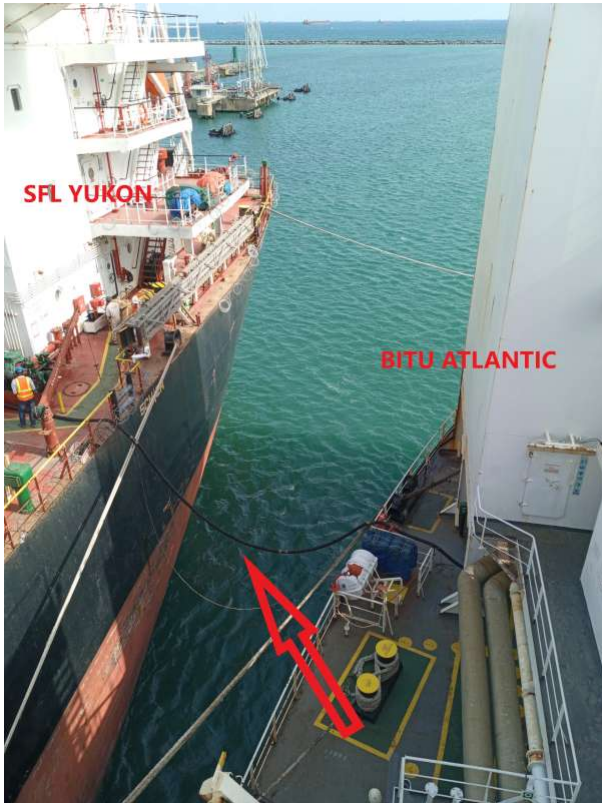
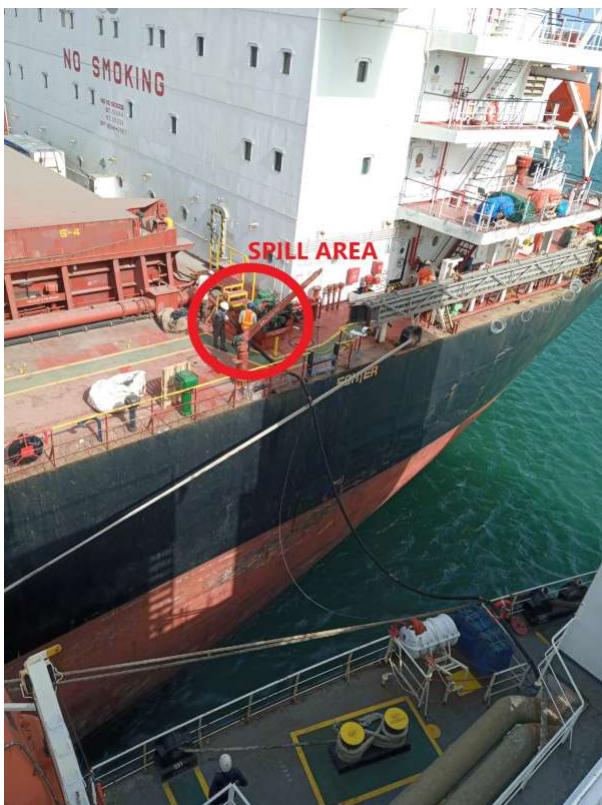
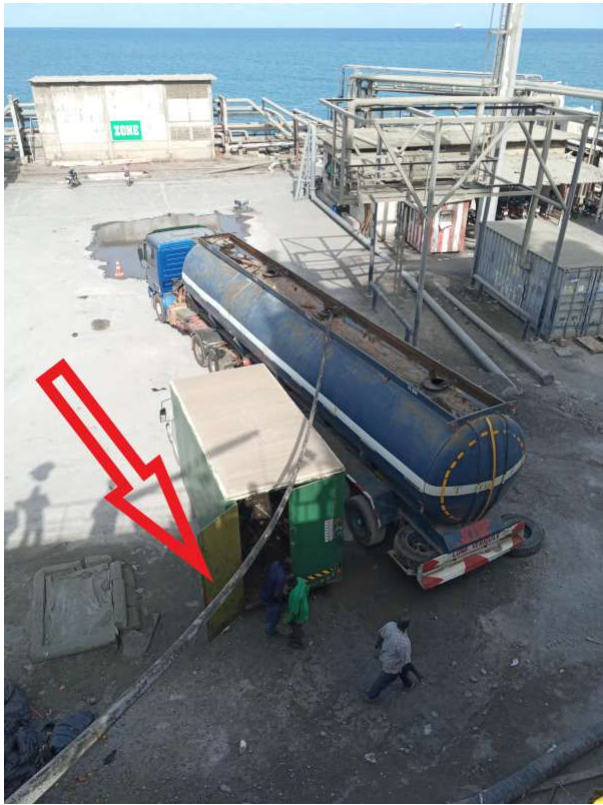
Date : 05-APR-23  
 Place : Lome  
 Berth : Mineral pier DB  
 V/I was DB with " SFL YUKON ". Truck is arranged at the jetty for discharging sludge. The discharge hoses (approx 10mtr x 5) were passing all the way from the ship via bulk carrier to the truck.  
 While discharging the sludge after approx 1.5hrs the hose started leaking on the bulk carrier, sluge spilled approx 25ltrs. Immediately stopped the sludge discharge.Sent the ship staff for the cleanup operation on the other vessel. SFL YUKON master was satisfied of the cleanup operation.  
 Sludge opeartor were not having any additional hose to replace so further operation cancelled.

Substandard Conditions Related to Carg
<b>Direct Causes- Unsafe Acts</b>
Other Substandard Act(s)
<b>Job Factors</b>
Wear and Tear (Not Related to Lack of Maintenance)
<b>Personal Factors</b>
Not Applicable
<b>Substandard Conditions</b>
Busting of Hose Pipes
Defective Materials

Follow Up			
On	By	Follow Up	
05/May/2023	Nawin Khaware	Basis submitted evidence, this incident could be considered as closed now.	
26/Apr/2023	Nawin Khaware	Incident took place due wear and tier of sludge discharge hose, spilled oil was cleaned and understand that no oil had gone overboard. Learning - All the discharge gear including hoses must be checked for it's proper integrity prior commencing the operation. All SOPEP gears must be deployed prior starting the operation.	
25/Apr/2023	Vivek Kashyap   Staff Code - 10239 - MST	AWAITING OFFICE ACTION for this job has been changed to Yes

Immediately stopped the sludge discharge.Sent the ship staff for the cleanup operation on the other vessel.

Preventive action: Check the condition of hose before discharge.  
 Prefer discharge to the barge instead to the truck with so many hoses which operation cannot be monitored from ship.
