Maritec Tanker Management

Incident Report's Details

Vessel : Bitu Atlantic	Defect ID : 270	NCR # : 5/2023	Is NCR ? : Yes
------------------------	-----------------	----------------	----------------

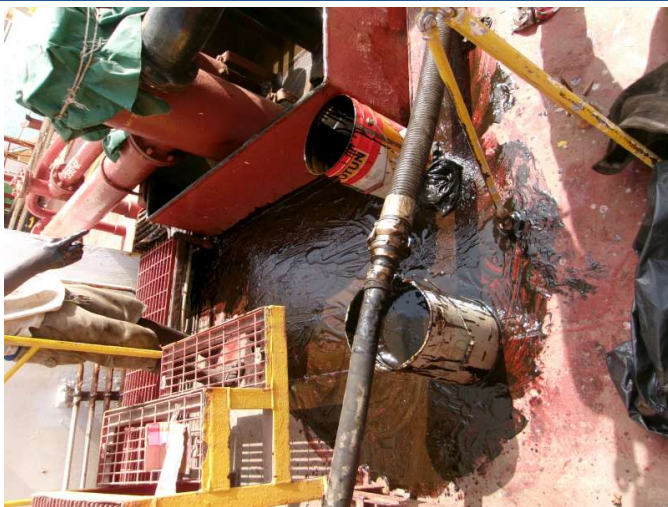
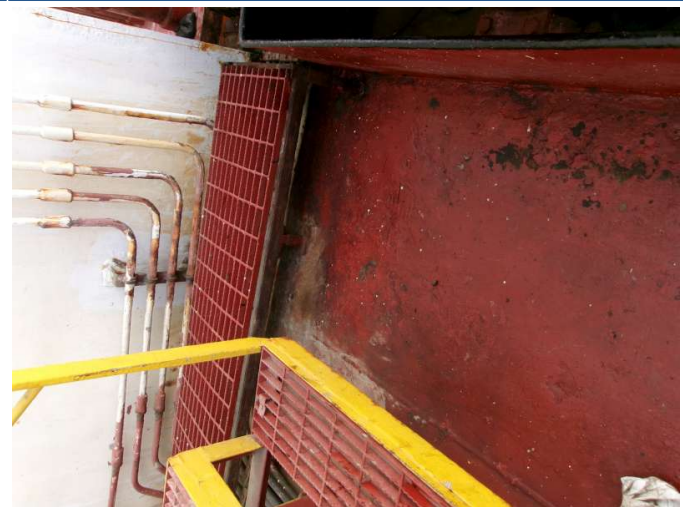
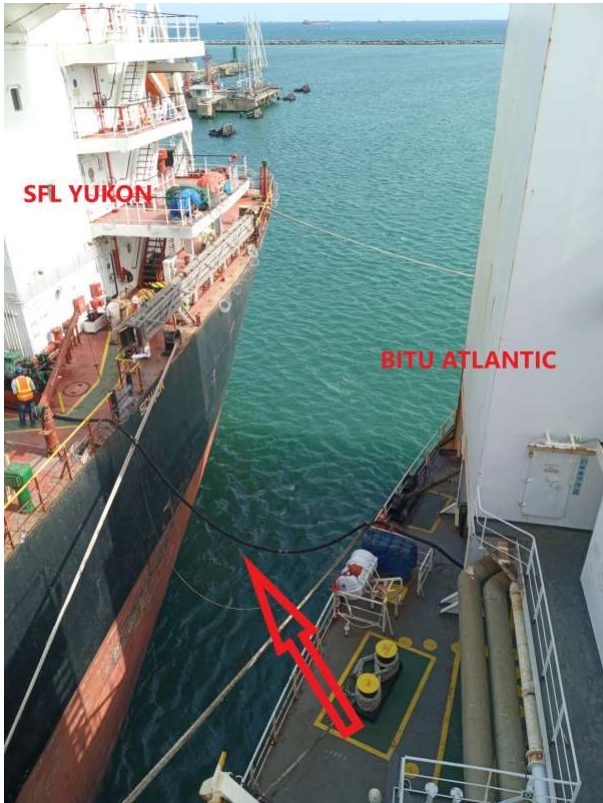
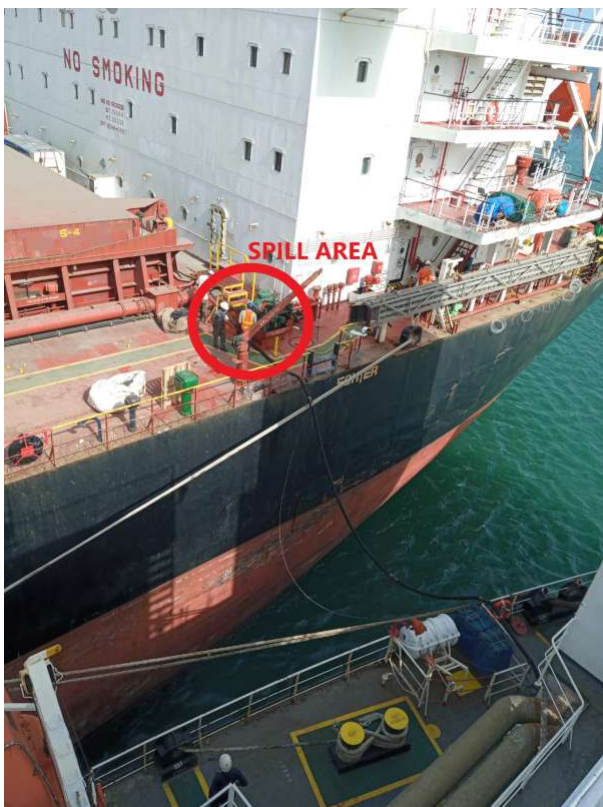
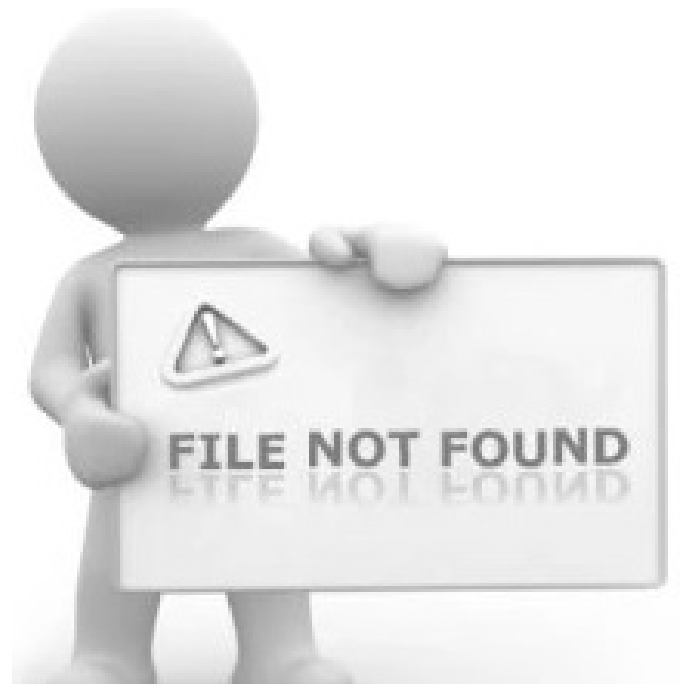
Before & After Pictures	
Before	After

Date : 05-APR-23
Place : Lome
Berth : Mineral pier DB
V/I was DB with " SFL YUKON ". Truck is arranged at the jetty for discharging sludge. The discharge hoses (approx 10mtr x 5) were passing all the way from the ship via bulk carrier to the truck.
While discharging the sludge after approx 1.5hrs the hose started leaking on the bulk carrier, sludge spilled approx 25ltrs. Immediately stopped the sludge discharge. Sent the ship staff for the cleanup operation on the other vessel. SFL YUKON master was satisfied of the cleanup operation.
Sludge operator were not having any additional hose to replace so further operation cancelled.

Inadequate Work Standards

Substandard Conditions Related to Carg
Direct Causes- Unsafe Acts
Other Substandard Act(s)
Job Factors
Wear and Tear (Not Related to Lack of Maintenance)
Personal Factors
Not Applicable
Substandard Conditions
Busting of Hose Pipes
Defective Materials

Follow Up			
On	By	Follow Up	
05/May/2023	Nawin Khaware	Basis submitted evidence, this incident could be considered as closed now.	
26/Apr/2023	Nawin Khaware	Incident took place due wear and tier of sludge discharge hose, spilled oil was cleaned and understand that no oil had gone overboard. Learning - All the discharge gear including hoses must be checked for it's proper integrity prior commencing the operation. All SOPEP gears must be deployed prior starting the operation.	
25/Apr/2023	Vivek Kashyap Staff Code - 10239 - MST	AWAITING OFFICE ACTION for this job has been changed to Yes

Immediately stopped the sludge discharge. Sent the ship staff for the cleanup operation on the other vessel.

Preventive action: Check the condition of hose before discharge.
Prefer discharge to the barge instead to the truck with so many hoses which operation cannot be monitored from ship.
