Maritec Tanker Management Private Limited

Incident Reports Details

Vessel : Biskra	Defect ID : 167	NCR # : 1/2024	Is NCR ? : Yes
-----------------	-----------------	----------------	----------------

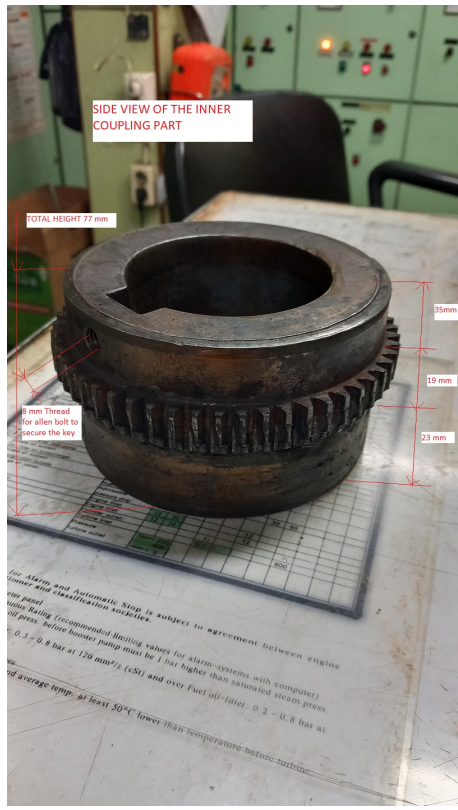
On 05.01.2024 at around 00:20 during discharging in Dakar/Senegal COP No.3 was suddenly stopped since the coupling between engine shaft and cargo pump was broken. Immediately OOW called C/O and Engineers in order to investigate the issue. After we checked in pumproom what was the issue we decided to stop the other COP No.1 in order to prepare the others 2 cargo pumps for discharging. P/man prepared line up for COP No.2 and COP No.4 in order to resume cargo operations with good rate. At 03:30 we resumed cargo operations with no any problem.

Metal fatigue

Inadequate Maintenance

Proper monitoring and greasing routines.
