Maritec Tanker Management

Incident Report's Details

Vessel : Biskra	Defect ID : 46	NCR # :	Is NCR ? : No
-----------------	----------------	---------	---------------

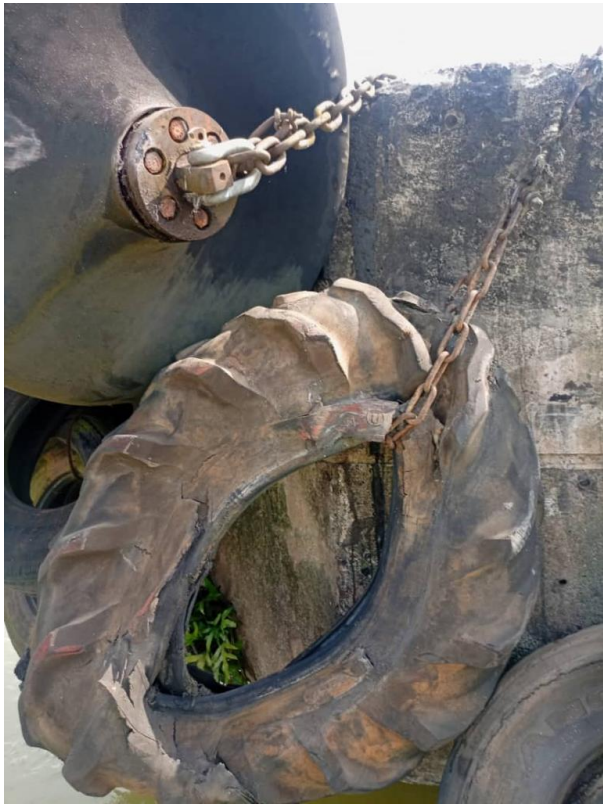
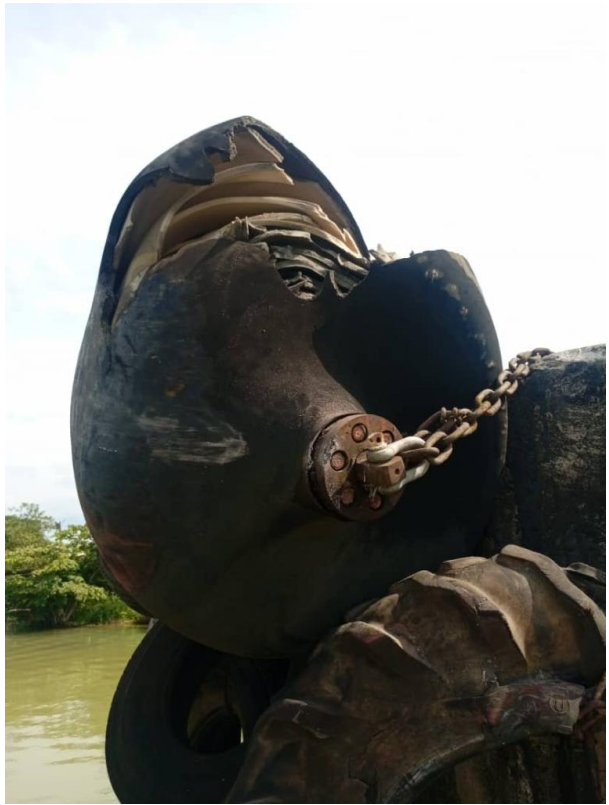
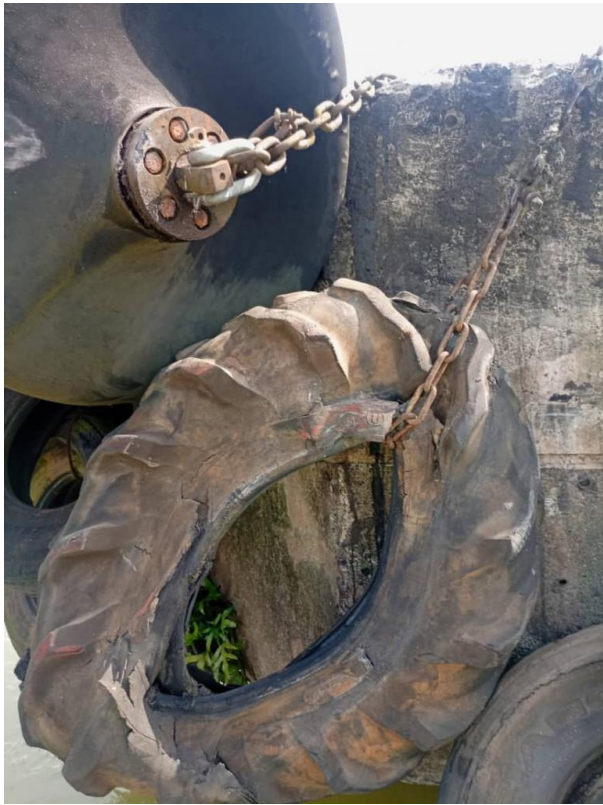
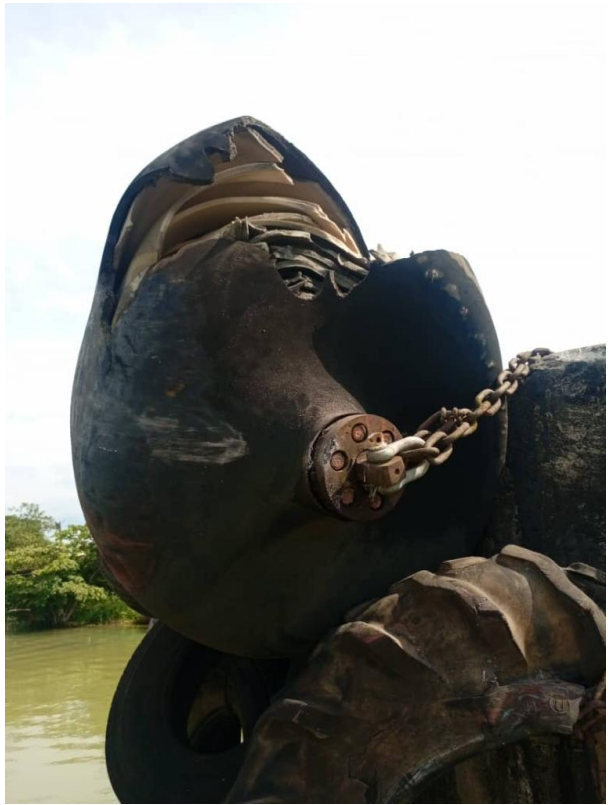
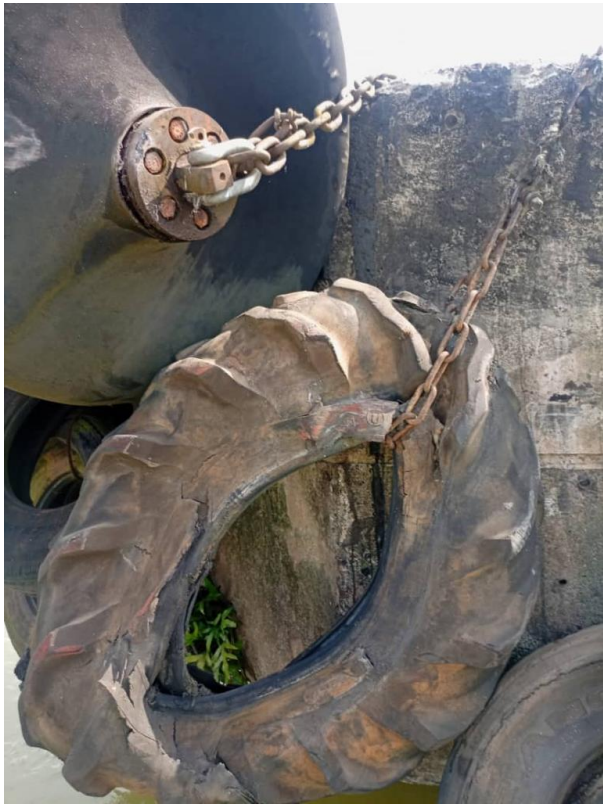
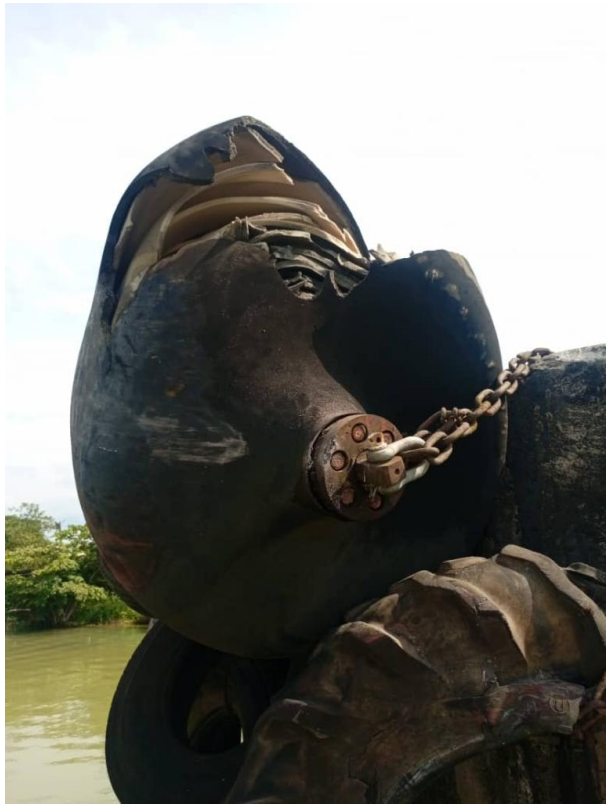
While berthing at Sapele Ringardas Jetty Vessel drifted towards neighbouring Jetty 200m astern of Ringardas jetty causing starboard quarter baby fenders to touch the neighbouring jetty fenders to be displaced from her position due to prevailing following currents and lack of manouevering skills of Harbour Pilot call sign HOTEL which was overiden finally by Master keeping vessel clear and away from further damage.

Improper maneuver - Company had issued circular in June 2021 where it's clearly stated that vessel must stem the tide while berthing at Sapele in order to have full control on ship's movement and it's bow. However Bridge team fail to comply with this instructions and planned the approach to berth with following tide due which vessel lost the control over ship's maneuvering which led to such incident. Current was pushing the vessel in ahead direction and to control the speed of approach vessel was constantly giving astern movement, due engine going to astern vessel lost the control over bow which resulted in swinging of bow to port and the starboard quarter started coming closer to NEPA jetty and finally baby fender rigged on starboard quarter of own vessel went and hit the fender of NEPA jetty. Impact was slight however due load of the vessel jetty dolphin fender pushed upwad and got damaged. During interview with bridge team, it was revealed that Pilot's action berthing with following tide was not challenged by any of the bridge team members and that seems to be the root cause of whole of this incident.

1. Whole bridge team was reminded to comply with company circular while berthing at Sapele.
2. Bridge Team were advised to challenge the pilot's action as and when deemed necessary.
3. Bridge team were again reminded to comply with SMS chapter 5 and BPG guide.

1. Fleetwide message circulated and our other vessels were advised to comply with Sapele berthing circular whenever she is calling at this port.
2. Bridge team were advised to go through Safe navigational procedure and discuss salient features with all bridge team members.
3. As per vessel, Pilot Hotel was onboard while incident took place so we have banned this pilot from our vessels due his adamant nature as he was reluctant in turning the vessel before approaching the berth.
