Maritec Tanker Management Private Limited

Incident Reports Details

Vessel : Morbihan	Defect ID : 134	NCR # :	Is NCR ? : No
-------------------	-----------------	---------	---------------

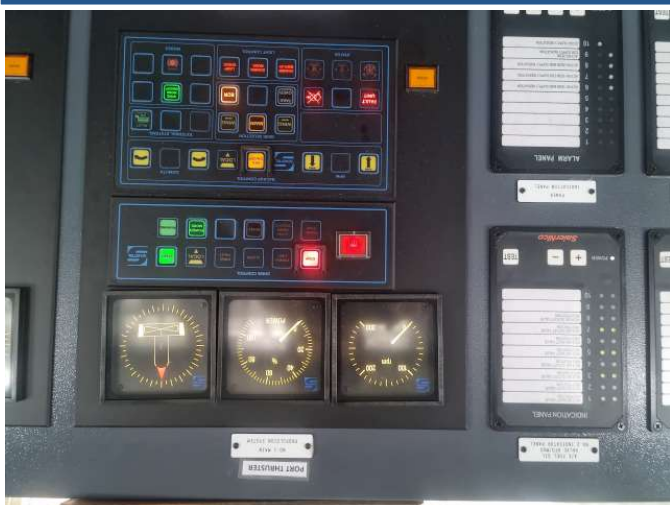
Before

On 07.04.2024/12:15 vessel's propulsion system has power failure for Port side Azimuth Thruster due to AE No.1 tripped. Starboard Azimuth Thruster was remaining in working condition and allowed vessel to make speed 3-4 knots. Port side Azimuth Thruster was restarted by crew and at 15:36 vessel resumed proceeding as per Voyage order and Thrusters running on max.190 RPM. AE No.1 does not have voltage and still under investigation.

AE No.1 tripped off. Port Azimuth thruster has failure of power supply.
