Vessel : Bitu Atlantic	Defect ID : 272	NCR # :	Is NCR ? : No
------------------------	-----------------	---------	---------------

Date : 07-Jun-2023  
Place : Dakar  
Berth : 91  
Length of the berth : 230Mtrs  
Total fenders : 9no  
Dist between 2 fenders : 25 mtrs  
Width of the fender : 0.90mtr  
Draft F: 6.40Mtr, A: 9.0Mtr  
Parallel body of a ship in partly loaded condition : 90Mtrs

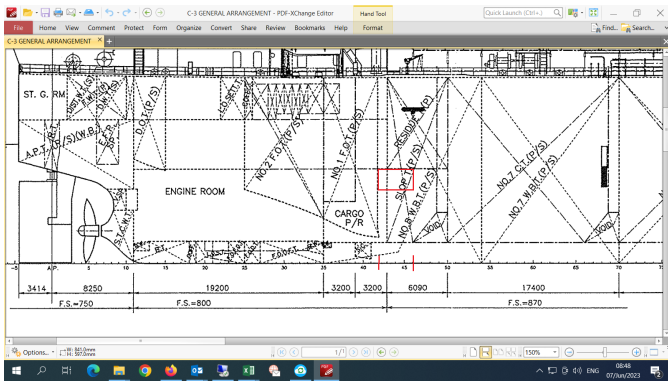
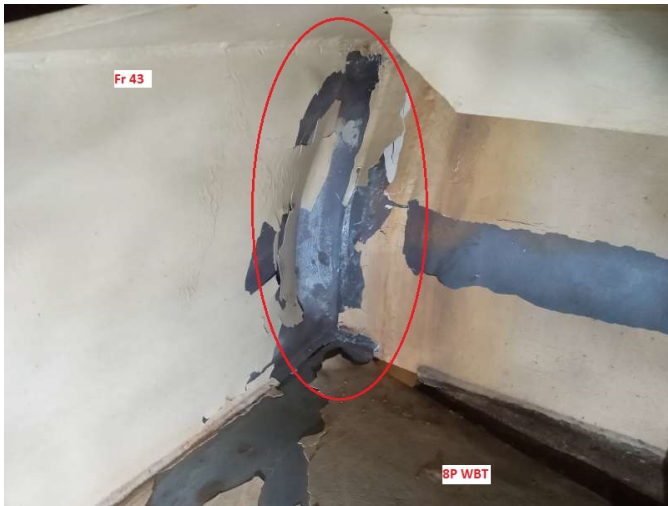
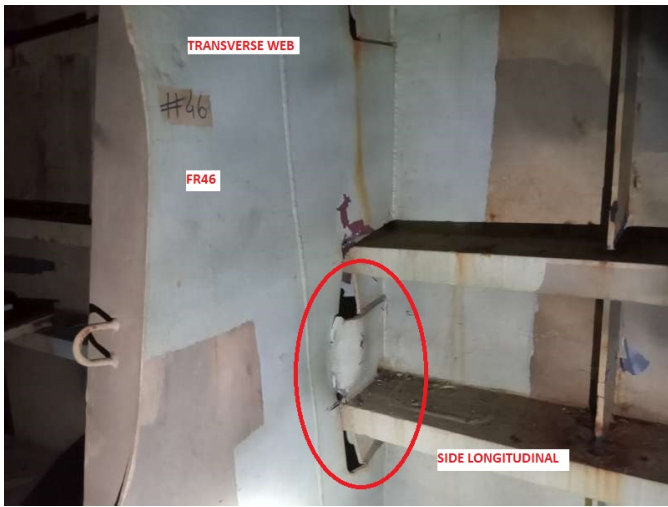
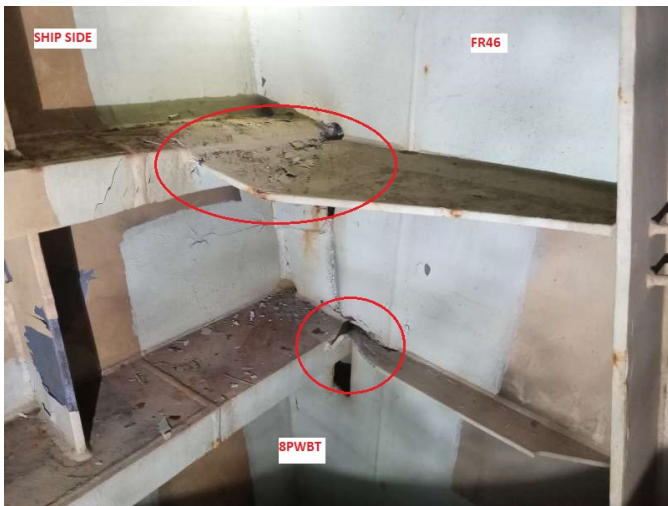
V/I has pilot on board and 2 tug's fast, 1 tug fwd S shoulder & 1 Tug aft centrelead. Both the tugs were of 50T bollard pull. During berthing of the vessel when vessel was parallel to the jetty in position and 10mtrs outward from the berth, than pilot instructed both the tugs(in french language) to push(min power) the vessel to come alongside self asked what orders has been given and reminded to communicate in English. After the order found that aft tug already pushed but fwd tug has not started pushing which resulted in stern started swinging in & bow out which was immediately pointed out to pilot by the time action has taken by the fwd tug the aft curved ships hull (near break of accomodation) already contacted the jetty. Resulting in an indentation on the ship side as well as minor damage to the jetty.

14/Jun/2023	Nawin Khaware	<p>Details of damages received from vessel are as follows :</p> <p>Ship side</p> <p>1) The indentation on ship side(Fr 42-43) &amp; Fr 46. (Find attached pics in FOLDER 1)</p> <p>Internal Damage(Seen from pumproom) (Side Longitudinal SL 10a)</p> <p>2) No.1 P HSFO tk (Fr 42) Buckling of Bulkhead plate.</p> <p>3) No.8 p WBT (Fr 43) buckling of bulkhead plate. (Find attached pics in FOLDER 2)</p> <p>Internal damage (In 8p WBT tk ) (Side Longitudinal SL 10a)</p> <p>4) Pic (8P WBT FR 43): Buckling of bulkhead plate (also shown the same buckling from proom side in folder 2).</p> <p>5) Pic(FR 46 8P WBT(1)) : Soft toe bracket bent at Fr 46.</p> <p>6) Pic(FR46 8P WBT OTHER SIDE) : Lug bent at Fr 46.</p> <p>7) Pic (FR47 8P WBT) : Welding cracked on vertical stiffener at Fr 47. (Find attached pics in FOLDER 3)</p>	
14/Jun/2023	Nawin Khaware	<p>After having discussion with Master &amp; basis analysis of all submitted evidence, Following are the identified root cause of this incident :</p> <ol style="list-style-type: none"> <li>1. Master-Pilot exchange was not effective</li> <li>2. Communication between Pilot &amp; Tug boats was in local language of French, So Master was unaware of the orders passed on by Pilot to Tug boats.</li> <li>3. Approach speed towards jetty was considerably high : Aft Tug was not controlled well as she was pushing hard resulting in gathering higher speed in athwartship direction by the vessel. Vessel does not have any means to control the speed in athwartship direction and during berthing vessel has to purely dependent on Tug boats to come alongside.</li> </ol> <p>Preventive Measures:</p> <ol style="list-style-type: none"> <li>1. Fleet wide awareness will be created to warn all our vessel Master to be vigilant and pay special attention towards approach speed of the vessel at the time of berthing.</li> <li>2. Ensure Master-Pilot exchange is effective and always ask pilot to communicate in English language while giving any orders to Tug boats/Bridge Teams.</li> <li>3. Bridge Team should remain alert during berthing/unberthing operation and monitor ship's approach speed properly and report to Master/Pilot as deemed necessary.</li> <li>4. Master should remain in command all the time and treat pilot as his adviser.</li> <li>5. Over-reliance on Pilot's action to be avoided.</li> </ol>

- 1) Reminded pilot to communicate in English.
- 2) Immediately told aft tug to control the aft swing of the vessel.

- 1) Follow SMS ( Follow Pilot card checklist. Working language between Bridge team and pilot, Pilot and shore team as per the pilot card is english language.)
