## Maritec Tanker Management

### Incident Reports Details

Vessel : Bitu Atlantic	Defect ID : 272	NCR # :	Is NCR ? : No
------------------------	-----------------	---------	---------------

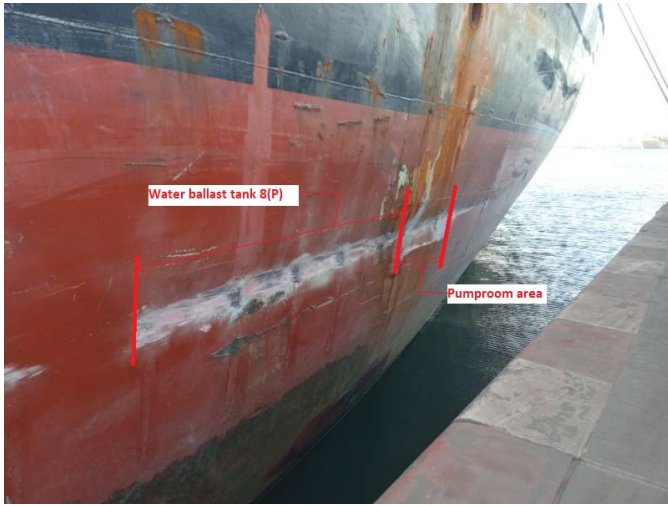
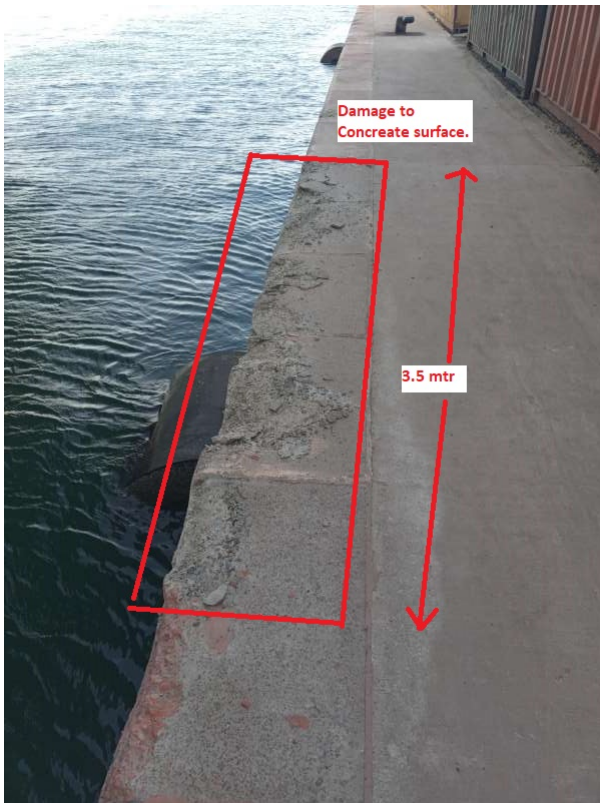
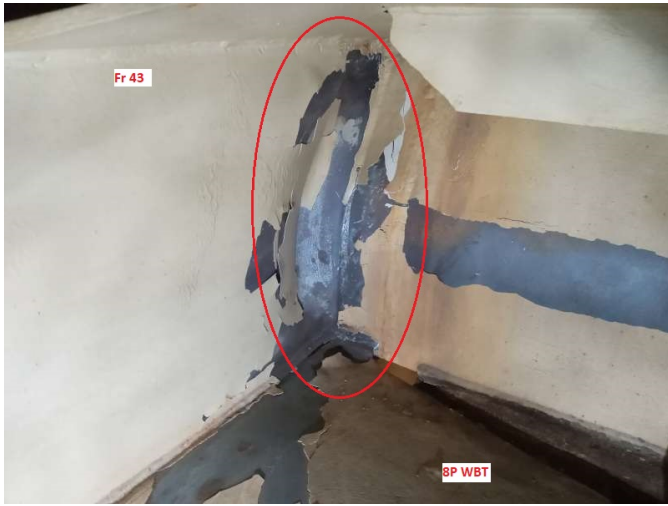
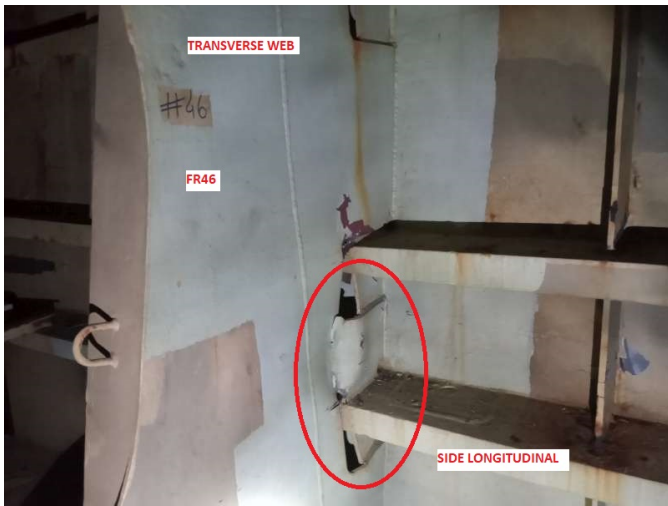
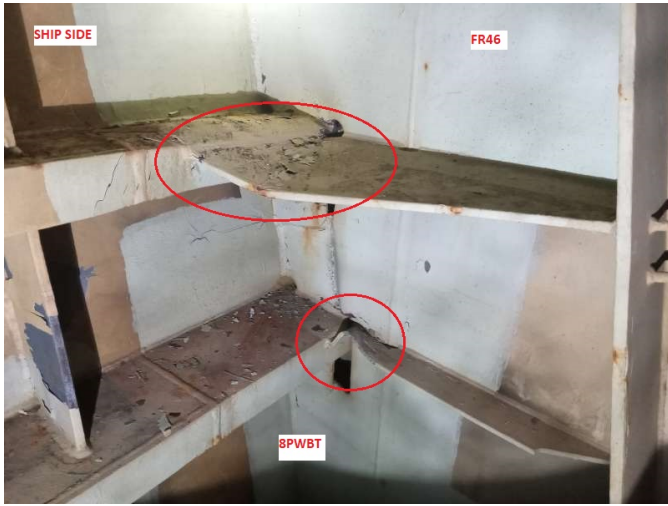
Before & After Pictures	
Before	After

V/I has pilot on board and 2 tug's fast, 1 tug fwd S shoulder & 1 Tug aft centrelead. Both the tugs were of 50T bollard pull. During berthing of the vessel when vessel was parallel to the jetty in position and 10mtrs outward from the berth, than pilot instructed both the tugs(in french language) to push(min power) the vessel to come alongside self asked what orders has been given and reminded to communicate in English.  
After the order found that aft tug already pushed but fwd tug has not started pushing which resulted in stern started swinging in & bow out which was immediately pointed out to pilot by the time action has taken by the fwd tug the aft curved ships hull (near break of accomodation) already contacted the jetty.  
Resulting in an indentation on the ship side as well as minor damage to the jetty.

14/Jun/2023	Nawin Khaware	<p>Details of damages received from vessel are as follows :</p> <p>Ship side</p> <p>1) The indentation on ship side(Fr 42-43) &amp; Fr 46. (Find attached pics in FOLDER 1)</p> <p>Internal Damage(Seen from pumproom) (Side Longitudinal SL 10a)</p> <p>2) No.1 P HSFO tk (Fr 42) Buckling of Bulkhead plate.</p> <p>3) No.8 p WBT (Fr 43) buckling of bulkhead plate. (Find attached pics in FOLDER 2)</p> <p>Internal damage (In 8p WBT tk ) (Side Longitudinal SL 10a)</p> <p>4) Pic (8P WBT FR 43): Buckling of bulkhead plate (also shown the same buckling from proom side in folder 2).</p> <p>5) Pic(FR 46 8P WBT(1)) : Soft toe bracket bent at Fr 46.</p> <p>6) Pic(FR46 8P WBT OTHER SIDE) : Lug bent at Fr 46.</p> <p>7) Pic (FR47 8P WBT) : Welding cracked on vertical stiffener at Fr 47. (Find attached pics in FOLDER 3)</p>	
14/Jun/2023	Nawin Khaware	<p>After having discussion with Master &amp; basis analysis of all submitted evidence, Following are the identified root cause of this incident :</p> <ol style="list-style-type: none"> <li>1. Master-Pilot exchange was not effective</li> <li>2. Communication between Pilot &amp; Tug boats was in local language of French, So Master was unaware of the orders passed on by Pilot to Tug boats.</li> <li>3. Approach speed towards jetty was considerably high : Aft Tug was not controlled well as she was pushing hard resulting in gathering higher speed in athwartship direction by the vessel. Vessel does not have any means to control the speed in athwartship direction and during berthing vessel has to purely dependent on Tug boats to come alongside.</li> </ol> <p>Preventive Measures:</p> <ol style="list-style-type: none"> <li>1. Fleet wide awareness will be created to warn all our vessel Master to be vigilant and pay special attention towards approach speed of the vessel at the time of berthing.</li> <li>2. Ensure Master-Pilot exchange is effective and always ask pilot to communicate in English language while giving any orders to Tug boats/Bridge Teams.</li> <li>3. Bridge Team should remain alert during berthing/unberthing operation and monitor ship's approach speed properly and report to Master/Pilot as deemed necessary.</li> <li>4. Master should remain in command all the time and treat pilot as his adviser.</li> <li>5. Over-reliance on Pilot's action to be avoided.</li> </ol>

- 1) Reminded pilot to communicate in English.
- 2) Immediately told aft tug to control the aft swing of the vessel.

- 1) Follow SMS ( Follow Pilot card checklist. Working language between Bridge team and pilot, Pilot and shore team as per the pilot card is english language.)
