Vessel : Bitu Atlantic	Defect ID : 272	NCR # :	Is NCR ? : No
------------------------	-----------------	---------	---------------

Date : 07-Jun-2023  
Place : Dakar  
Berth : 91  
Length of the berth : 230Mtrs  
Total fenders : 9no  
Dist between 2 fenders : 25 mtrs  
Width of the fender : 0.90mtr  
Draft F: 6.40Mtr, A: 9.0Mtr  
Parallel body of a ship in partly loaded condition : 90Mtrs

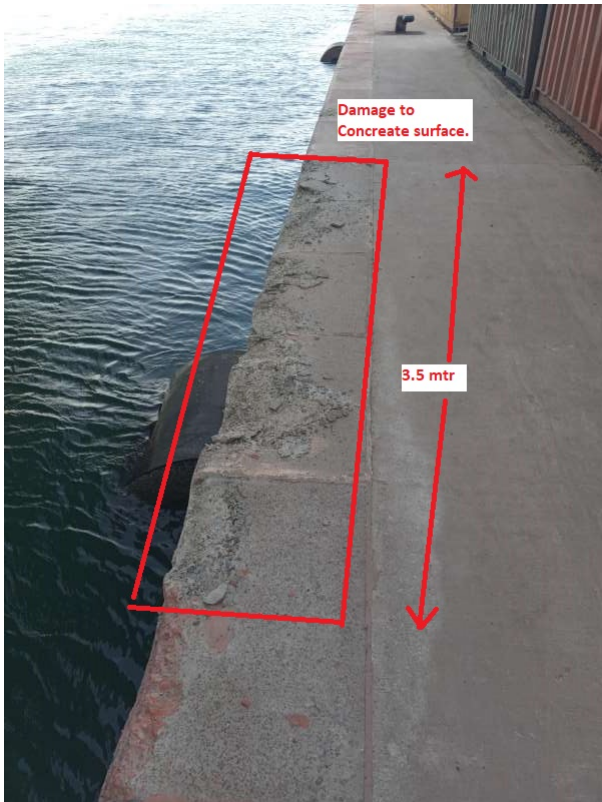
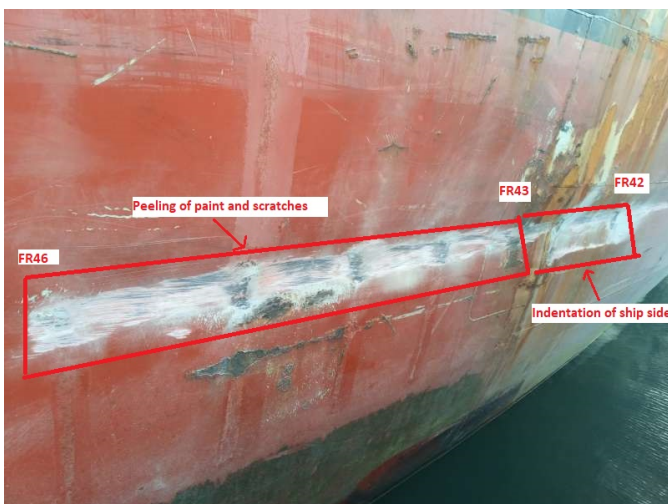
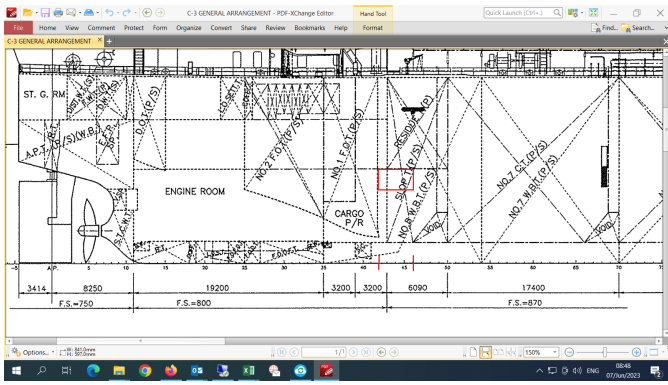
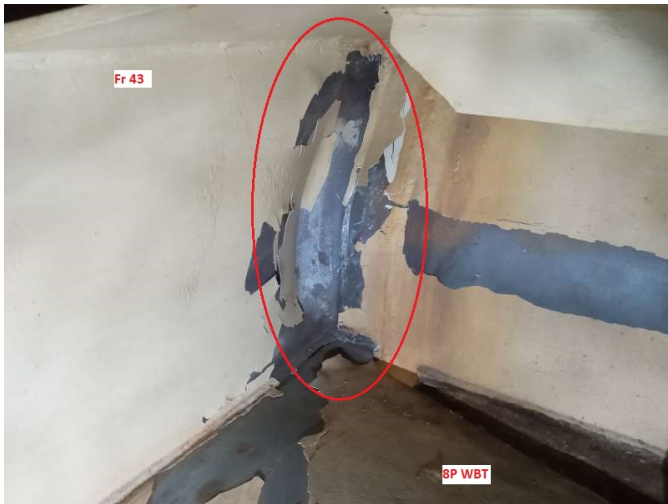
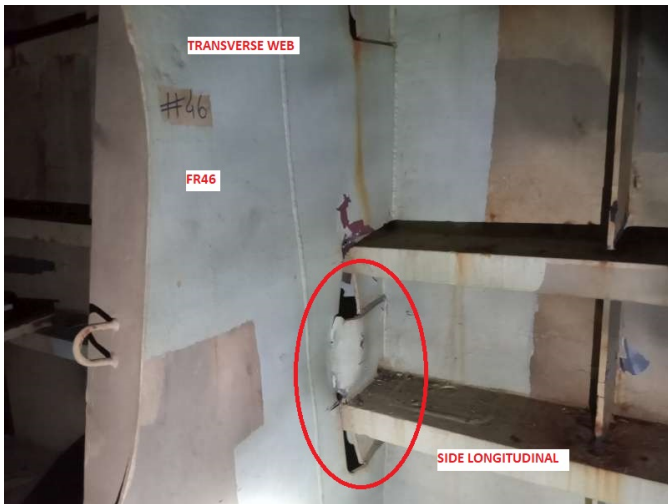
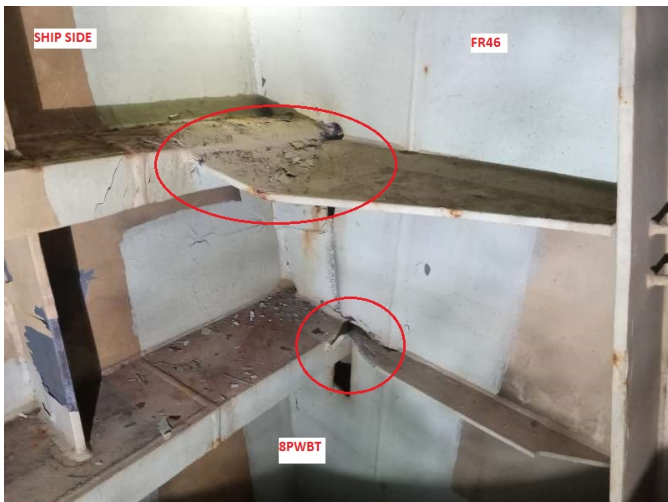
14/Jun/2023	Nawin Khaware	<p>Details of damages received from vessel are as follows :</p> <p>Ship side</p> <p>1) The indentation on ship side(Fr 42-43) &amp; Fr 46. (Find attached pics in FOLDER 1)</p> <p>Internal Damage(Seen from pumproom) (Side Longitudinal SL 10a)</p> <p>2) No.1 P HSFO tk (Fr 42) Buckling of Bulkhead plate.</p> <p>3) No.8 p WBT (Fr 43) buckling of bulkhead plate. (Find attached pics in FOLDER 2)</p> <p>Internal damage (In 8p WBT tk ) (Side Longitudinal SL 10a)</p> <p>4) Pic (8P WBT FR 43): Buckling of bulkhead plate (also shown the same buckling from proom side in folder 2).</p> <p>5) Pic(FR 46 8P WBT(1)) : Soft toe bracket bent at Fr 46.</p> <p>6) Pic(FR46 8P WBT OTHER SIDE) : Lug bent at Fr 46.</p> <p>7) Pic (FR47 8P WBT) : Welding cracked on vertical stiffener at Fr 47. (Find attached pics in FOLDER 3)</p>	
14/Jun/2023	Nawin Khaware	<p>After having discussion with Master &amp; basis analysis of all submitted evidence, Following are the identified root cause of this incident :</p> <ol style="list-style-type: none"> <li>1. Master-Pilot exchange was not effective</li> <li>2. Communication between Pilot &amp; Tug boats was in local language of French, So Master was unaware of the orders passed on by Pilot to Tug boats.</li> <li>3. Approach speed towards jetty was considerably high : Aft Tug was not controlled well as she was pushing hard resulting in gathering higher speed in athwartship direction by the vessel. Vessel does not have any means to control the speed in athwartship direction and during berthing vessel has to purely dependent on Tug boats to come alongside.</li> </ol> <p>Preventive Measures:</p> <ol style="list-style-type: none"> <li>1. Fleet wide awareness will be created to warn all our vessel Master to be vigilant and pay special attention towards approach speed of the vessel at the time of berthing.</li> <li>2. Ensure Master-Pilot exchange is effective and always ask pilot to communicate in English language while giving any orders to Tug boats/Bridge Teams.</li> <li>3. Bridge Team should remain alert during berthing/unberthing operation and monitor ship's approach speed properly and report to Master/Pilot as deemed necessary.</li> <li>4. Master should remain in command all the time and treat pilot as his adviser.</li> <li>5. Over-reliance on Pilot's action to be avoided.</li> </ol>
