Maritec Tanker Management

Incident Reports Details

Vessel : Bitu Atlantic	Defect ID : 272	NCR # :	Is NCR ? : No
------------------------	-----------------	---------	---------------

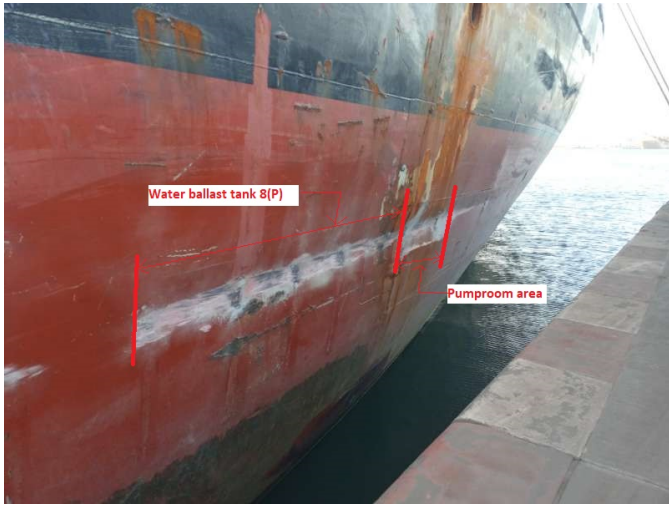
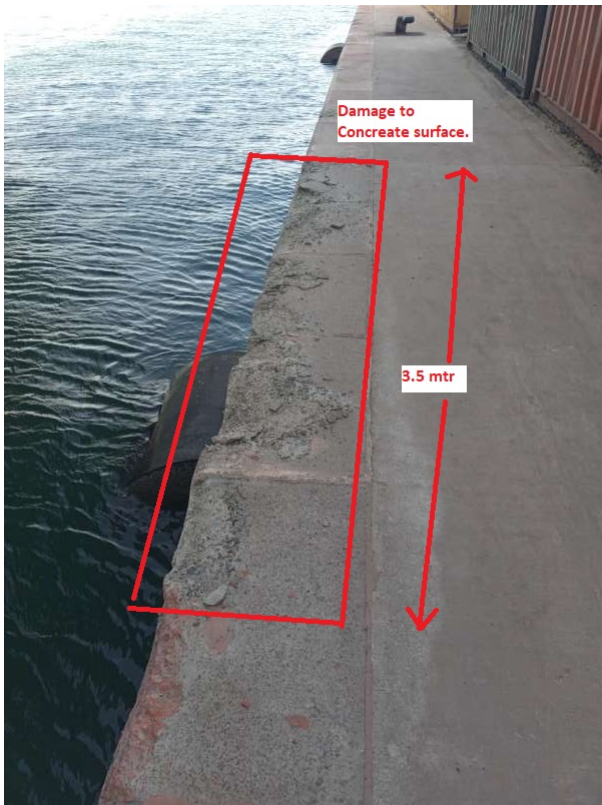
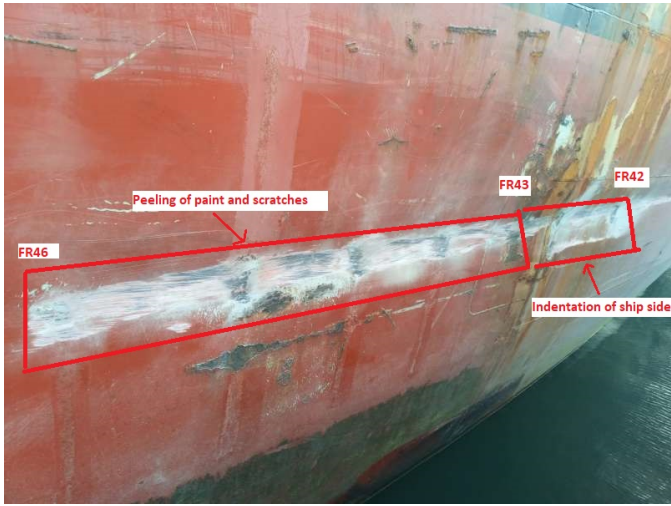
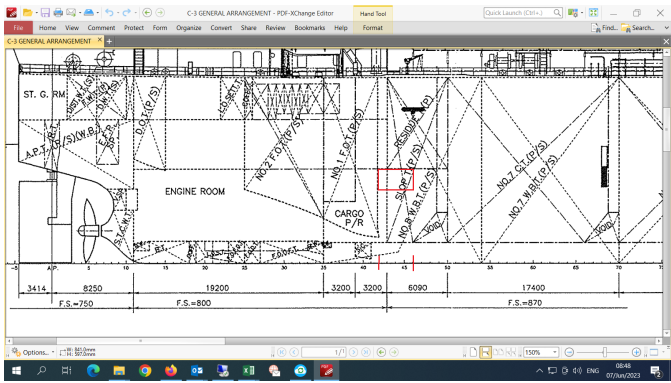
Before

V/I has pilot on board and 2 tug's fast, 1 tug fwd S shoulder & 1 Tug aft centrelead. Both the tugs were of 50T bollard pull. During berthing of the vessel when vessel was parallel to the jetty in position and 10mtrs outward from the berth, than pilot instructed both the tugs(in french language) to push(min power) the vessel to come alongside self asked what orders has been given and reminded to communicate in English.
After the order found that aft tug already pushed but fwd tug has not started pushing which resulted in stern started swinging in & bow out which was immediately pointed out to pilot by the time action has taken by the fwd tug the aft curved ships hull (near break of accomodation) already contacted the jetty.
Resulting in an indentation on the ship side as well as minor damage to the jetty.

14/Jun/2023	Nawin Khaware	<p>Details of damages received from vessel are as follows :</p> <p>Ship side</p> <p>1) The indentation on ship side(Fr 42-43) & Fr 46. (Find attached pics in FOLDER 1)</p> <p>Internal Damage(Seen from pumproom) (Side Longitudinal SL 10a)</p> <p>2) No.1 P HSFO tk (Fr 42) Buckling of Bulkhead plate.</p> <p>3) No.8 p WBT (Fr 43) buckling of bulkhead plate. (Find attached pics in FOLDER 2)</p> <p>Internal damage (In 8p WBT tk) (Side Longitudinal SL 10a)</p> <p>4) Pic (8P WBT FR 43): Buckling of bulkhead plate (also shown the same buckling from proom side in folder 2).</p> <p>5) Pic(FR 46 8P WBT(1)) : Soft toe bracket bent at Fr 46.</p> <p>6) Pic(FR46 8P WBT OTHER SIDE) : Lug bent at Fr 46.</p> <p>7) Pic (FR47 8P WBT) : Welding cracked on vertical stiffener at Fr 47. (Find attached pics in FOLDER 3)</p>	
14/Jun/2023	Nawin Khaware	<p>After having discussion with Master & basis analysis of all submitted evidence, Following are the identified root cause of this incident :</p> <ol style="list-style-type: none"> 1. Master-Pilot exchange was not effective 2. Communication between Pilot & Tug boats was in local language of French, So Master was unaware of the orders passed on by Pilot to Tug boats. 3. Approach speed towards jetty was considerably high : Aft Tug was not controlled well as she was pushing hard resulting in gathering higher speed in athwartship direction by the vessel. Vessel does not have any means to control the speed in athwartship direction and during berthing vessel has to purely dependent on Tug boats to come alongside. <p>Preventive Measures:</p> <ol style="list-style-type: none"> 1. Fleet wide awareness will be created to warn all our vessel Master to be vigilant and pay special attention towards approach speed of the vessel at the time of berthing. 2. Ensure Master-Pilot exchange is effective and always ask pilot to communicate in English language while giving any orders to Tug boats/Bridge Teams. 3. Bridge Team should remain alert during berthing/unberthing operation and monitor ship's approach speed properly and report to Master/Pilot as deemed necessary. 4. Master should remain in command all the time and treat pilot as his adviser. 5. Over-reliance on Pilot's action to be avoided.
