## Maritec Tanker Management

### Incident Report's Details

Vessel : Bahama Blue	Defect ID : 89	NCR # :	Is NCR ? : No
----------------------	----------------	---------	---------------

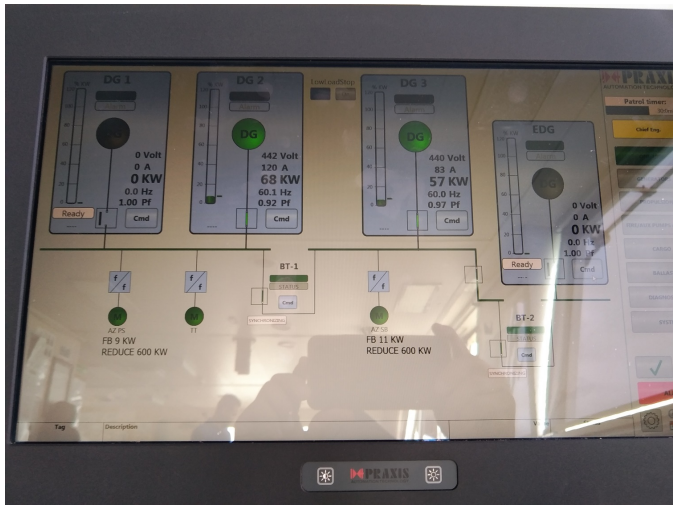
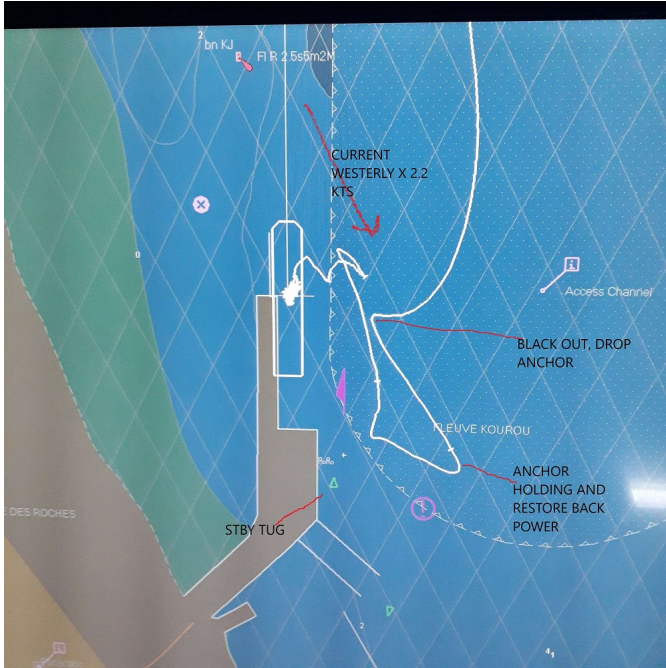
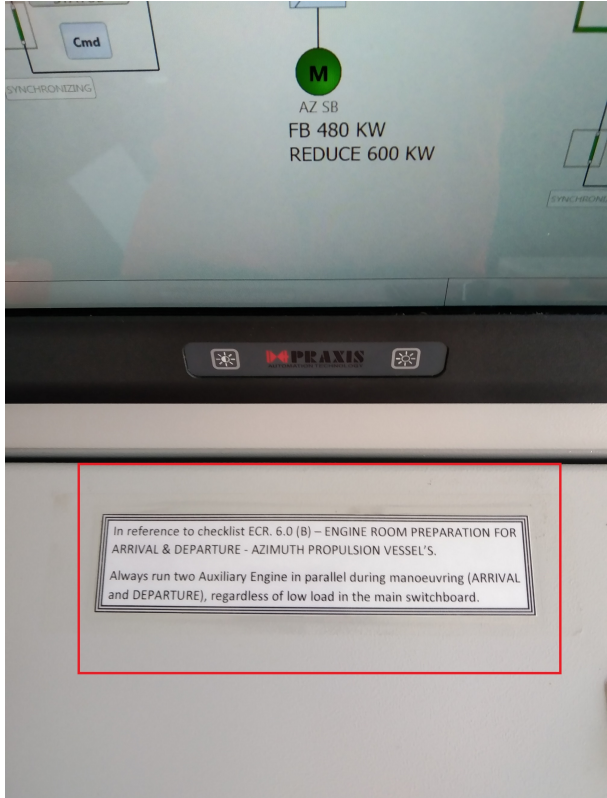
At around 07:22 HLT, 08th November 2021, during vessel manoeuvring (berthing) here at Kouro, French Guiana, vessel experience loss of propulsion due to (black out). Kindly find series of events: At 07:11 during vessel approach to berth using two main auxiliary engine, the propulsion power was reduce as vessel approaching berth. Alarm activated to both auxiliary engine, which always happening when reducing the RPM. Having very low load on main busbar at around 50kw to both engine, we decided to stop no. 3 auxiliary engine. At 07:22 hrs alarm for UPS power fail out, followed by series of alarms, general alarm to bow thruster, and trip of number 2 auxiliary engine which is on service causing black out. The same time number 3 auxiliary engine automatically started and come on load. Within a minute we have manage to drop stbd anchor and restore back the power to stbd main propulsion and bow thruster. At 07:54 Hrs vessel was safely alongside portside at SARA berth.

Trip - off of running auxiliary engine on service / From low load to sudden increase of load.

Dropped starboard anchor to avoid drift toward shore / bridge. Auto start of standby auxiliary engine, reset the frequency converter and manage to start starboard main thruster and bow thruster. Request to stanby the tug which was on the berth through the pilot.

Always run two Auxiliary Engine in parallel during manoeuvring ( ARRIVAL / DEPARTURE) regardless of low load in the main switchboard. After vessel was securely moored, meeting was held with concerned crew and discussed the incident and the measures to prevent reoccurrence.
