Maritec Tanker Management

Incident Reports Details

Vessel : Demerara	Defect ID : 16	NCR # : 1/2023	Is NCR ? : Yes
-------------------	----------------	----------------	----------------

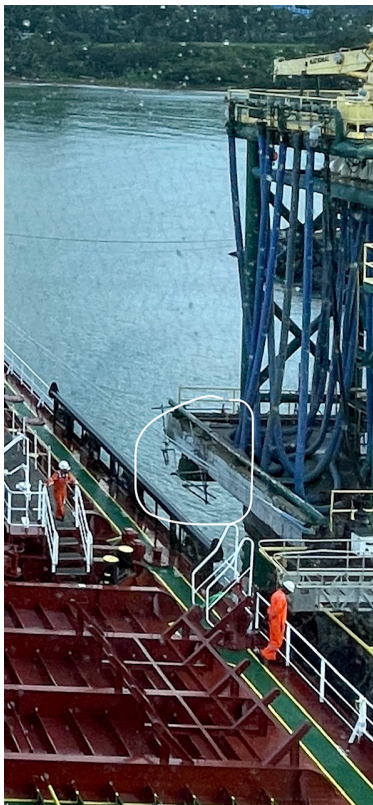
On 08.02.2023 at 21.30 LT during berthing manoeuvre with stbd in Cul de Sac / St. Lucia, the bow thruster suddenly failed shortly after used and the ship touched the scaffolding of the berth which were coming out from the berth as attached.

As a result, scaffoldings scratched the ship's paint in the starboard side as attached. Tub boat was in assistance as usual but not fasted.

Bow thruster failure under investigation under GC 0036, waiting reply from the maker. Bow thruster was at 50% and breaker overloaded from unknown reasons.

Bow thruster electrical circuits under investigation and vessel staff informed regarding present situation.

Carry out the operational test of all navigational equipments prior calling to any port to avoid recurrence of such issues in future.
