## Maritec Tanker Management

### Incident Reports Details

Vessel : Demerara	Defect ID : 16	NCR # : 1/2023	Is NCR ? : Yes
-------------------	----------------	----------------	----------------

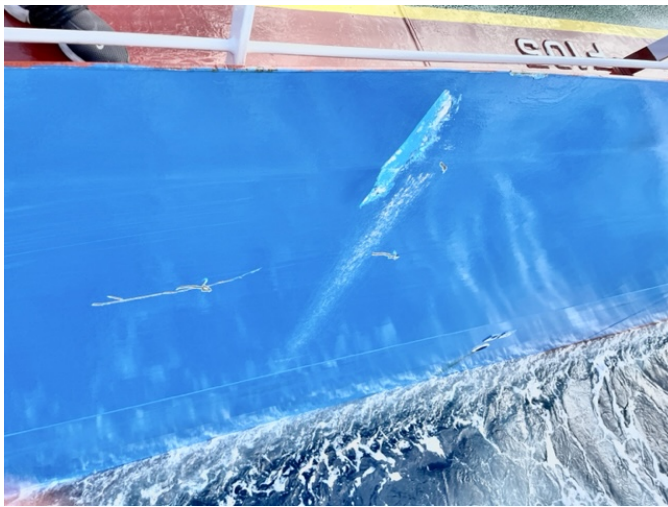
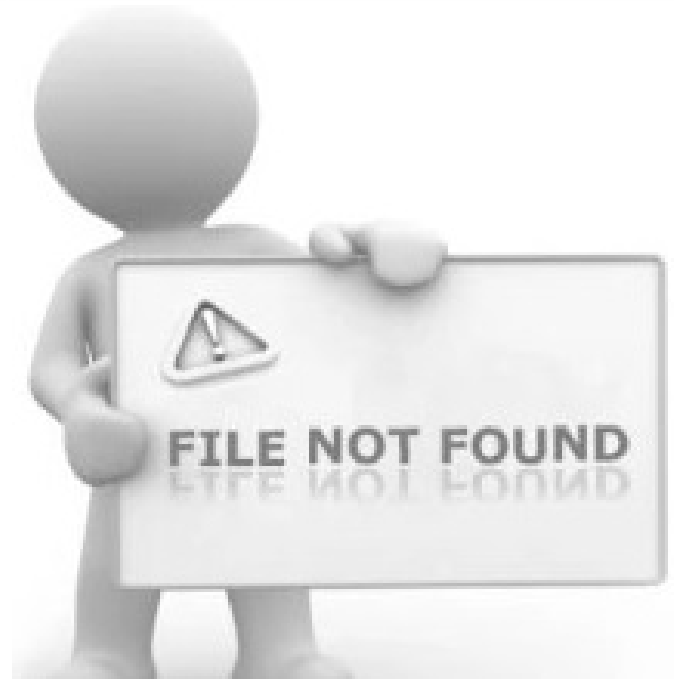
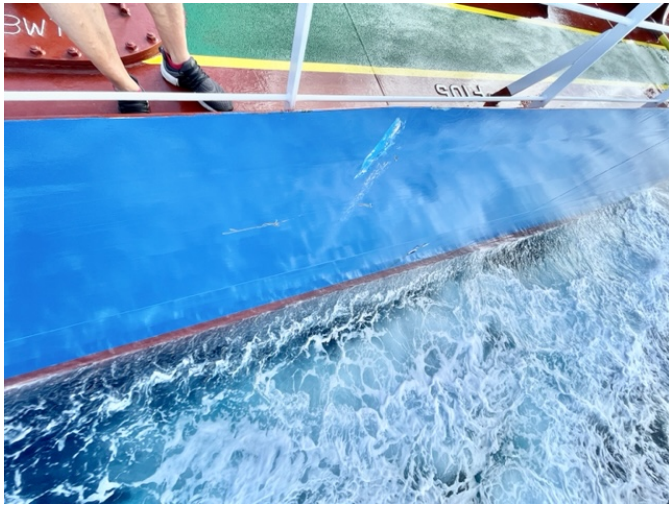
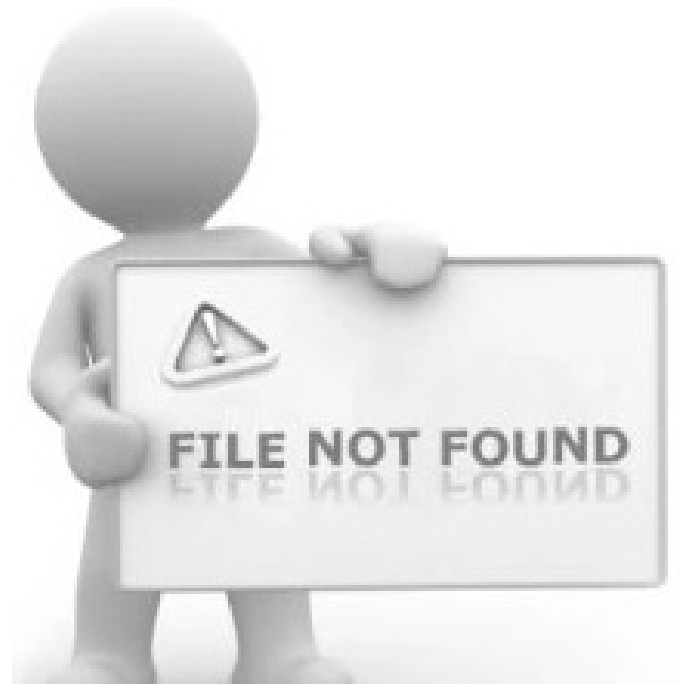
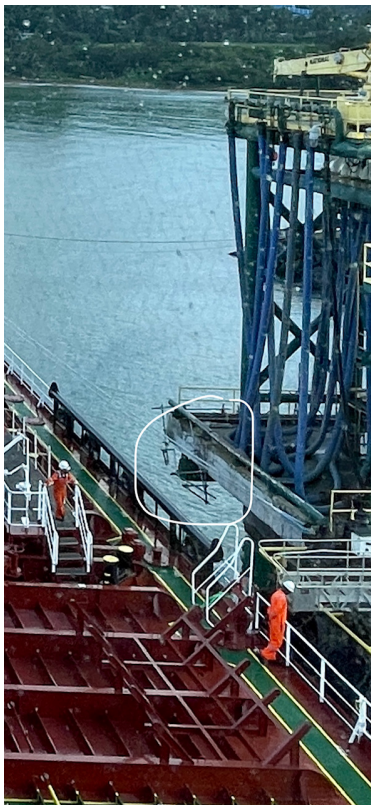
On 08.02.2023 at 21.30 LT during berthing manoeuvre with stbd in Cul de Sac / St. Lucia, the bow thruster suddenly failed shortly after used and the ship touched the scaffolding of the berth which were coming out from the berth as attached.

As a result, scaffoldings scratched the ship's paint in the starboard side as attached. Tub boat was in assistance as usual but not fasted.

Bow thruster failure under investigation under GC 0036, waiting reply from the maker. Bow thruster was at 50% and breaker overloaded from unknown reasons.

Bow thruster electrical circuits under investigation and vessel staff informed regarding present situation.

Carry out the operational test of all navigational equipments prior calling to any port to avoid recurrence of such issues in future.
