# Maritec Tanker Management Private Limited

## Incident Reports Details

Vessel : Bitu River	Defect ID : 56	NCR # : 9/2023	Is NCR ? : Yes
---------------------	----------------	----------------	----------------

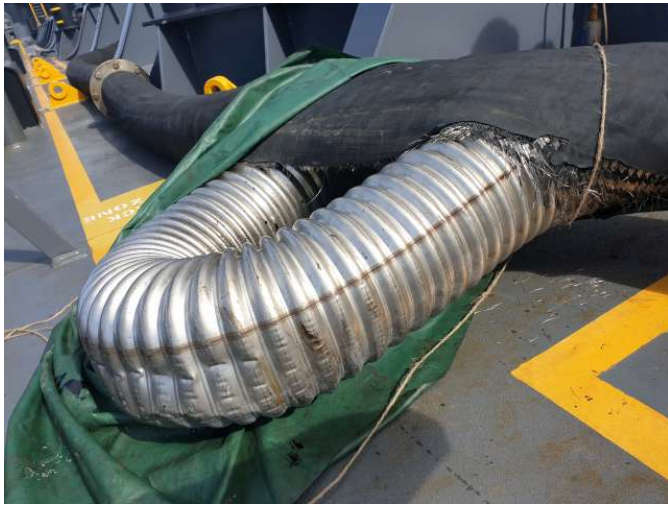
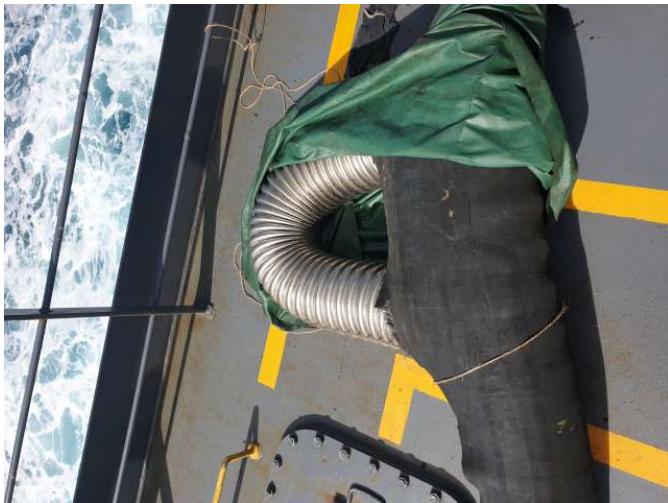
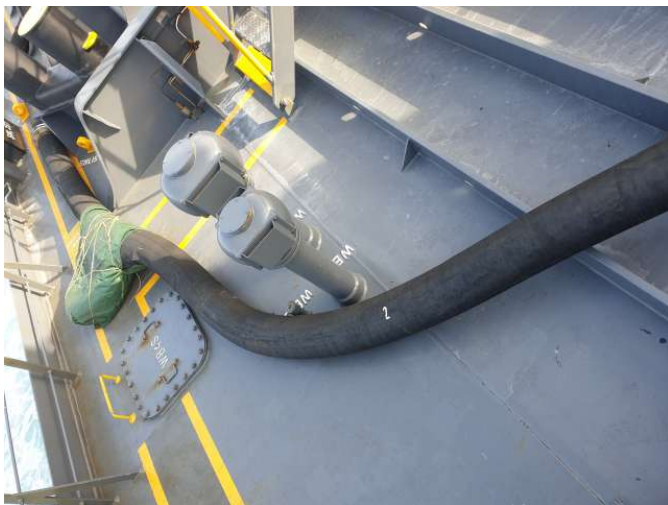
During cargo discharge completion at Cape Town,awaiting the shore to start cargo hoses air blow,sudden pressure observed at ship's manifold.Noticed that shore staff already commenced to blow shore line without informing the ship and shore valve towards ship's cargo hose was in open position which caused the sudden increase in pressure and causing the damage of ship's cargo hose no.2

Terminal tried to blow their shore line before ship's blowing the cargo hoses without informing ship's staff and without closing the shore valve .

Call terminal to stop air blowing

To be stated in ship-shore cargo operation agreement the air blowing procedure. Going forward, only vessel will be doing airblowing upon completion of cargo operation or as requested by the terminal to ensure pressure is regulated properly so that damage to hoses could be avoided.
