# Maritec Tanker Management

## Incident Report's Details

Vessel : Bitu Express	Defect ID : 183	NCR # : 23/2021	Is NCR ? : Yes
-----------------------	-----------------	-----------------	----------------

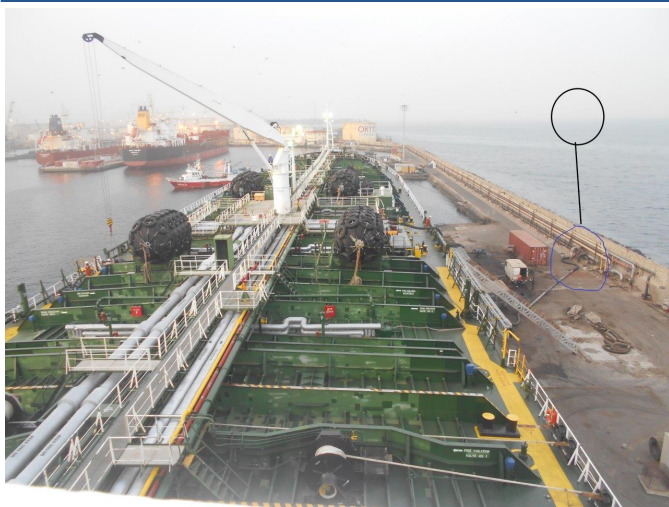
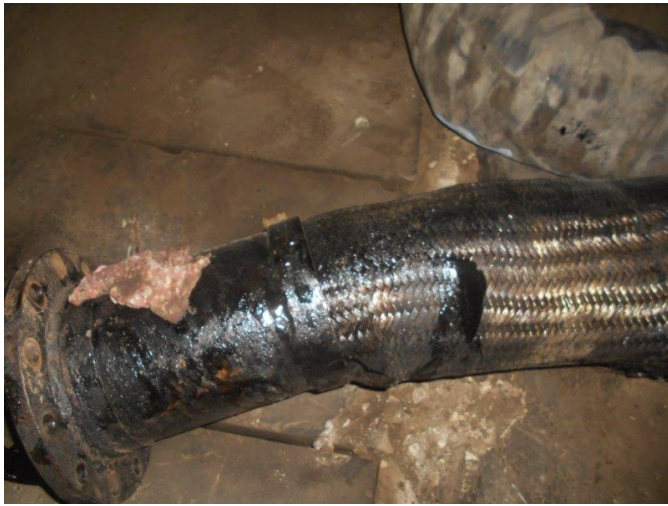
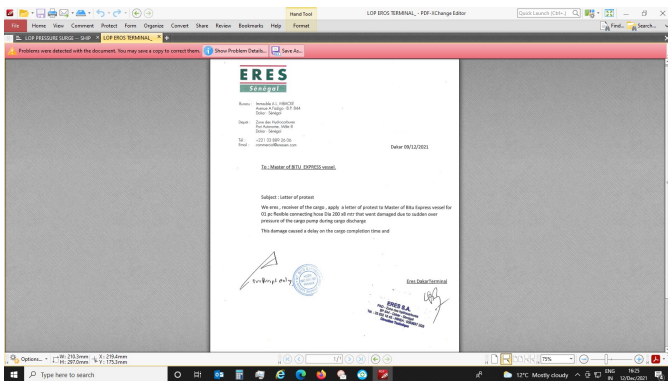
Pressure surge at manifold (0-5Bar) twice at start of operation suspect was due to obstruction in shore line.  
At 1006Hr stoppage, Terminal Rep Mr Manga from Eres requested ships hose to resume operation as shore flexi hose not suitable.  
At 1248Hr upon resuming cargo, for couple minutes pressure surge monitored (Max maintained 5Bars) and at 1254Hrs pressure was steady (Suspect shore line cleared of obstruction)  
Attached please find position of Damaged shore hose and Replaced Flexi hose used in between steel pipe shore lines.

Probable point of concern Is Bitumen obstruction in shore line

On	By	Follow Up	
14/Dec/2021	Nawin Khaware	With submitted evidence and details provided by the vessel it's evident that hose got ruptured due clogging of shore cargo line as they were using this line almost after 1.5 years so there's high chances that line must have got choked due availability of Bitumen cargo residue from previous operation. Basis above we consider this report as closed now.

Monitor carefully disch and pump pressure, keep one person on stand-by at the drop valve

Shore line must be heated and free of any bitumen obstructions.
