Maritec Tanker Management

Incident Report's Details

Vessel : Bitu Express	Defect ID : 123	NCR # : 9/2021	Is NCR ? : Yes
-----------------------	-----------------	----------------	----------------

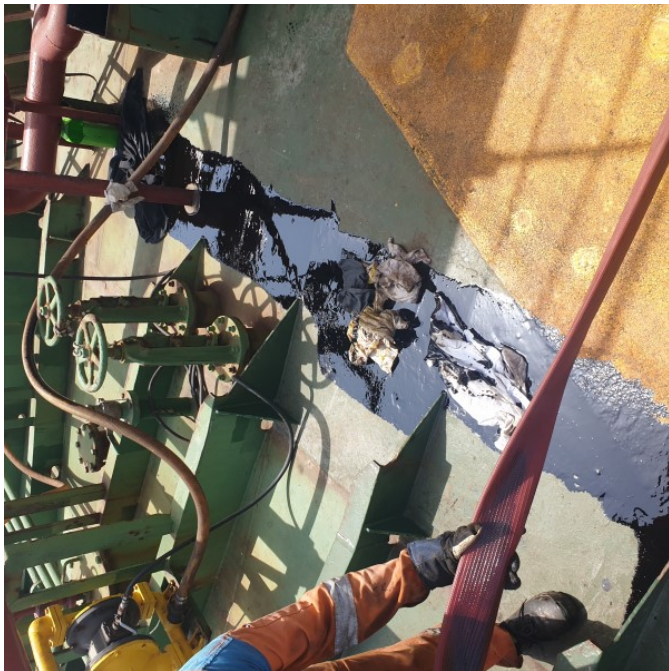
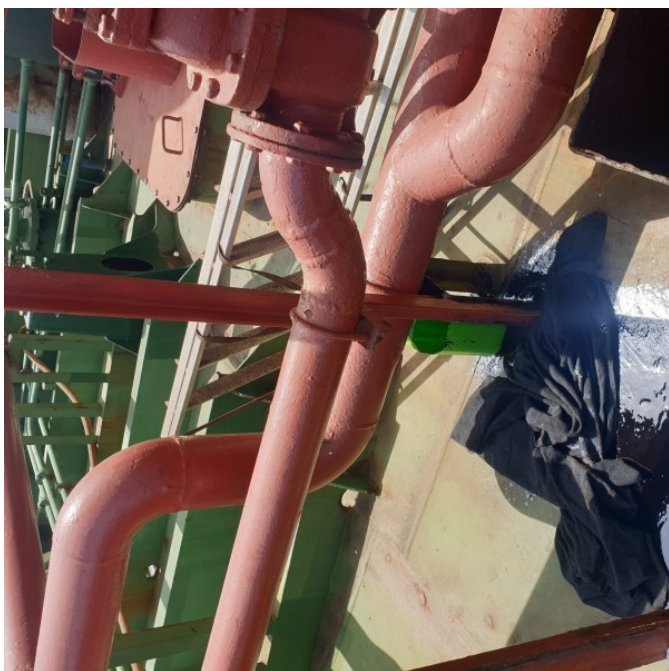
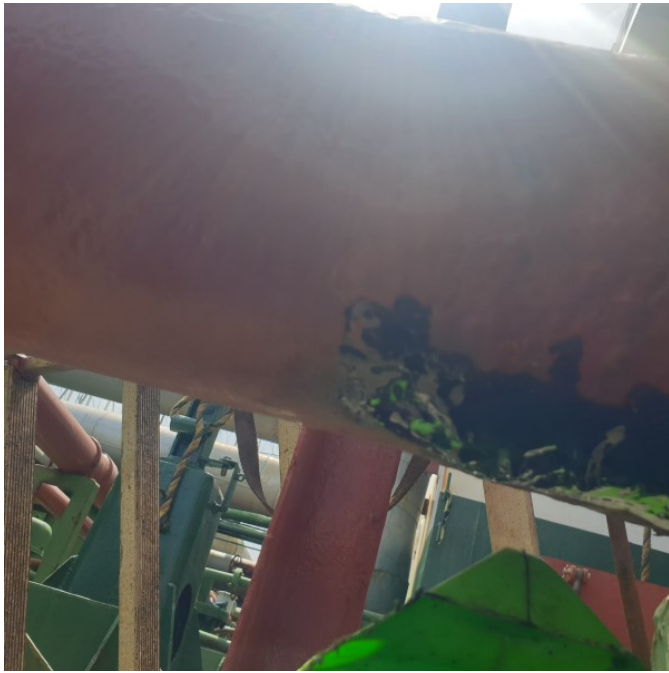
Deck Bunker line on portside, front of accommodation, has leakage from a hole on pipe.

Poor condition of material on that part of bunker pipe

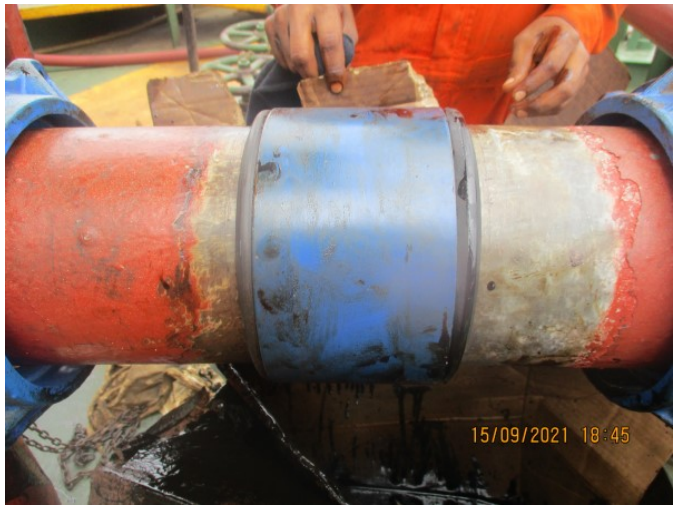
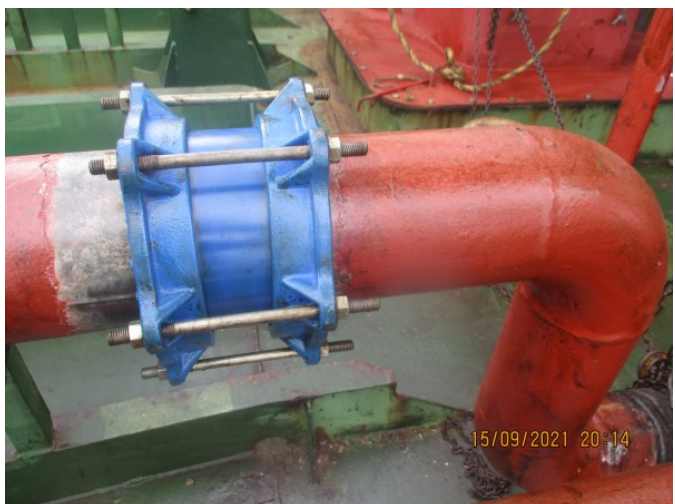
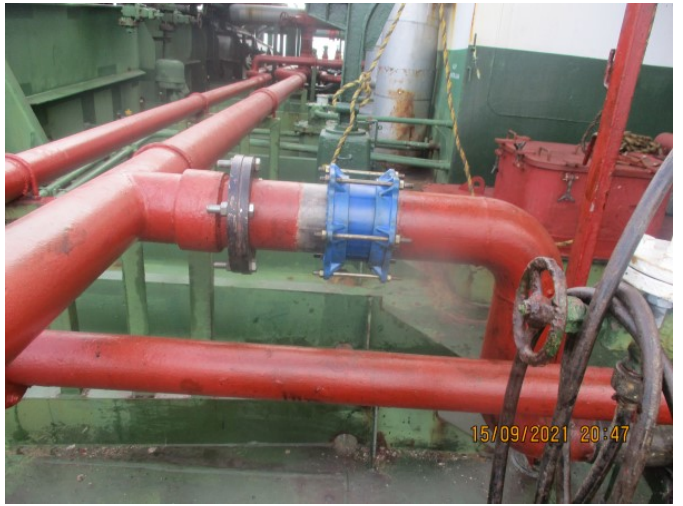
Currently temporarily repaired

To be renewed that part of pipe
