Maritec Tanker Management Private Limited

Incident Reports Details

Vessel : Bitu River	Defect ID : 61	NCR # : 1/2024	Is NCR ? : Yes
---------------------	----------------	----------------	----------------

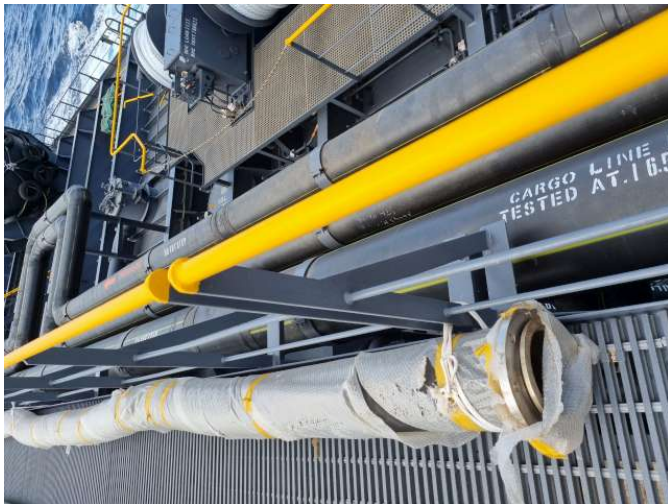
During discharging double banking at Mineral pier, the rubber protection of one cargo hose connected at manifold suddenly cracked and the metal part of hose came out. Discharge pressure at manifold during incident 2.5 bars. The discharged operation suspended and cargo hose replaced.

Poor design and quality of rubber protection(single layer)

Cargo discharged suspended and cargo hose replaced.

Purchasing a better quality of cargo hoses.
