Maritec Tanker Management

Incident Report's Details

Vessel : Bitu Atlantic	Defect ID : 263	NCR # : 2/2023	Is NCR ? : Yes
------------------------	-----------------	----------------	----------------

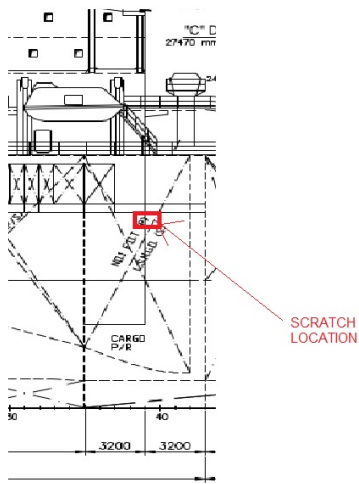
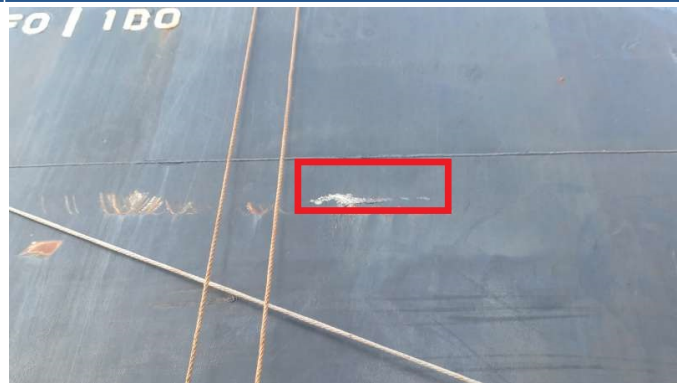
DURING THE DEPARTURE MANEUVER FROM END OF STS OPS, THE SHIP MT"XING HAI WAN" AS THE DAUGHTER VESSEL,PERFORMED THE WRONG MANEUVER SO FAST IT TOUCHED THE BODY OF OUR SHIP MT"BITU ATLANTIC" AS THE MOTHER VESSEL

On	By	Follow Up	
20/Jan/2023	Gelu Antin Staff Code - 10124 - MST	LoP issued & sent , Incident Report raised	Link1
20/Jan/2023	Gelu Antin Staff Code - 10124 - MST	CONTACT LOCATION INSPECTED , NO ANY BEND , ONLY A SCRATCH @ 40CM ON STARTBOARD SIDE BELOW LIFEBOAT BETWEEN FRAME 38-40, BELOW MAIN DECK @ 2.5 M	Link1
20/Jan/2023	Gelu Antin Staff Code - 10124 - MST	COMPANY ADPA WAS INFORMED IMMEDIATELY	Link1

STS CL TO BE CARRIED OUT PROPERLY

PROPER COMMUNICATION BETWEEN VESSELS
