Maritec Tanker Management Incident Reports Details

Vessel: Bitu Atlantic Defect ID: 268 NCR #: Is NCR ?: No

Defect Details

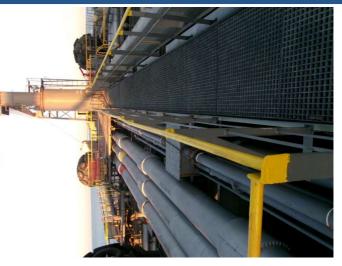
Before

During defendering operation ships railing on the catwalk near 6W COT & railing on the Midship store deformed. As fender bumped on the railing due to rolling during the defendering operation.

As vessel was rolling caused uncontrolled movement of fender resulted in damaging railings at 2 places

Fenders secured with extra guiding lines
