Maritec Tanker Management

Incident Reports Details

| Vessel : Bitu Atlantic | Defect ID : 268 | NCR # : | Is NCR ? : No |

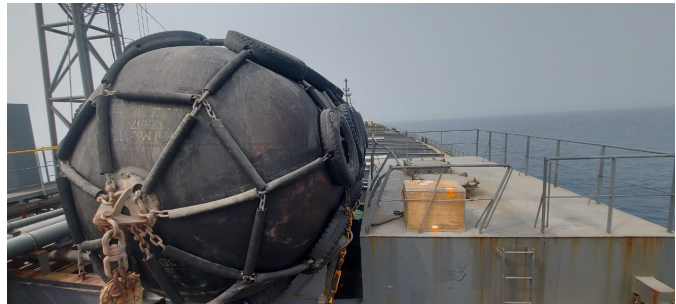
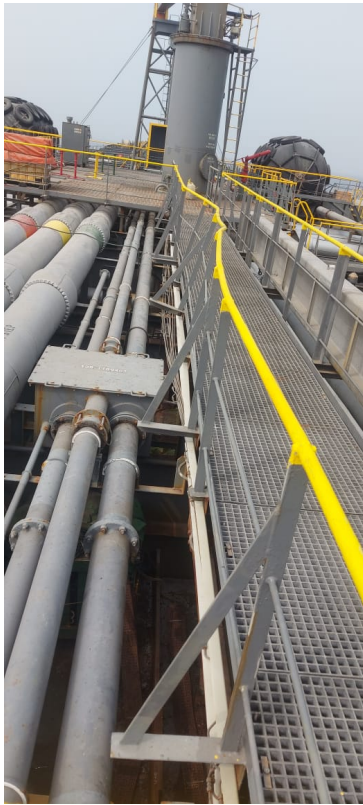
During defending operation ships railing on the catwalk near 6W COT & railing on the Midship store deformed. As fender bumped on the railing due to rolling during the defending operation.

As vessel was rolling caused uncontrolled movement of fender resulted in damaging railings at 2 places

Fenders secured with extra guiding lines
