Maritec Tanker Management Incident Reports Details

Vessel: Bitu Atlantic Defect ID: 268 NCR #: Is NCR ?: No

Defect Details

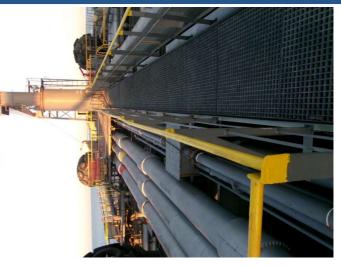
Before

During defendering operation ships railing on the catwalk near 6W COT & railing on the Midship store deformed. As fender bumped on the railing due to rolling during the defendering operation.

As vessel was rolling caused uncontrolled movement of fender resulted in damaging railings at 2 places

On	Ву	Follow Up	
07/Mar/2023	Vivek Kashyap br/> Staff Code - 10239 - MST	Straightening of railings for Midship catwalk & Midship store completed.
