Maritec Tanker Management

Incident Reports Details

Vessel : Bitu Atlantic	Defect ID : 268	NCR # :	Is NCR ? : No
------------------------	-----------------	---------	---------------

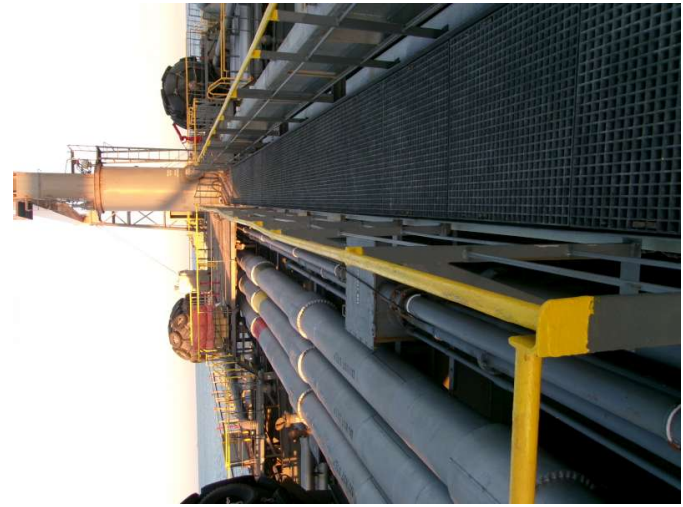
During defending operation ships railing on the catwalk near 6W COT & railing on the Midship store deformed. As fender bumped on the railing due to rolling during the defending operation.

As vessel was rolling caused uncontrolled movement of fender resulted in damaging railings at 2 places

On	By	Follow Up	
07/Mar/2023	Vivek Kashyap Staff Code - 10239 - MST	Straightening of railings for Midship catwalk & Midship store completed.
