## Maritec Tanker Management

### Incident Report's Details

Vessel : Biskra	Defect ID : 66	NCR # :	Is NCR ? : No
-----------------	----------------	---------	---------------

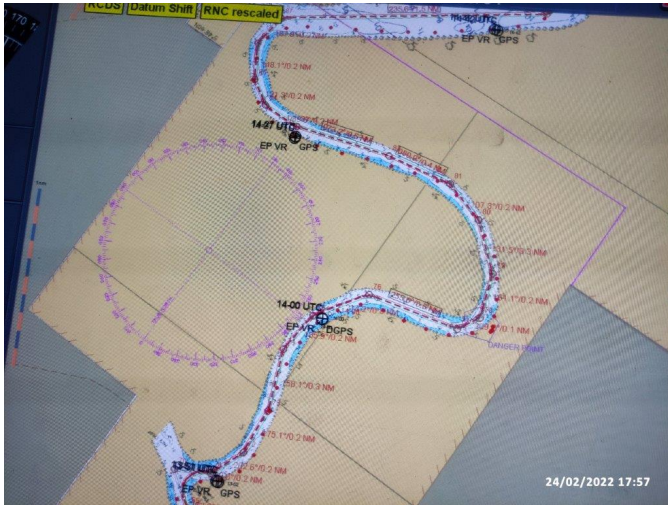
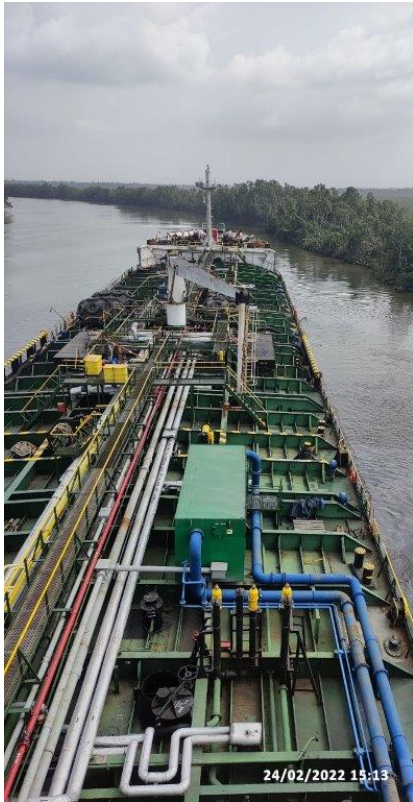
Steering very slow responding vessel on maneuvering speed ,wheel hard port and bow thruster full to port but there is very slow response in bend position lat 05-49.05N,long 005-19.33E at 1510hrs 24/02/2022.Distance from the creek around 10 meters.Continue steering hard port,bow full to port,stop the engine,slow astern until bow start swinging port and Resumed river passage.

Steering very slow responding vessel on maneuvering speed 7.1 knots ,wheel hard port and bow thruster full to port but there is very slow response in bend position lat 05-49.05N,long 005-19.33E at 1510hrs 24/02/2022.

Continue steering hard port,bow full to port,stop the engine,slow astern until bow start swinging port.

Be vigilant on this bend as per attached photo and markings on the ECDIS.
