# Maritec Tanker Management Incident Reports Details

#### **Defect Details**

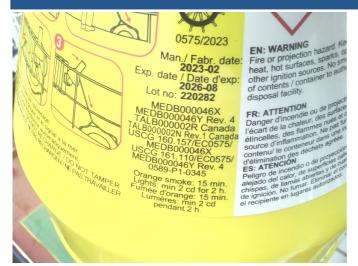
# Before

This happen that MOB buoy Light and Smoke signal(Port side) was occasionally released and activated during demonstration of procedure.

Human factor - wrong action.

Vessel raised urgent requisition BBLU-SF-V230085 - MOB buoy Light and Smoke signal and send to Purchase department. Temporarily instruction posted to use Starboard side MOB Smoke&Light signal buoy.
