Maritec Tanker Management Private Limited

Incident Reports Details

Vessel : Asphalt Teranga	Defect ID : 184	NCR # : 26/2023	Is NCR ? : Yes
--------------------------	-----------------	-----------------	----------------

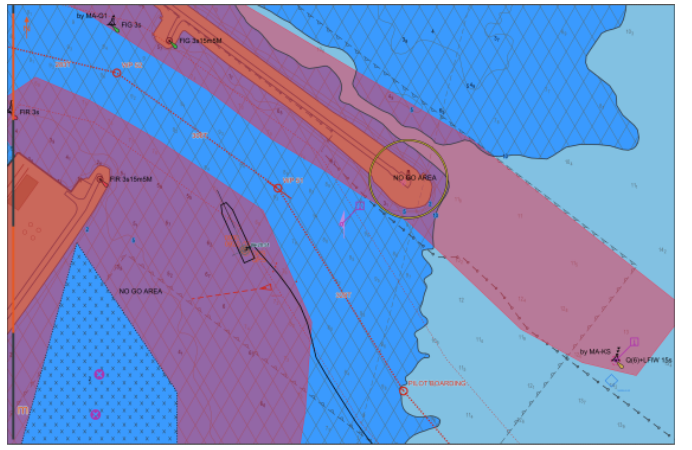
Before & After Pictures

On 28 Sept 2023 while vsl safely anchored at Mangalia Anchorage in postn 43°49.88'N, 028° 42.59'E received instruction from Mangalia Port Control at 0545LT to heave up anchor and proceed for berthing. Weather condition at the time Wind Force 6-7 (NE), Wave 1.5 - 2m.

At 0905LT in postn 43°47.7748'N 028°35.9091'E, COG:335.0°, SOG: 3.8kn, HDG:338.5°, STW:3.1kn, DPTH: 5.2m, observed some vibration from the aft part of the ship. Then at 0908LT, vsl stopped in 43°47.8774'N, 028°35.8294'E, COG:116.6°, SOG: 0.1kn, HDG:316.2°, DPTH: 2.7m. Vsl immediately engaged in astern propulsion but no success.

4. Improper monitoring of passage & Lack of situational awareness. Due strong wind and heavy swell she was continuously setting towards shallow patch and finally she ran aground on her port bow area.

1. Vessel tried to refloat by giving astern movement on engine however failed so requested with port for the assistance of two strong tug to pull her out from grounded position.
2. Vessel refloated with the help of 02 tugs and maneuvered safely to the berth.
3. Diving Team were arranged for carrying out underwater inspection to assess the damages.
