Maritec Tanker Management Private Limited

Incident Reports Details

Vessel : Asphalt Teranga	Defect ID : 184	NCR # : 26/2023	Is NCR ? : Yes
--------------------------	-----------------	-----------------	----------------

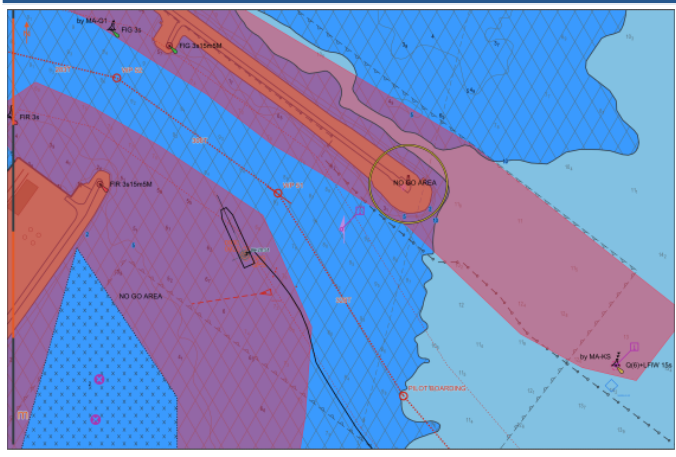
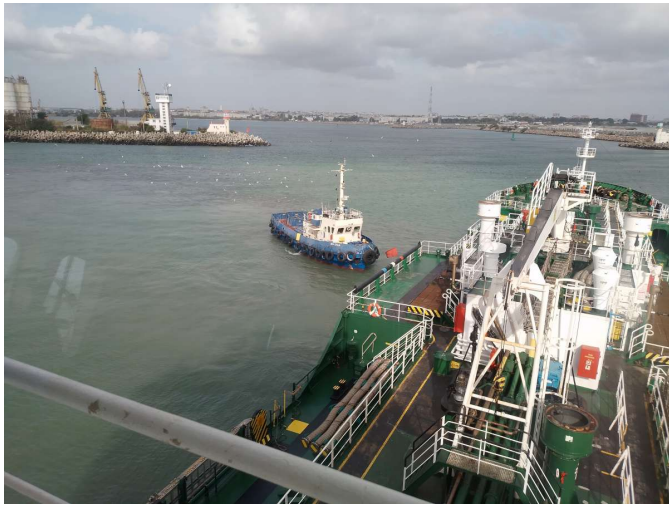
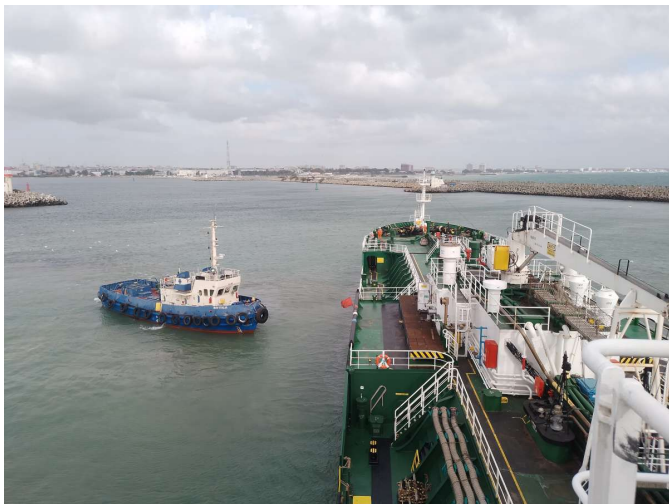
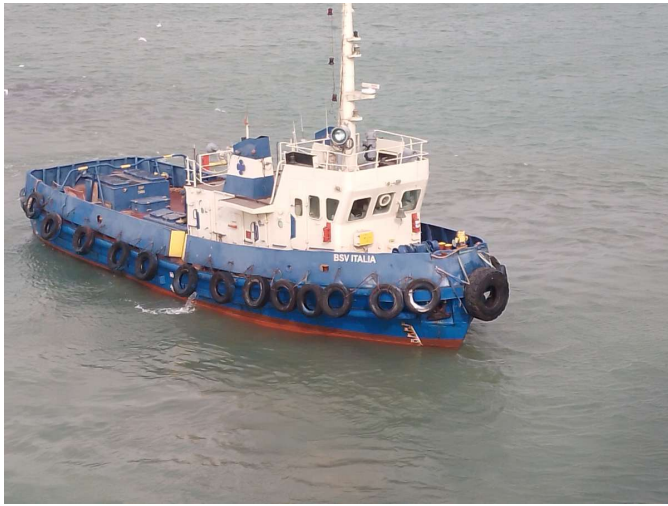
Before & After Pictures

1. Weather condition unfavourable - Wind Force 6-7 (NE), Wave 1.5 - 2m
2. Vsl went off channel and charted track due to heavy swell, current and strong wind from STBD QTR
3. Availability of only 1 tug for manuevering/berthing - Small tug and low power

1. Requested for 2 tugs assistance from Harbour Master to pull vsl out
2. Vsl floated and manuevered safely on charted track the berth with tugs assistance
