Maritec Tanker Management Private Limited

Incident Reports Details

Vessel : Asphalt Teranga	Defect ID : 184	NCR # : 26/2023	Is NCR ? : Yes
--------------------------	-----------------	-----------------	----------------

Grounding

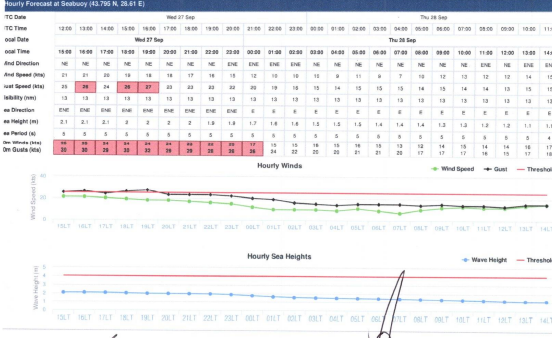
1. Weather condition unfavourable - Wind Force 6-7 (NE), Swell 1.5 - 2m
2. Vsl was unable to maintain heading due heavy swell, and strong wind experienced from stbd quarter.

Hourly Winds: Wind Speed, Gust, Threshold

Hourly Sea Heights: Wave Height, Threshold
