Maritec Tanker Management

Incident Report's Details

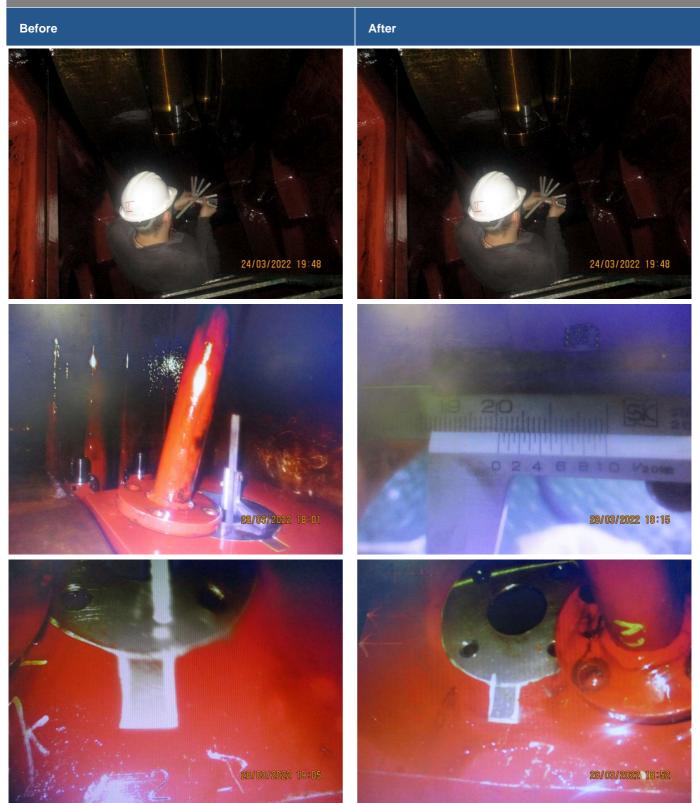
Before & After Pictures

Rev Dale . N/A			
Vessel : Bitu	Vessel : Bitu Express Defect IE		D : 189 NCR # : 5/2022		ls	Is NCR ? : Yes			
Defect Details									
24 Mar 2022 NC During the RINA (intermediate) ISM audit, NC is raised by Surveyor MR. Mohamed Anwar Abd Allah Ibrahim									
No evidence that the overdue PMS items since 02Mar2022 (M/E unit no.2,3,4,5,6,7 Main bearing, connec. Rod bearing clearence measurements) have been carried out or postponed as per the requirements of relevent procedure SMS manual Ch. 5.3.5.									
Requisition Code :									
Categories									
Primary :	Incident	ncident Inspector - I			Vessel Dept	: Engine			
Secondary :	Procedures not Followed	Inspec	ctor External :		Office Dept:	Technical			
		Inspec	ction Date :	24-Mar-2022					
Applicable Dates									
Date Raised : 29-Mar-2022			ETC : 15-Apr-2022		Date Completed :				
Other Details									
Priority : Urgent			Assigned By : Classification Society		Verified By :

Display in Daily Meeting? : No			SFI :		Verified On :				
Causes									
These PMS jobs arise on 02Mar2022. As these jobs are for ME need to be done at anchorage or at berth only. V/I was at Loading port Agioi Theodoroi(Greece) from 23rd Feb - 27th Feb where no permission was given to do the job. After sailing out from Agioi next call Lome vI reached on 13th Mar'22 where v/I was having back to back discharge STS opereaion & operation at berth. During this time vI has done many important jobs on ME which were due.									
Corrective Action									
Job code : 1092-1097 ME Connecting rod No1,2,3,4,5,& 6 bearing measurement done on 24th Mar 2022 and closed in JOT.									
Job code : 1086-1091 ME Main bearing No2,3,4,5,6 & 7 bearing measurement done on 28th Mar 2022 and closed in JOT.									
Preventive Action									
Applicable Tags									
Follow Up									
On	Ву		Follow Up

br/:	CLEARANCE F 2)RA ME inspe 3) RA enclsed 28th Mar'22 - J 1) ECR. 3.3 -N CLEARANCE F	ob completed IAIN AND AUXILIARY ENGINE BEARING REPORT FORM ction space ob completed IAIN AND AUXILIARY ENGINE BEARING REPORT FORM bearing measurement	Link1 Link2 Link3 Link4 Link5 Link6
----------	---	---	--
